**CHAIN VALLEY COLLIERY
EXTRACTION PLAN
MINIWALLS CVB1 to CVB3**

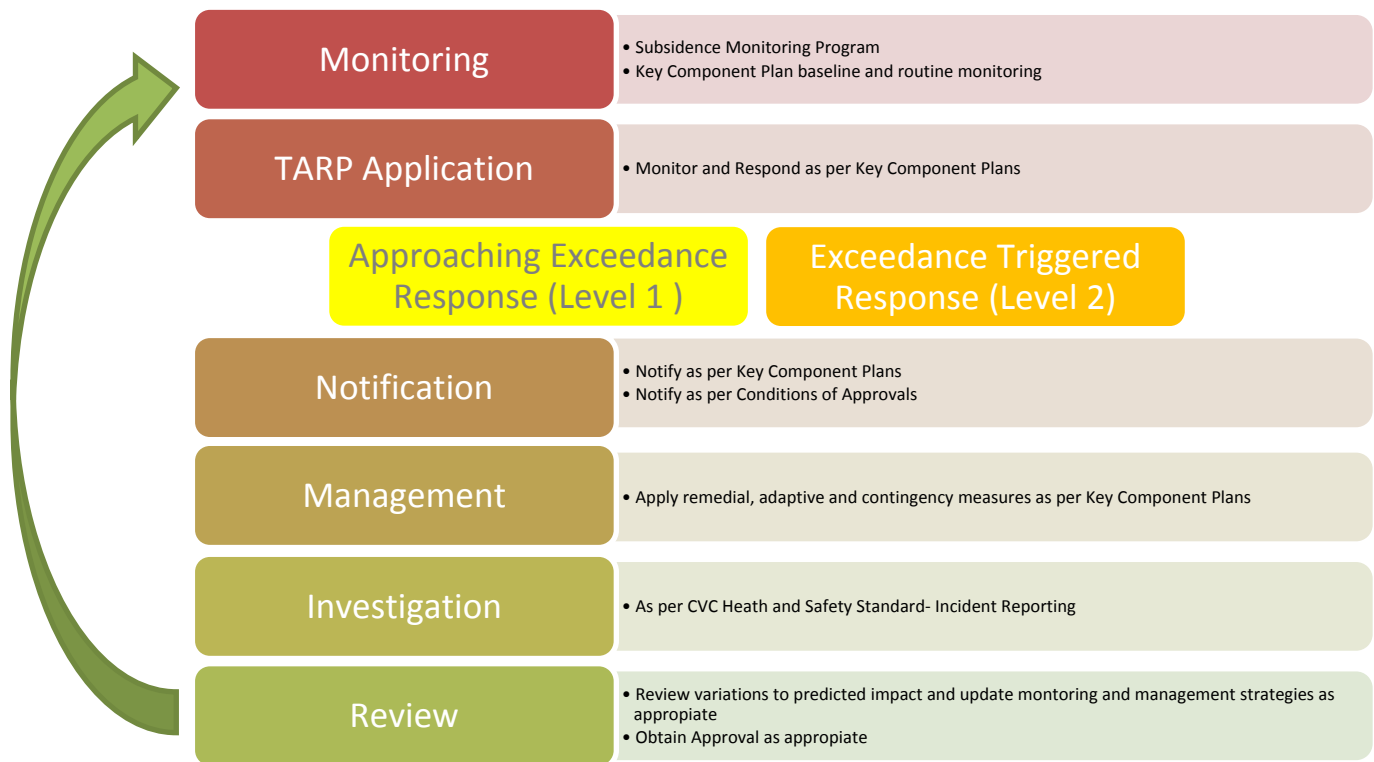
Figure 7- Subsidence Monitoring and Management Framework

The overall framework for subsidence monitoring and management of impacts under this Extraction Plan may be described by:

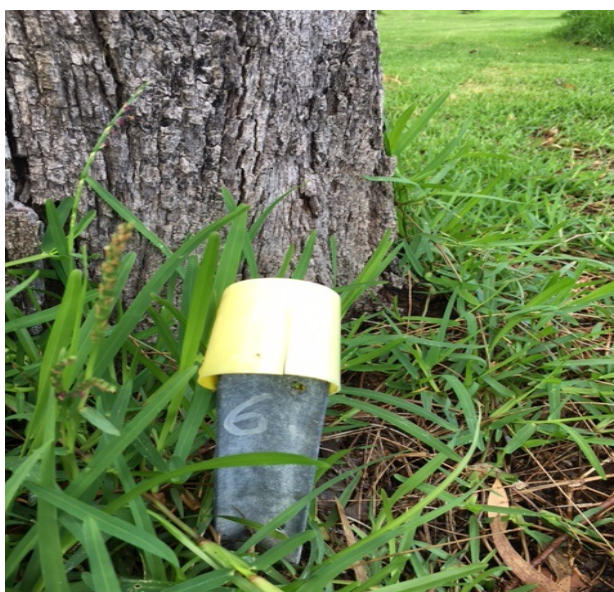
Figure 5: Example subsidence monitoring point with safety cap.

Established survey lines 23, 32 and 33a extend around the northern and eastern foreshore of Chain Valley Bay. These consist of star pickets, feno pegs and pins (**Figure 5**). These are to be monitored as per the Subsidence Monitoring Program. These routine surveys prior, during and after extraction will allow for identification and review of subsidence starting to develop outside predicted levels and thus trigger a review of any potentially new Public Safety concerns. Ongoing subsidence is expected to occur at the foreshore due to historical mine workings independent of the proposed Fassifern extraction, but will still be considered as to the need to trigger any Public Safety controls. Given this is still only limited impact (mainly <20mm and only up to 220mm above the overlying secondary worked seam areas of the northern foreshore, again public safety risk is not considered likely. Only in the event subsidence was proven to be increased at the foreshore due to Fassifern extraction (i.e. outside of predicted credible worst case) would Chain Valley Colliery be in part responsible for the impacts.

Survey pegs installed for monitoring will be clearly identified and as appropriate have ‘safety caps’ placed on them as per **Figure 5**.
