**RE: CHAIN VALLEY COLLIERY – EXTRACTION PLAN Miniwalls S1 and N1**

**CHAIN VALLEY COLLIERY  
EXTRACTION PLAN  
MINIWALLS S1 and N1**

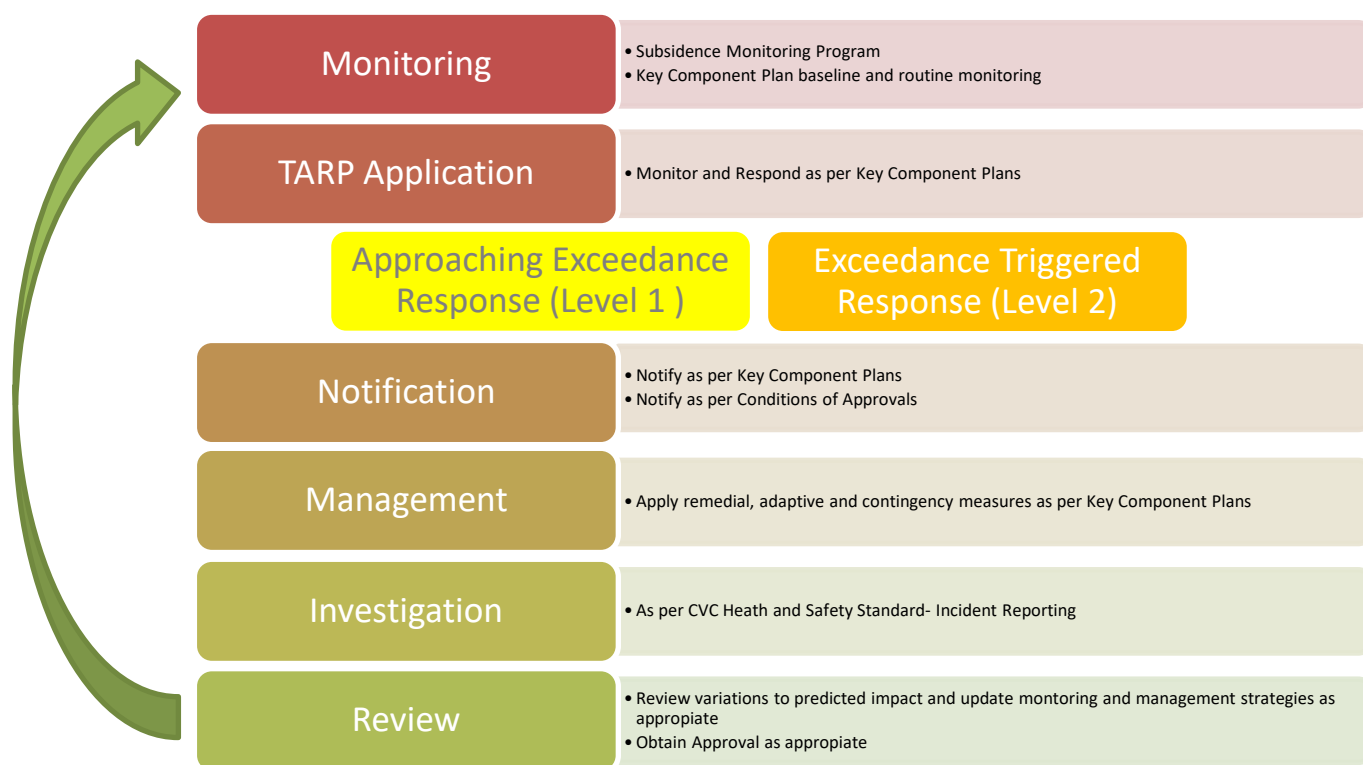
**Figure 10- Subsidence Monitoring and Management Framework**

The overall framework for subsidence monitoring and management of impacts under this Extraction Plan may is described by:

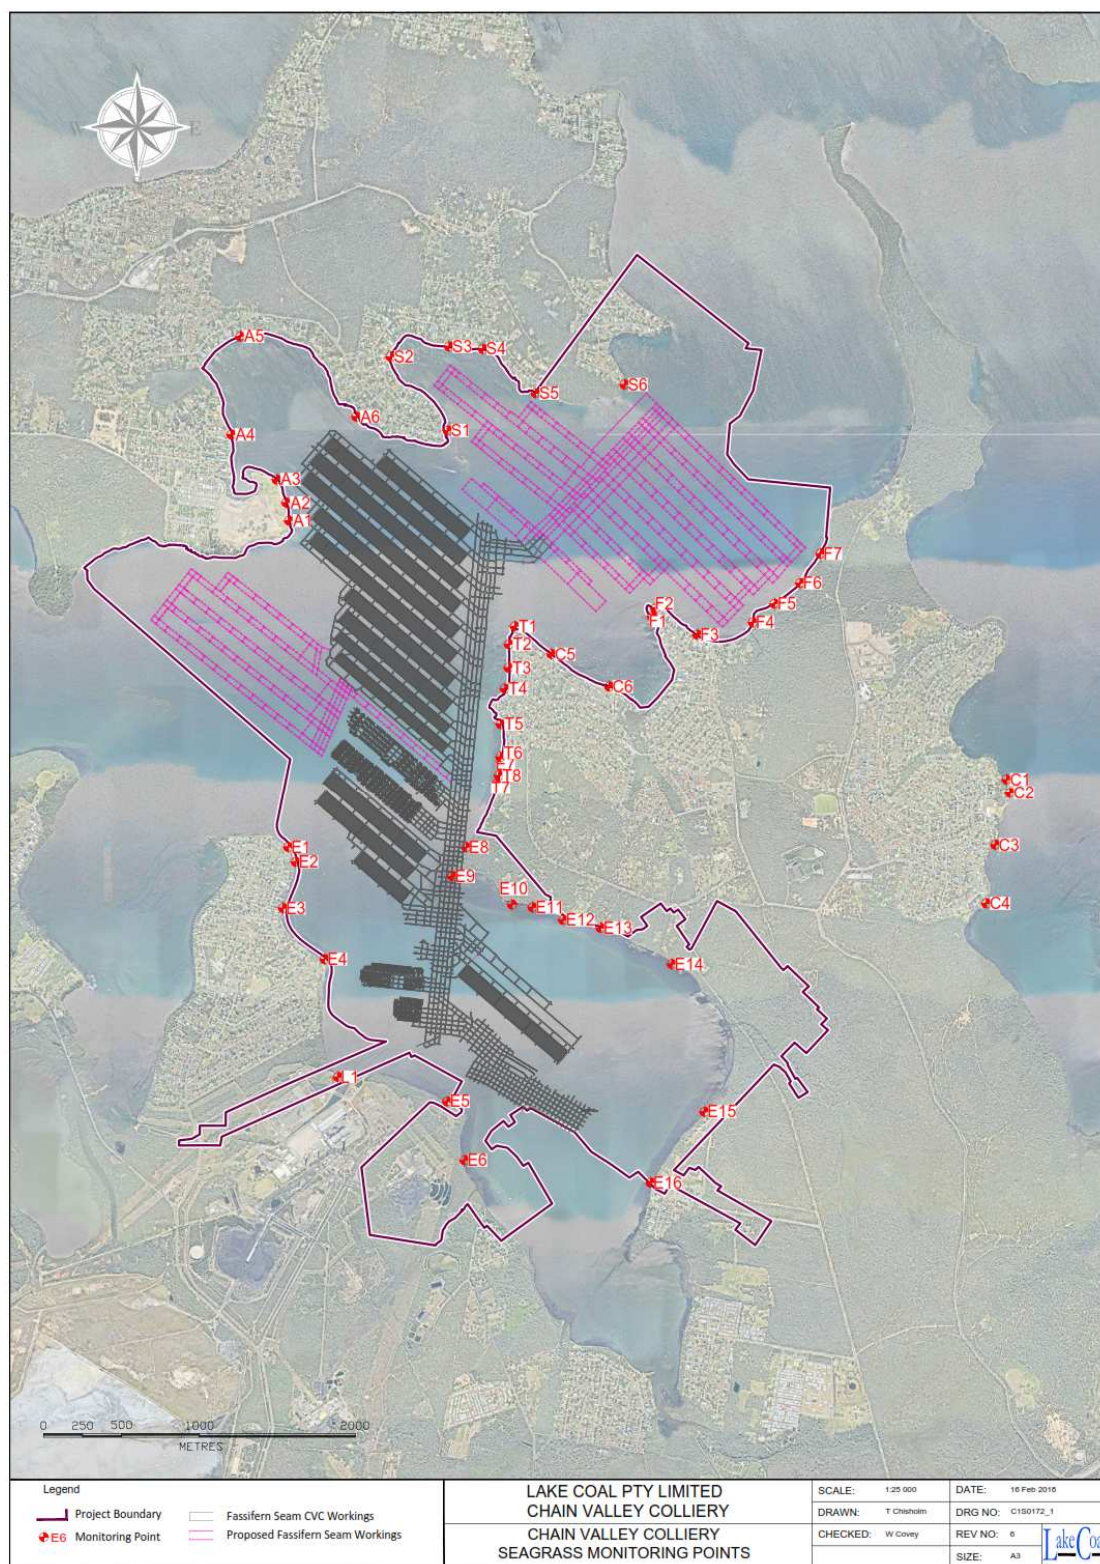
Figure 4: Locations of Seagrass Monitoring Transects

- Transects E1 to E16      Transects primarily in Chain Valley Bay and adjacent Summerland Point
- Transects T1 to T8      Transects adjacent Summerland Point
- Transects C1 to C6      Control stations in Crangan Bay and Frying Pan Bay
- Transects A1 to A6      Transects primarily in Bardens Bay
- Transect L1      Transect above potential future first workings in Chain Valley Bay
- Transects S1 to S6      Transect adjacent Sugar Bay
- Transects F1 to F7      Transects adjacent Frying Pan Bay and along Point Wolstoncroft.

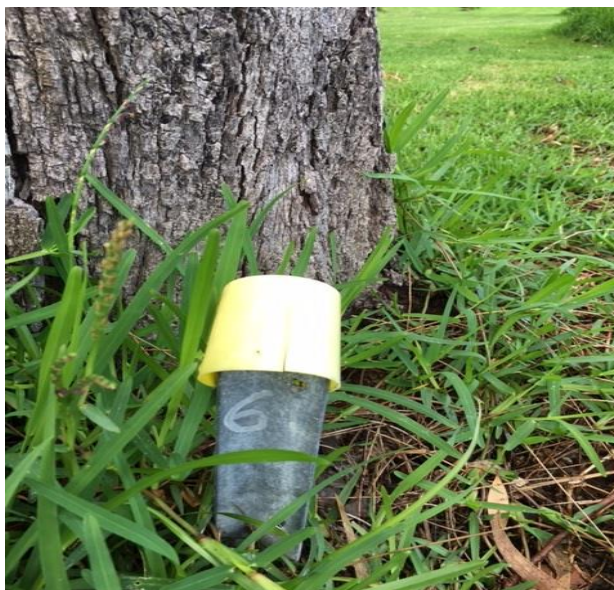
Figure 3: Example subsidence monitoring point with safety cap.

During the routine foreshore monitoring, observations and records for change will be noted as outlined in the Subsidence Monitoring Program. This will include observations for surface cracking, embankment movement, cracking, and validation of impacts to drainage or dwellings in areas of measured subsidence increase outside predicted.
