**CHAIN VALLEY COLLIERY
EXTRACTION PLAN
MINIWALLS S2 and S3**

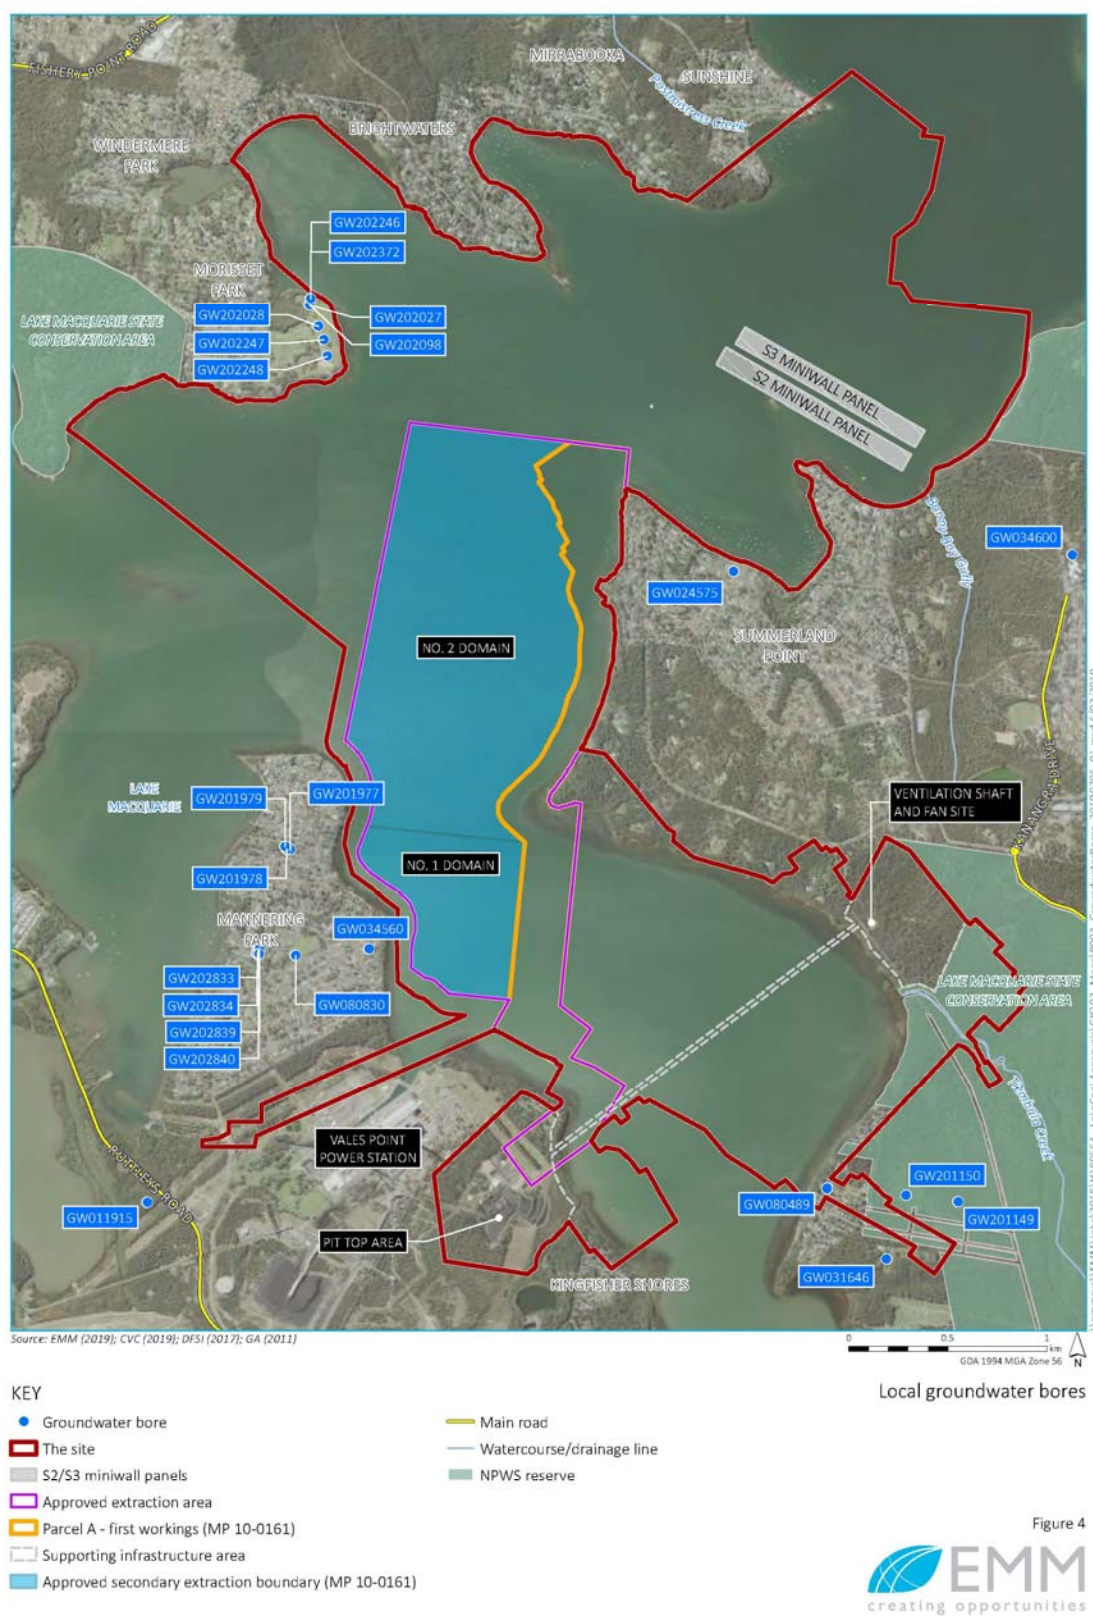
Figure 4 Local Groundwater Bores

Fifteen DIW registered bores are located within or near the GwMP area as shown in **Figure 4** and **Table 3**.

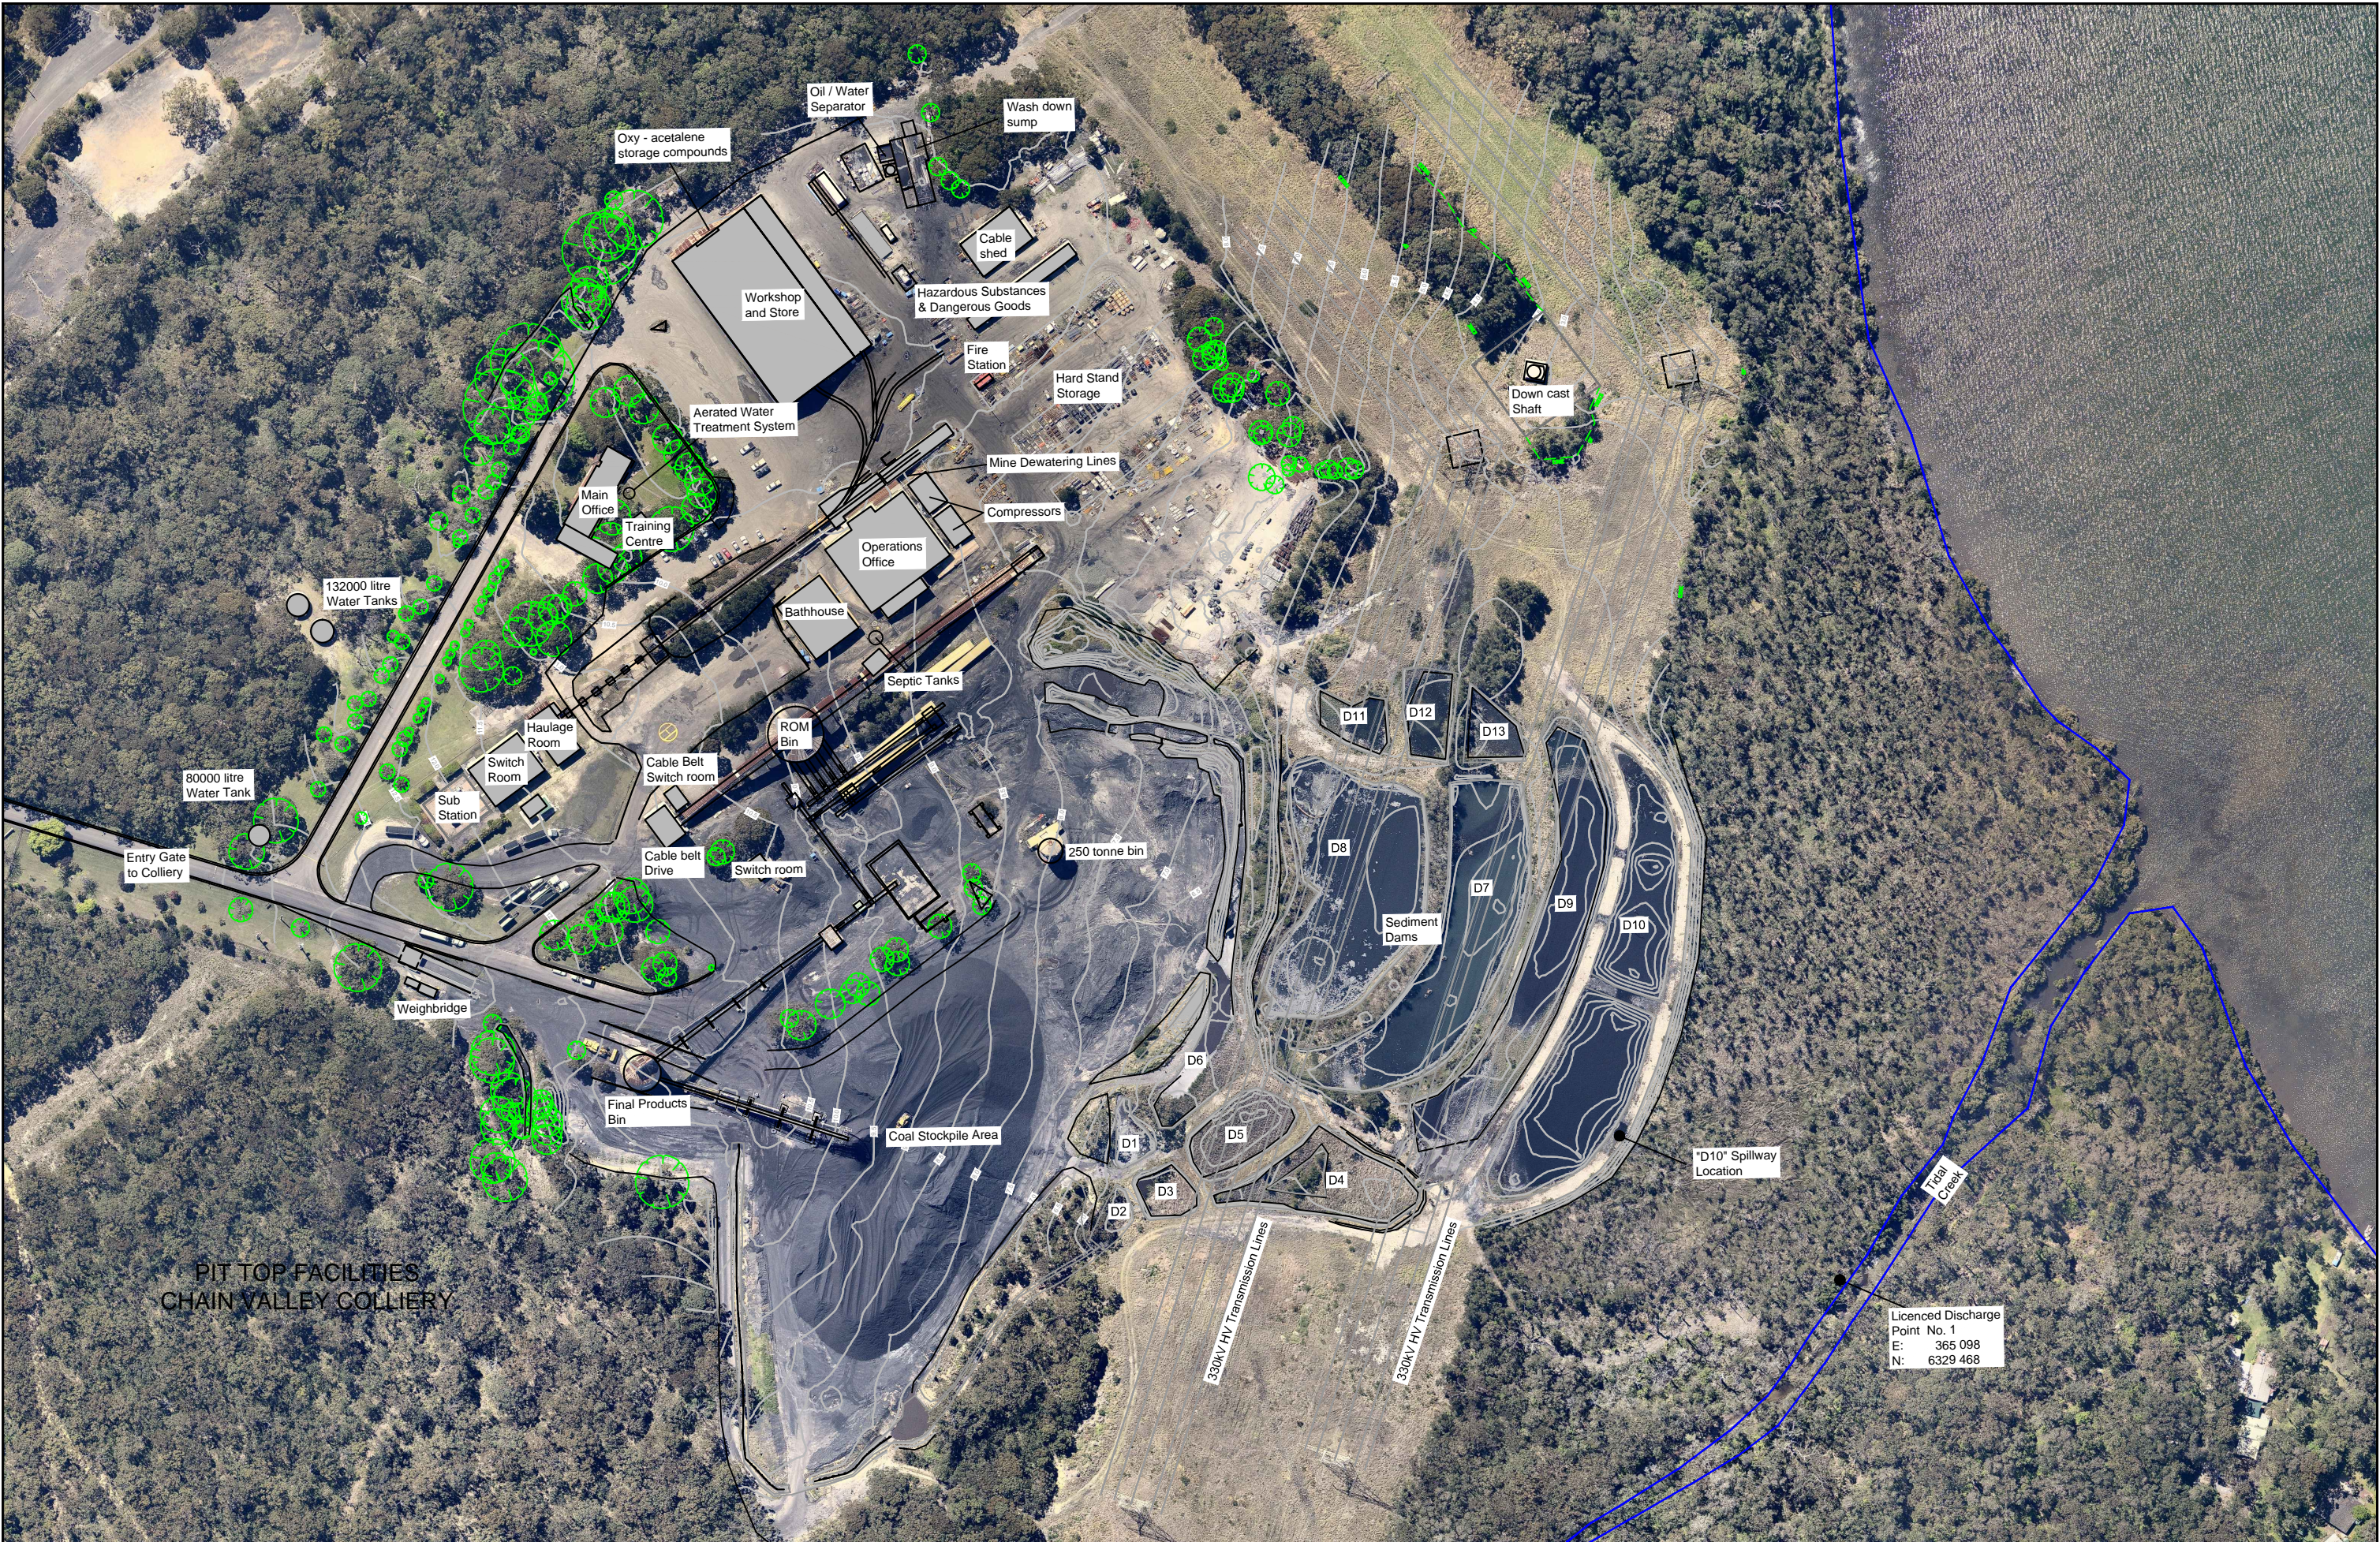
LAKE COAL PTY LIMITED CHAIN VALLEY COLLIERY	SCALE: 1:2000	DATE: 13 Nov 2014	
		DRAWN: T Chisholm	DRG NO: C1S0154_1	
	REHABILITATION MANAGEMENT PLAN FIGURE 3.1 - SURFACE FACILITIES	CHECKED: C Ellis	REV NO: 1	Lake Coal
		REVISION: 1	SIZE: A3

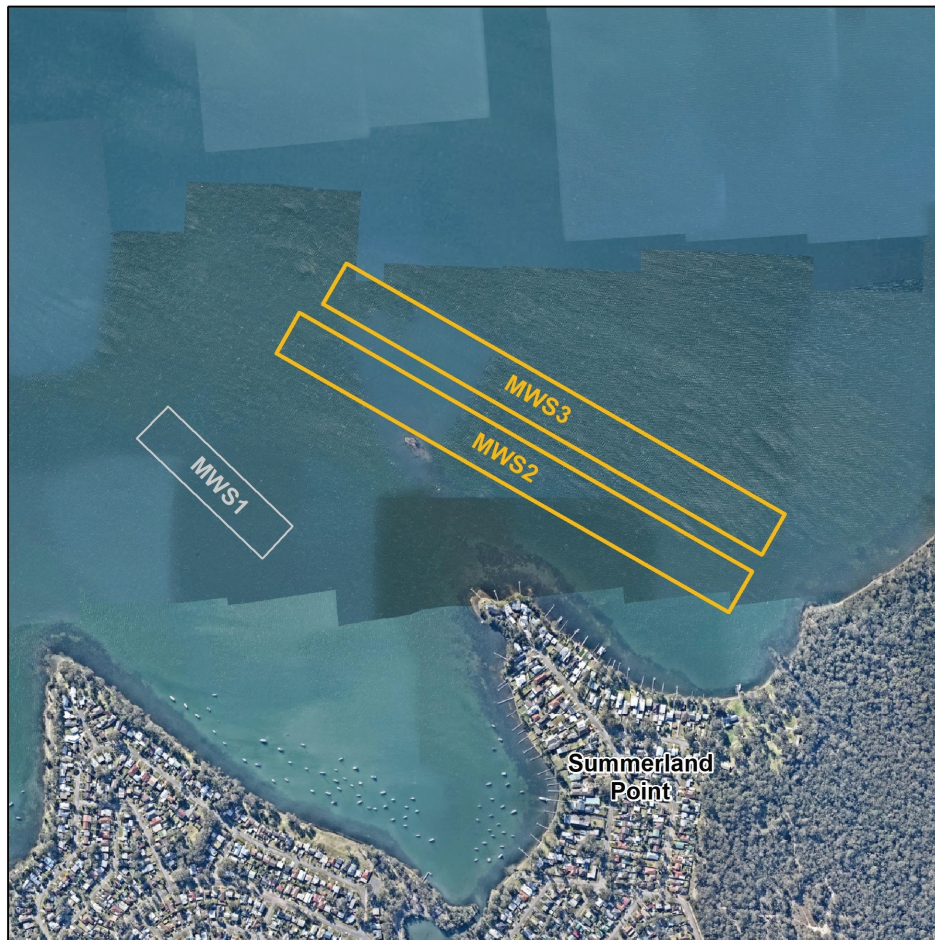
Fig. 1.1 Aerial photograph and MWS2 and MWS3

The locations of the existing and proposed miniwalls are shown in Drawings Nos. MSEC979-01 and MSEC979-02, in Appendix D. MWS2 and MWS3 have also been overlaid on an aerial photograph in Fig. 1.1. These two miniwalls are located north of the suburb of Summerland Point.

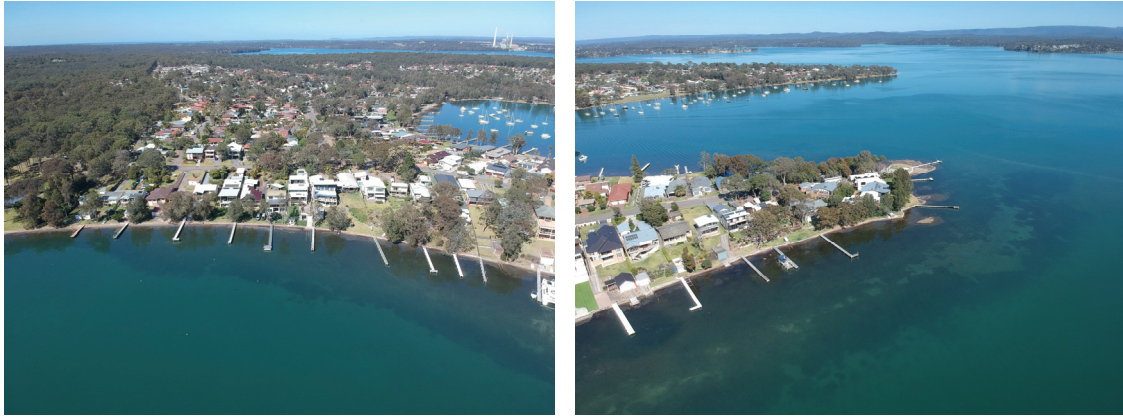
The sea grass beds are located along the lake foreshore below the low-water mark. The mapped extents of the sea grass beds are shown in Drawing No. MSEC979-11. Photographs of these sea grass beds are also provided in Fig. 5.2.

Fig. 5.2 Sea grass beds along the lake foreshore

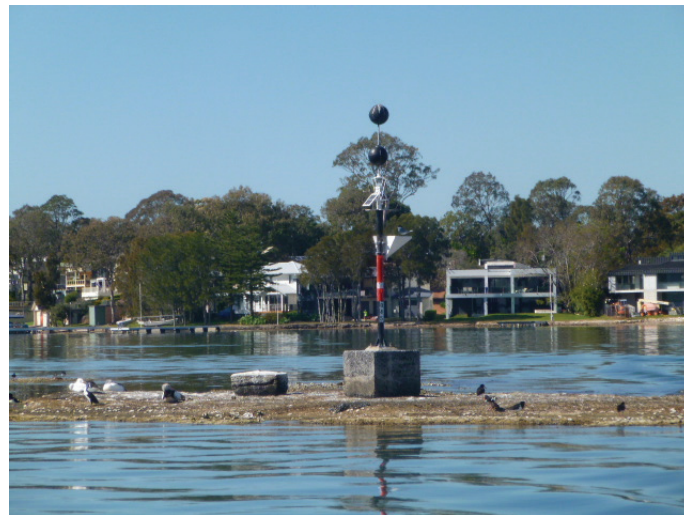
The Pelican Rock Navigation Marker is located on the rock outcrop that extends into Lake Macquarie from Summerland Point. The marker is located outside but immediately adjacent to the tailgate of MWS2. A photograph of this navigation marker is provided in Fig. 5.5.

Fig. 5.5 Pelican Rock Navigation Marker

The predicted vertical subsidence for the navigation marker due to MWS2 and MWS3 is 90 mm. The predicted subsidence should be provided to Roads and Maritime Services (RMS) so that management strategies can be developed for the marker, if required.

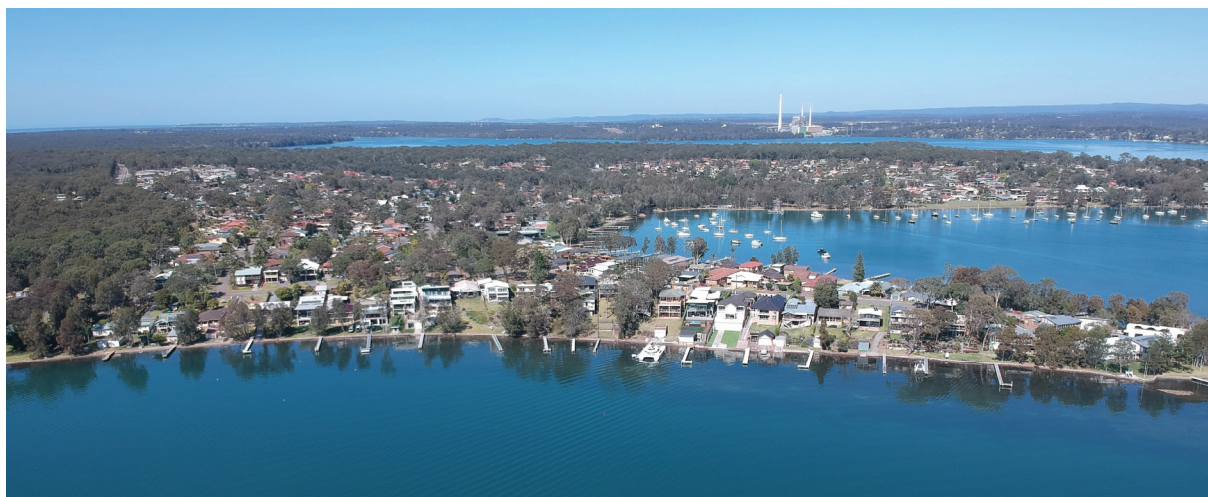
Many of the built features located along the foreshore can be seen Fig. 5.6. These features include houses, other associated structures, jetties, moorings, roads and services.

Fig. 5.6 Built features along the foreshore at Summerland Point

The predicted vertical subsidence at the mapped sea grass beds and, hence, at the lake foreshore is less than 20 mm. It is unlikely, therefore, that there would be adverse impacts on the surface features located above the sea grass beds (i.e. jetties and moorings) or along the lake foreshore, including houses, other associated structures, roads and services.

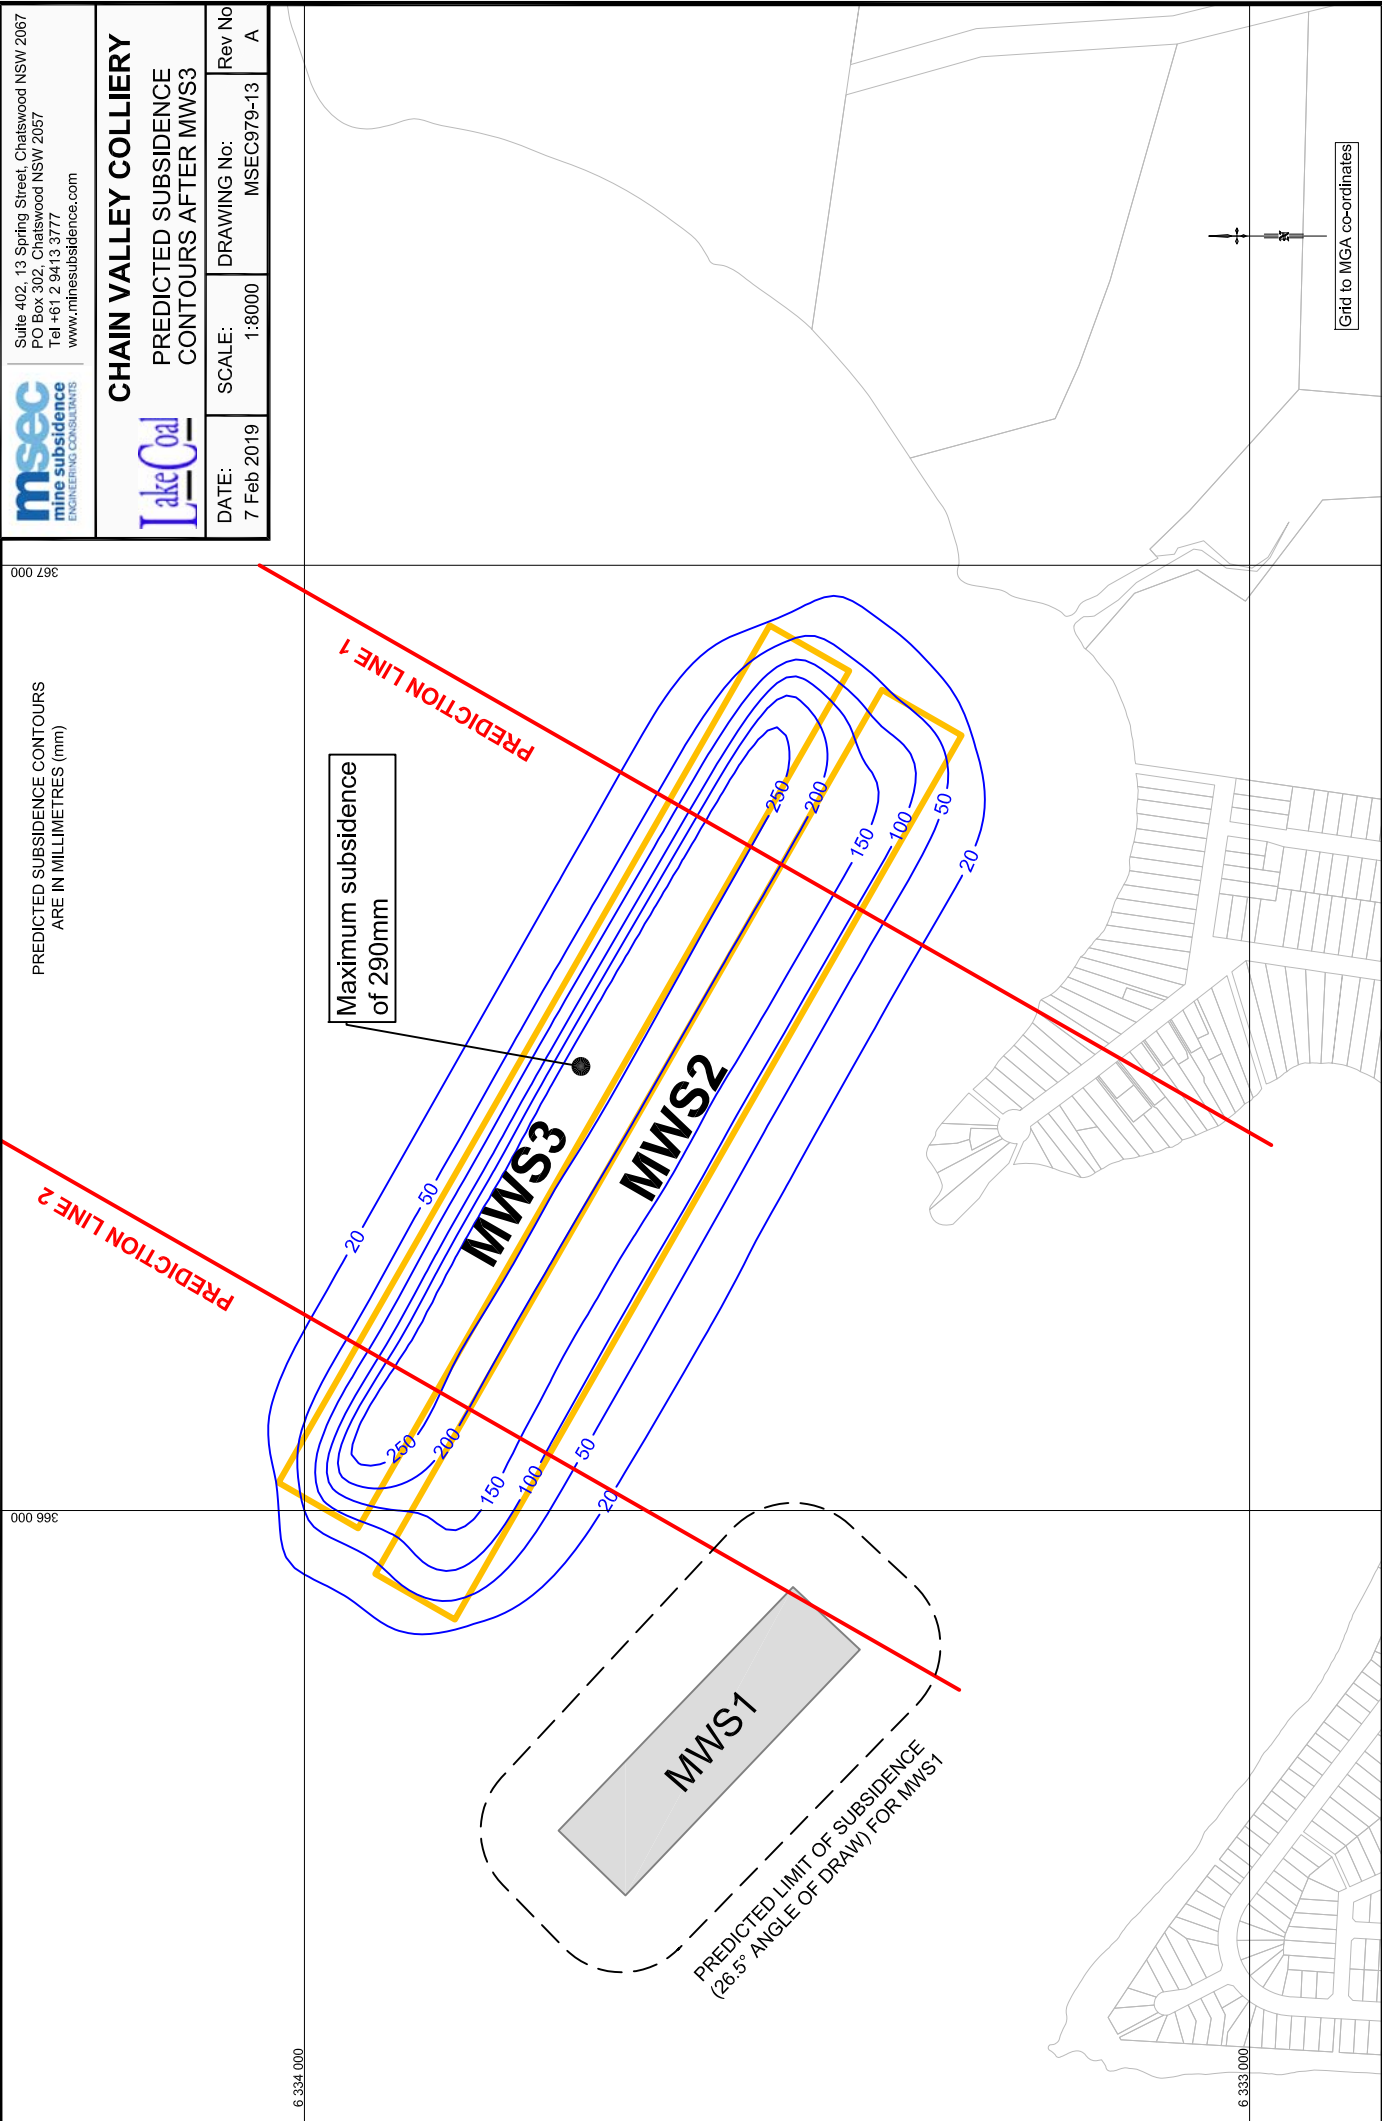
DATE: 7 Feb 2019	SCALE: 1:8000	DRAWING No: MSEC979-13	Rev No A
---------------------	------------------	---------------------------	-------------

**PREDICTED SUBSIDENCE
CONTOURS AFTER MWS3**
