CHAIN VALLEY COLLIERY AND MANNERING COLLIERY  
**Mining Operations Plan**  
**Amendment 2**  
**Rehabilitation Management Plan**  
**2020-2023**

Table 1 MOP Title Block

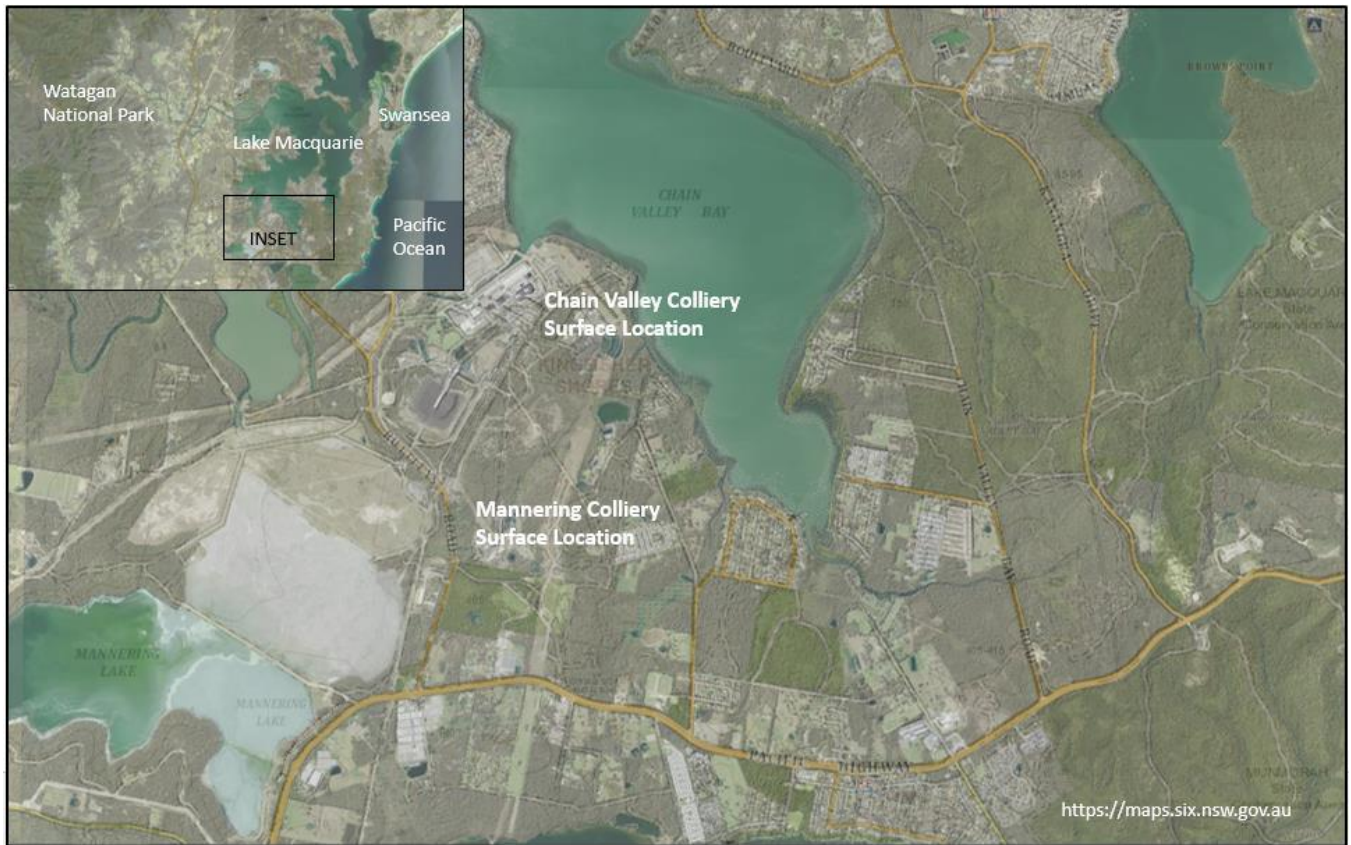
**Figure 1.1: Chain Valley Colliery and Mannering Colliery Surface Locations**

Chain Valley Colliery (CVC) is an underground coal mine (colliery) situated in the Newcastle coalfields of New South Wales, at the southern end of Lake Macquarie (see **Figure 1.1**). Chain Valley Colliery is located directly adjacent to the Vales Point Power Station. The below table outlines the key mining and ownership milestones over the site's 60 year history.

Mannering Colliery is an underground coal mine located directly adjacent to the Chain Valley Colliery (see **Figure 1.1**). The below table outlines the key mining and ownership milestones over the site's 60 year history.

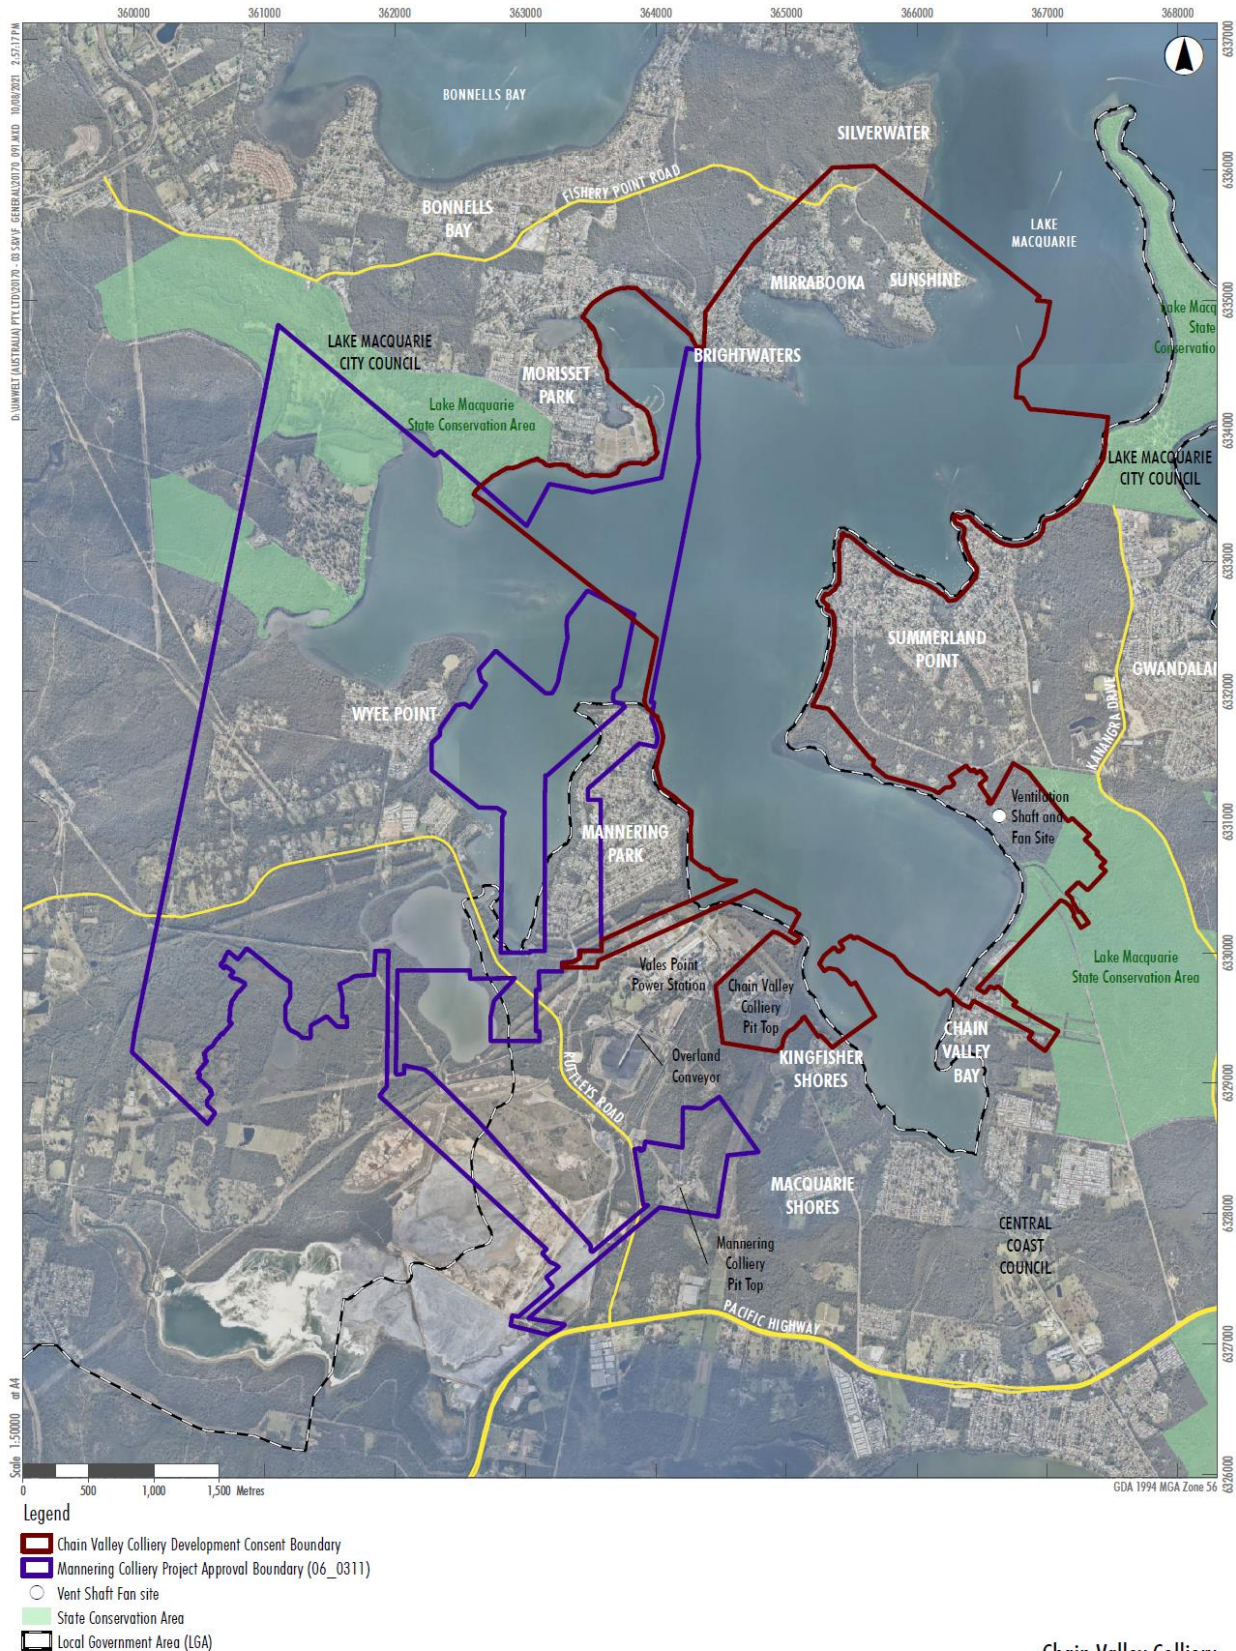
**Figure 2.1: Approval Boundaries**

**Figure 2.1** shows the boundaries applicable to the Chain Valley Development Consent and Mannering Project Approval.

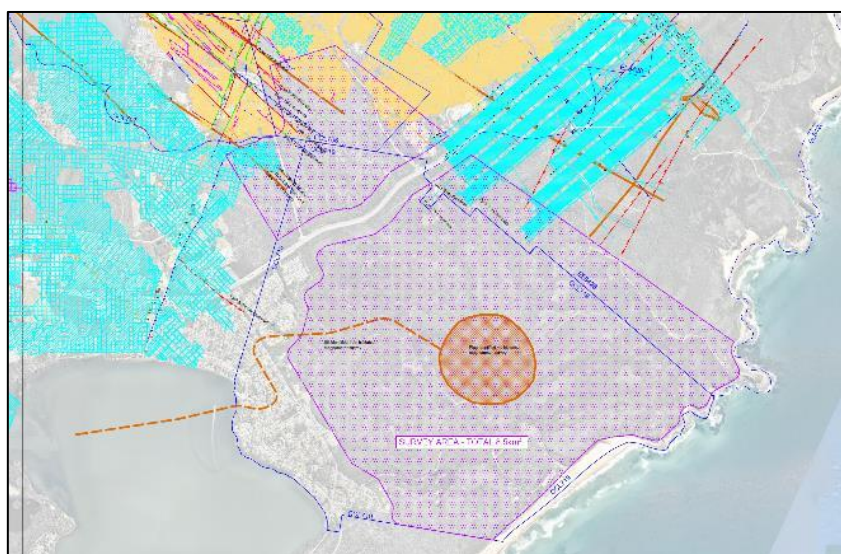
**Figure 2.2: Proposed drone aerial magnetic survey over the Munmorah State Conservation Area for igneous intrusions presented in the Conceptual Project Development Plan presentation in June 2020**

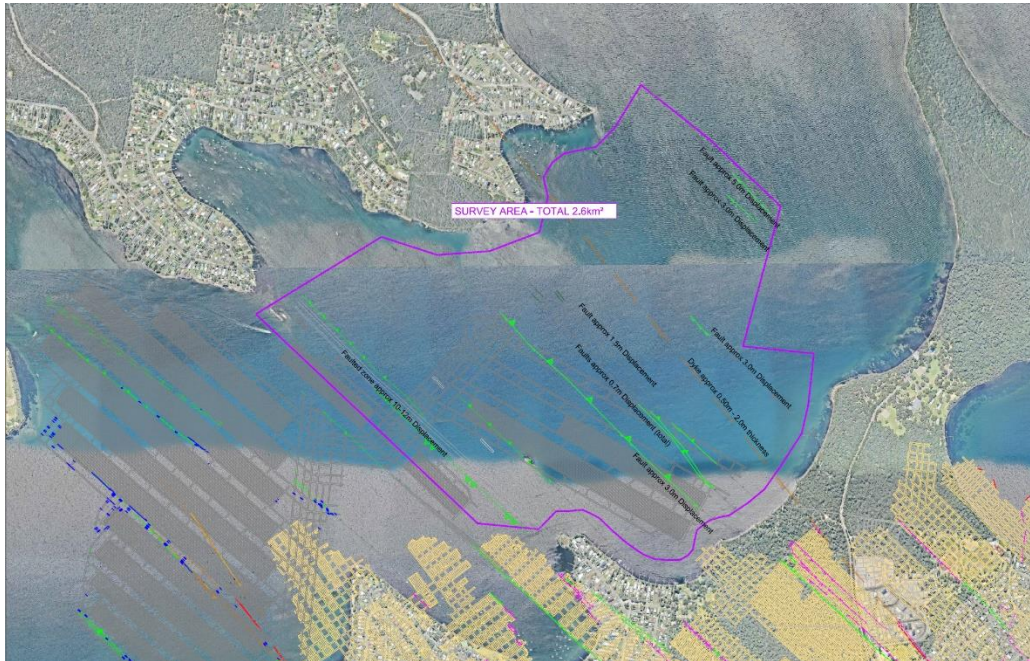
Figure 2.3: Proposed drone aerial magnetic survey over Lake Macquarie for igneous intrusions over the Northern Mining Area

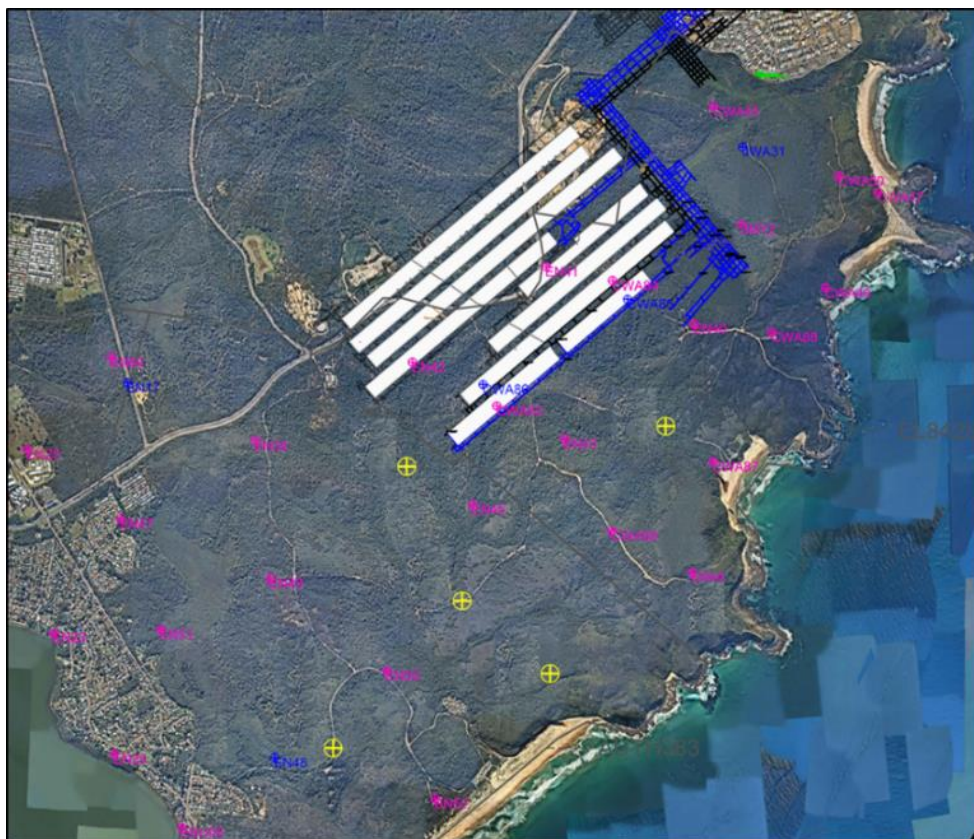
Figure 2.4: Indicative exploration drill hole plan presented in the Conceptual Project Development Plan presentation in June 2020

There is surface drilling planned to be conducted during the MOP period. An indicative exploration program was presented to MEG in the Concept Project Development Plan (Figure 2.4). The location, number and purposes of these boreholes are yet to be fully defined as their location/s will be based upon on variety of factors; drill hole spacing and data availability, field reconnaissance, geological and geophysical surveys and mapping, possible environmental and community impacts and constraints. The purposes of this drilling will be for gathering groundwater, geotechnical or exploration related data for mine planning. Although not deemed exploration, a groundwater monitoring program will be conducted to provide baseline groundwater data (Figure 2.4a) which will include similar sampling and data acquisition. Drill planning and risk assessment will be undertaken to minimise environmental and community impacts. Existing cleared tracks and sites will be utilised where possible to minimise impact and external sumps will be used during the drilling process to minimise the chance of contamination.

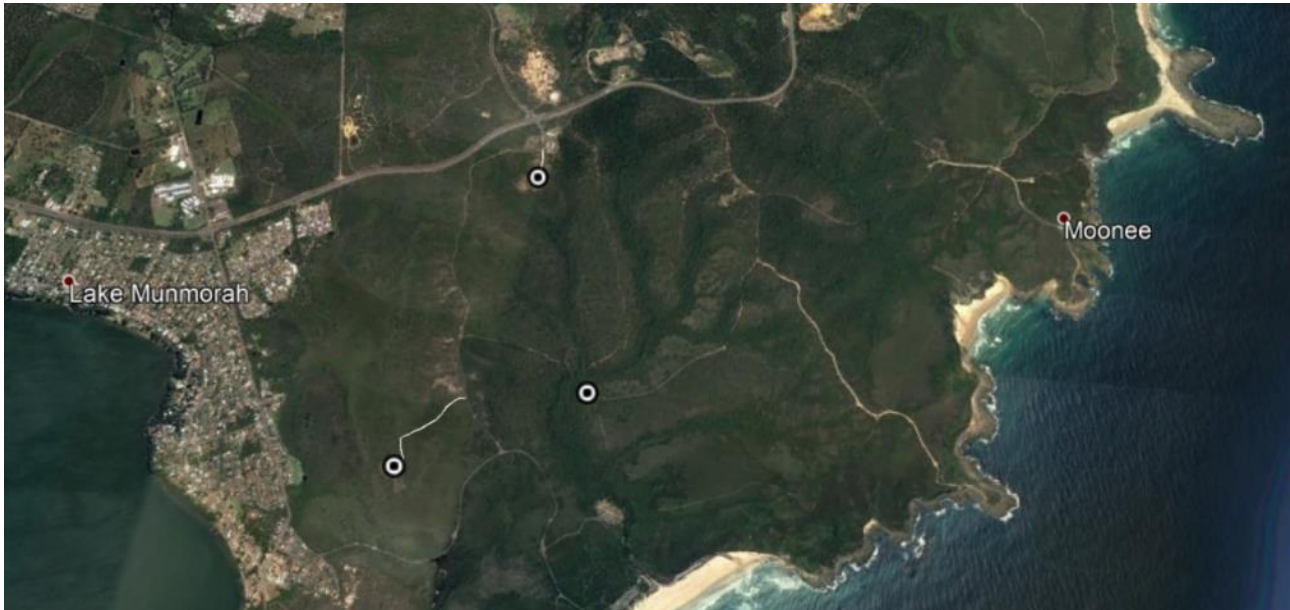
**Figure 2.4a: Indicative groundwater monitoring drill hole location plan**

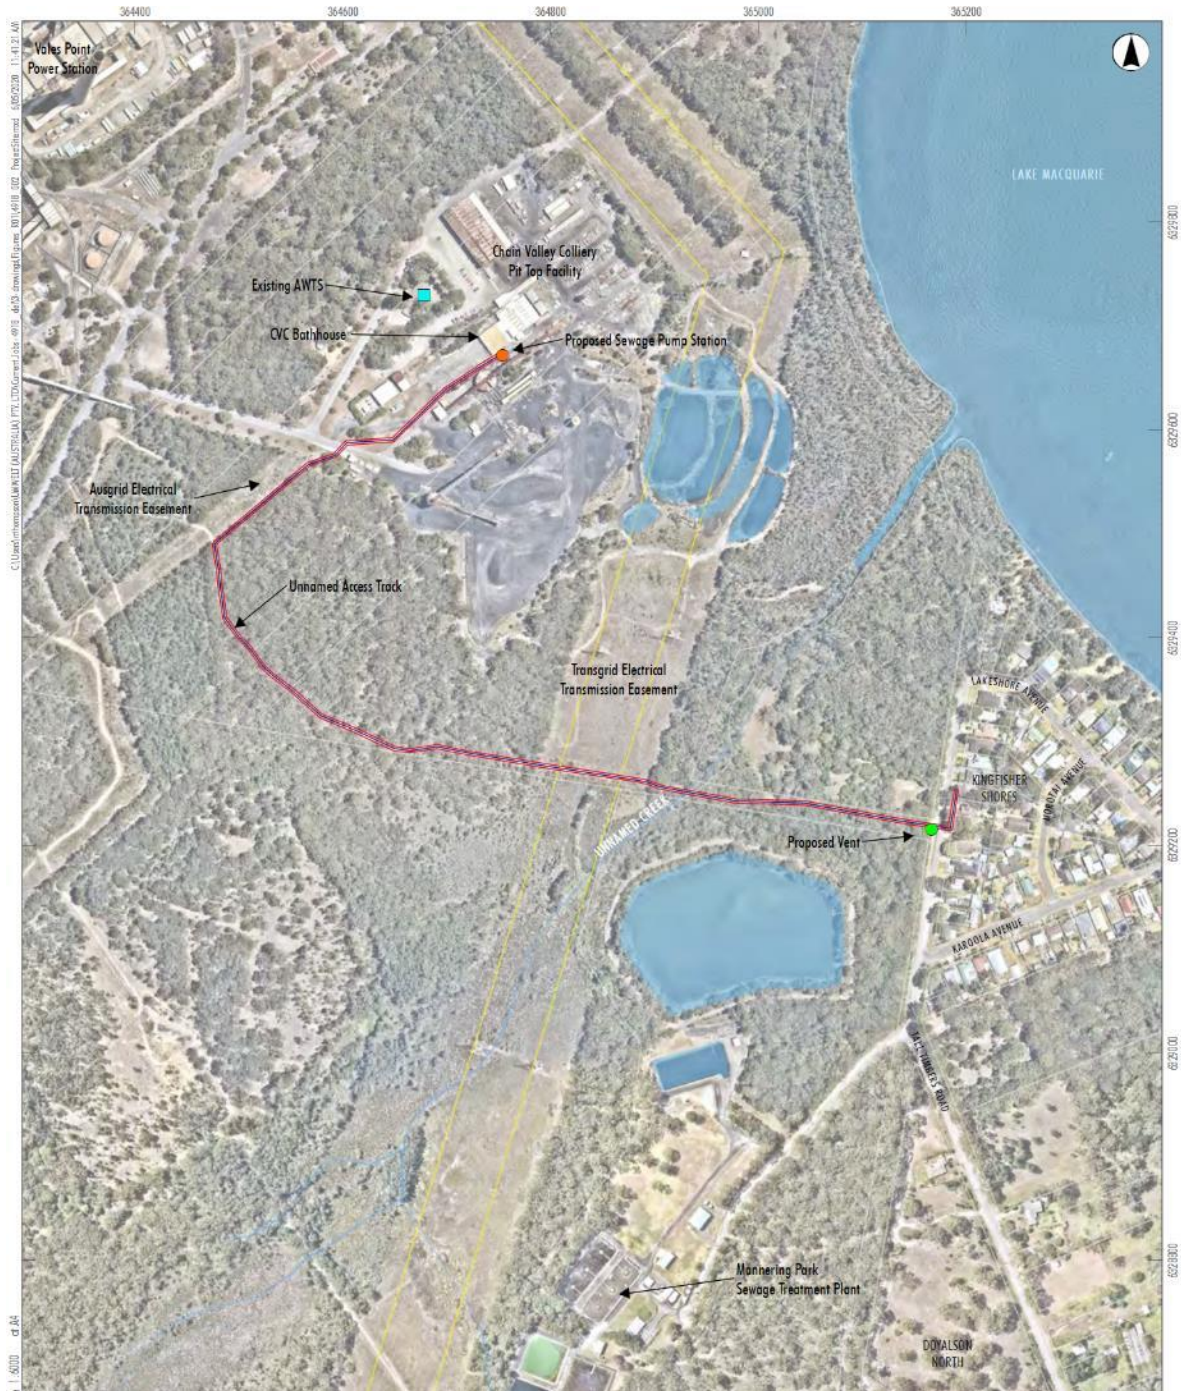
**Figure 2.5: Proposed Sewer Pipeline installation**

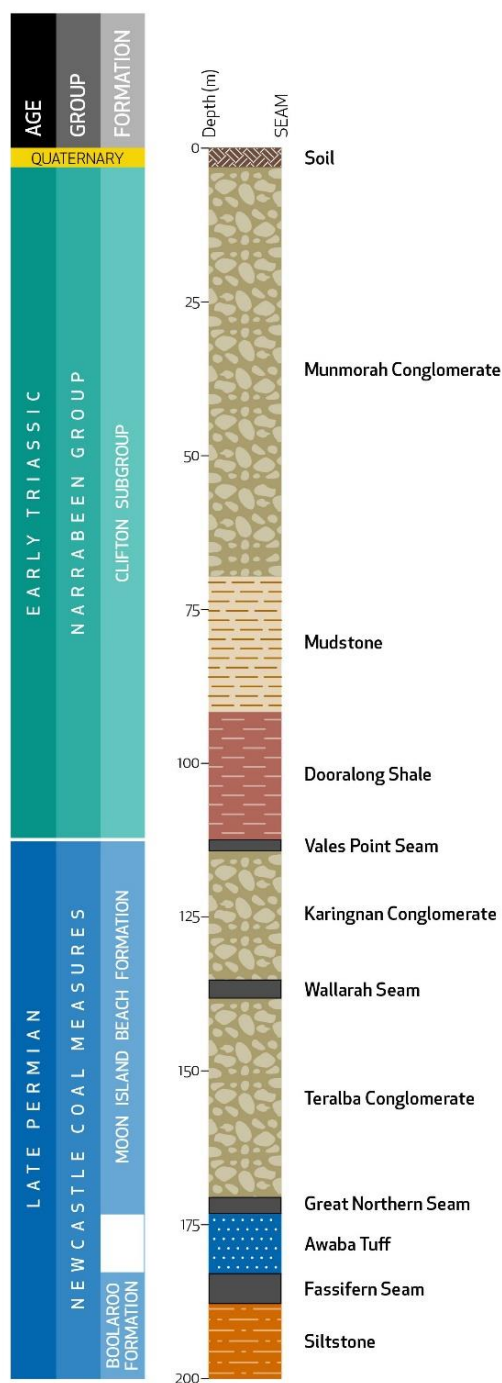
Figure 3.1: General Stratigraphic Column within Colliery Holding area

depth of around 150 to 210 metres (based on known and inferred contour data). The Fassifern Seam is approximately 4.5 to 5.5 metres thick, with the immediate roof and floor comprising a tuffaceous claystone of varying hardness. Mining involves the extraction of a 3.5m section of coal (approximate) beneath the A and B plies. The A and B plies, which comprise approximately 1.0 to 1.2 metres of inferior coal, are left on the roof (Seedsman 2011) dependant on mining conditions. Up to approximately 0.8 m coaly shale is left in the floor. The general geology within the Chain Valley Colliery area is shown on Figure 3.1. There are no recognised aquifers within the stratigraphic sequence, except for the coal seams themselves.

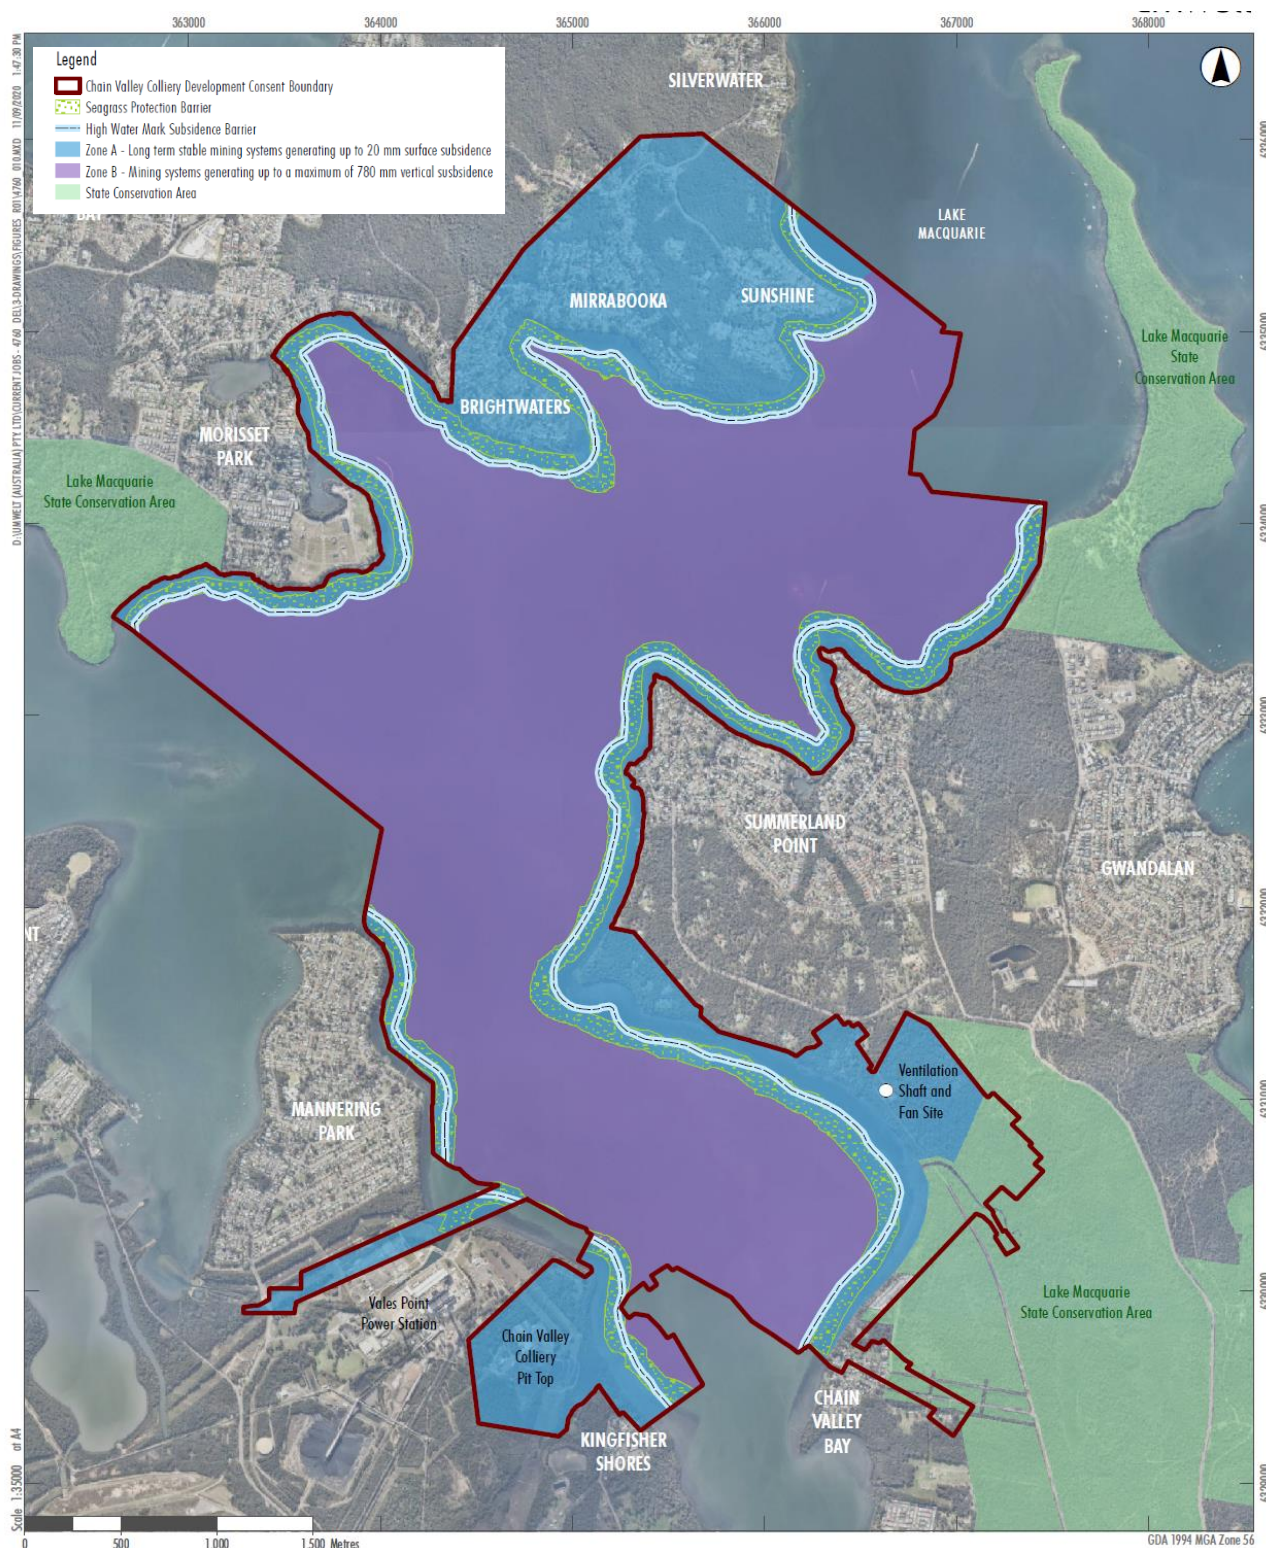
**Figure 3.2: Development Layout - Mining areas subsidence management zone figure from SSD 5465**

All secondary extraction is planned to occur beneath Lake Macquarie (Figure 3.2). For the proposed secondary extraction, the total maximum vertical subsidence is modelled to result in a maximum of 780 mm of subsidence. There are no threatened or endangered species or ecological communities impacted by the planned subsidence and negligible environmental impacts are expected due to mining restrictions (seagrass protection barrier and high water subsidence protection barrier) which eliminate impact to the foreshore or land based areas.

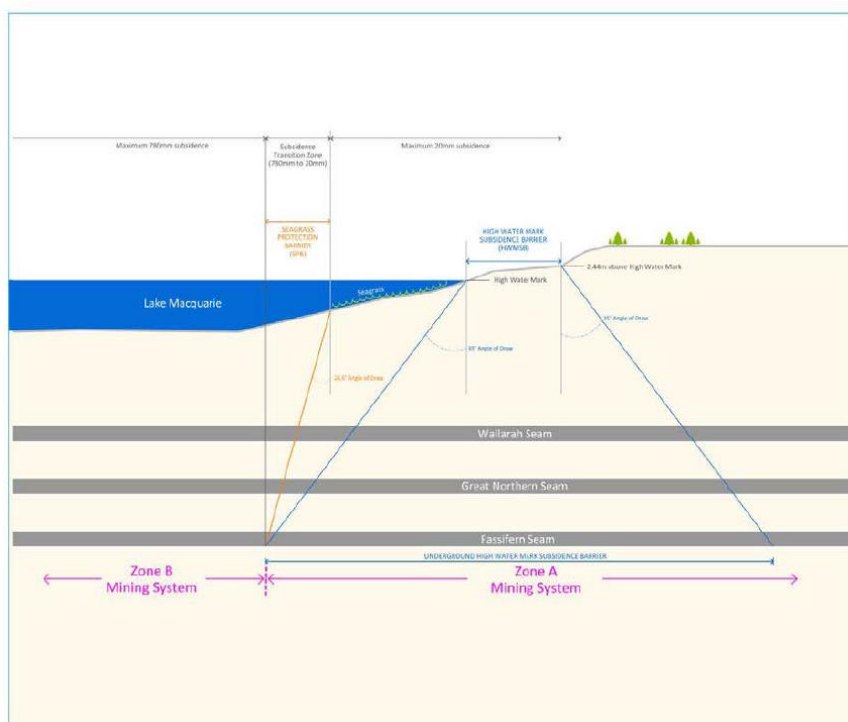
**Figure 3.3: High Water Mark Subsidence Barrier and Seagrass Protection Barrier cross section figure from SSD 5465**

No secondary extraction is proposed within the High Water Mark Subsidence Barrier (HWMSB), a protection zone around the Lake Macquarie foreshore defined by a 35 degree angle of draw from the high water mark to the seam. Additionally, a Seagrass Protection Barrier (SPB) will be maintained to protect the seagrass communities around the perimeter of the lake: a 26.5 degree angle of draw has been used from mapped the seaward edge of seagrass communities to determine the extent of the barrier (Figure 3.3).

This same SPB definition has been applied for the Fassifern Seam workings for more than 10 years and to date no subsidence or impact to the seagrass communities has been identified through monitoring. Recent updates to the subsidence models for miniwall and pillar extraction within the Fassifern Seam have accounted for the increase in measured subsidence above that predicted in the miniwall 1 to 12 area. Taking this and the subsidence development mechanisms into consideration, the mine plan for the Northern Mining Area has increased chain pillars sizes to ensure subsidence remains within currently approved limits.

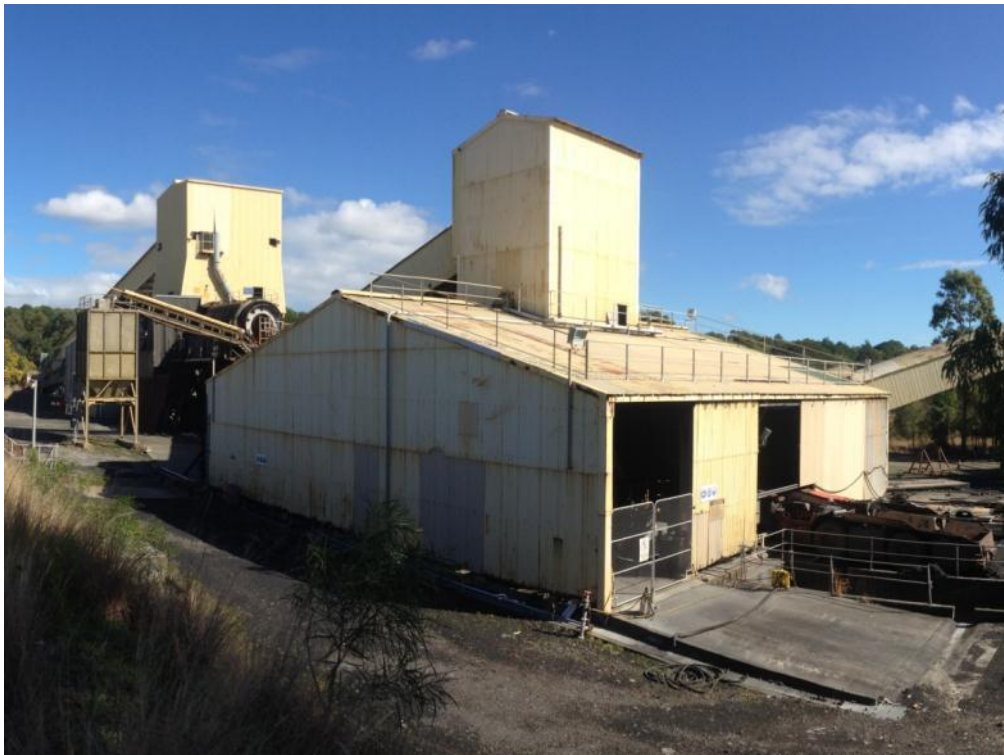
**Plate 7.4: Mannering coal clearance and processing facilities**

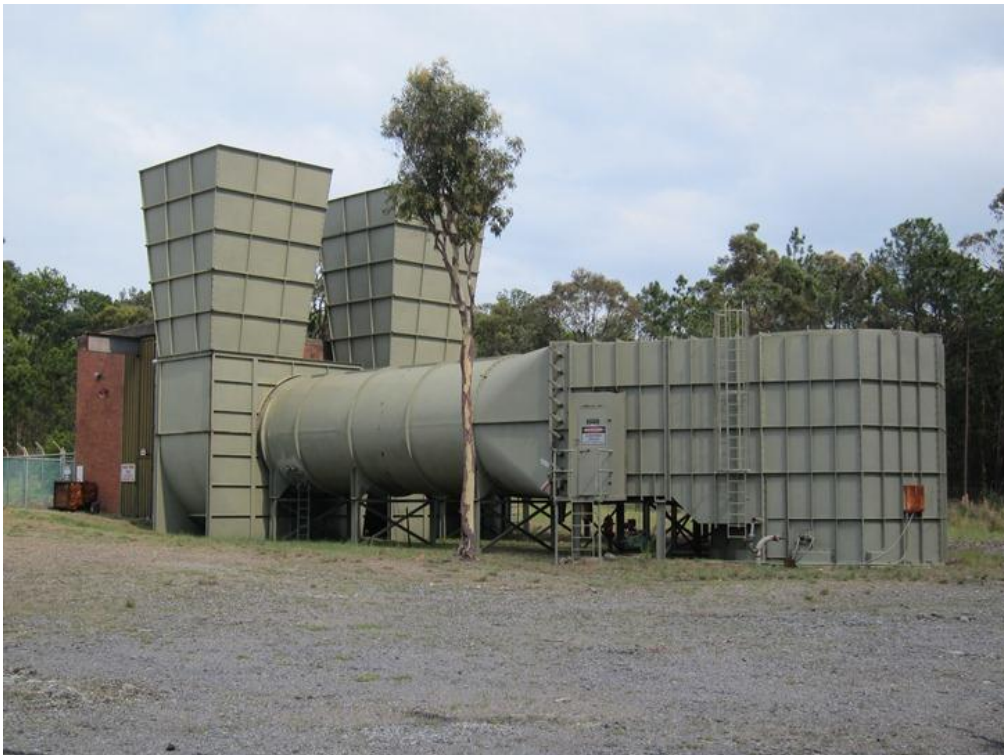
**Plate 7.6: Mannering main ventilation fans**

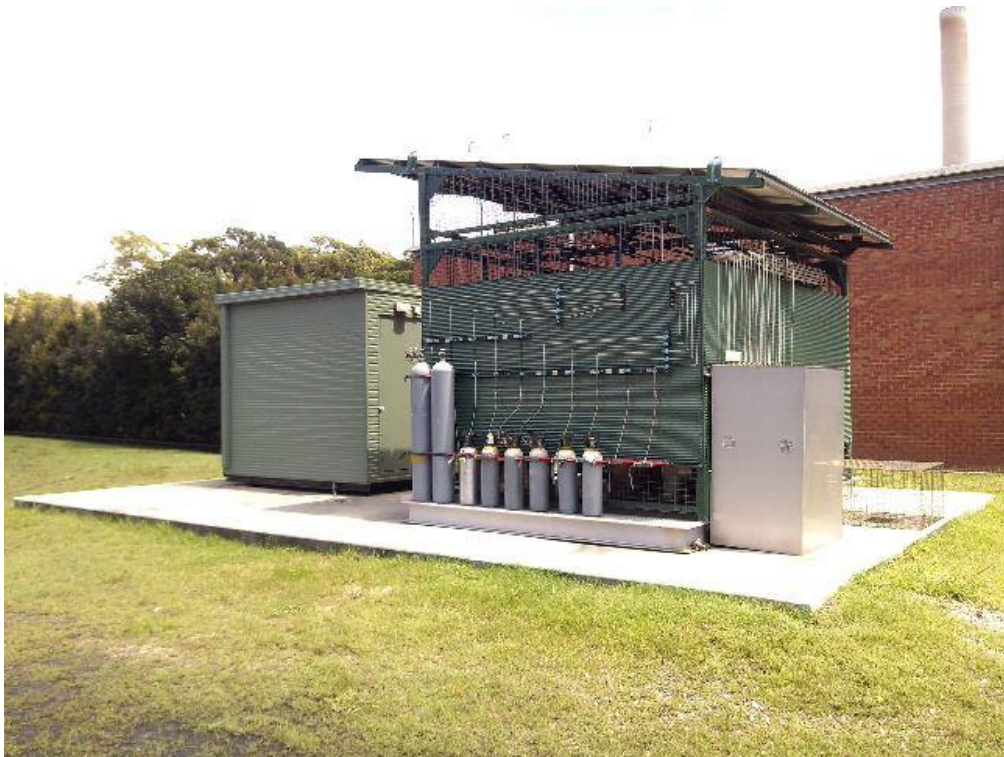
**Plate 7.14: Chain Valley tube bundle monitoring (main winder and switchroom building behind)**

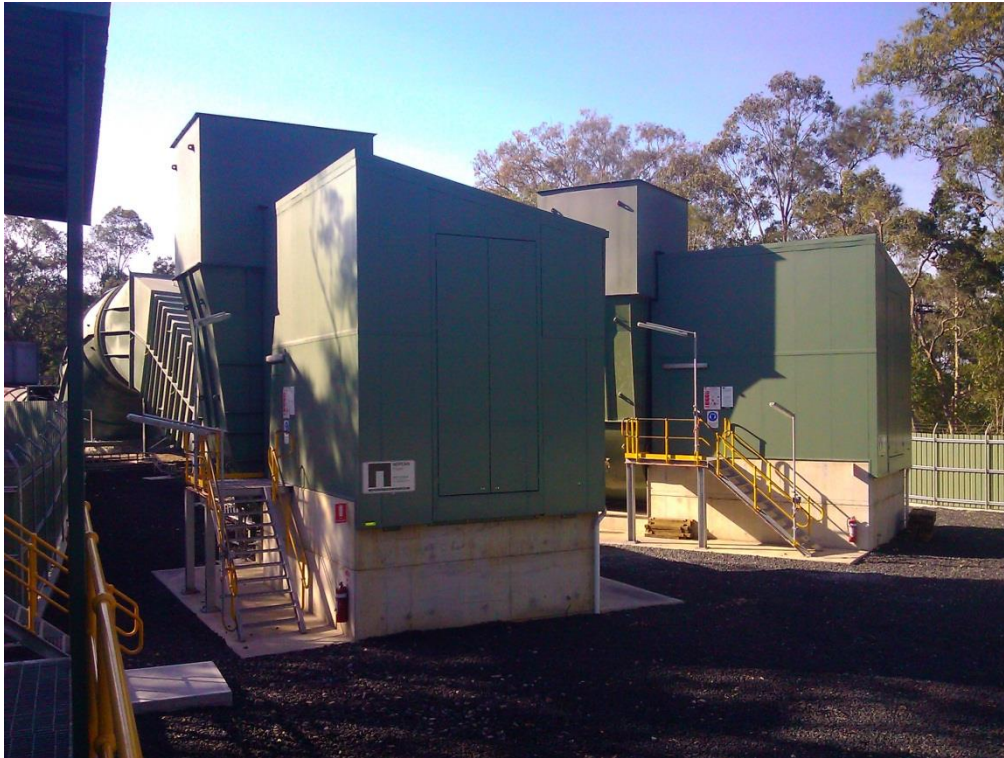
**Plate 7.17: Chain Valley main ventilation fans**

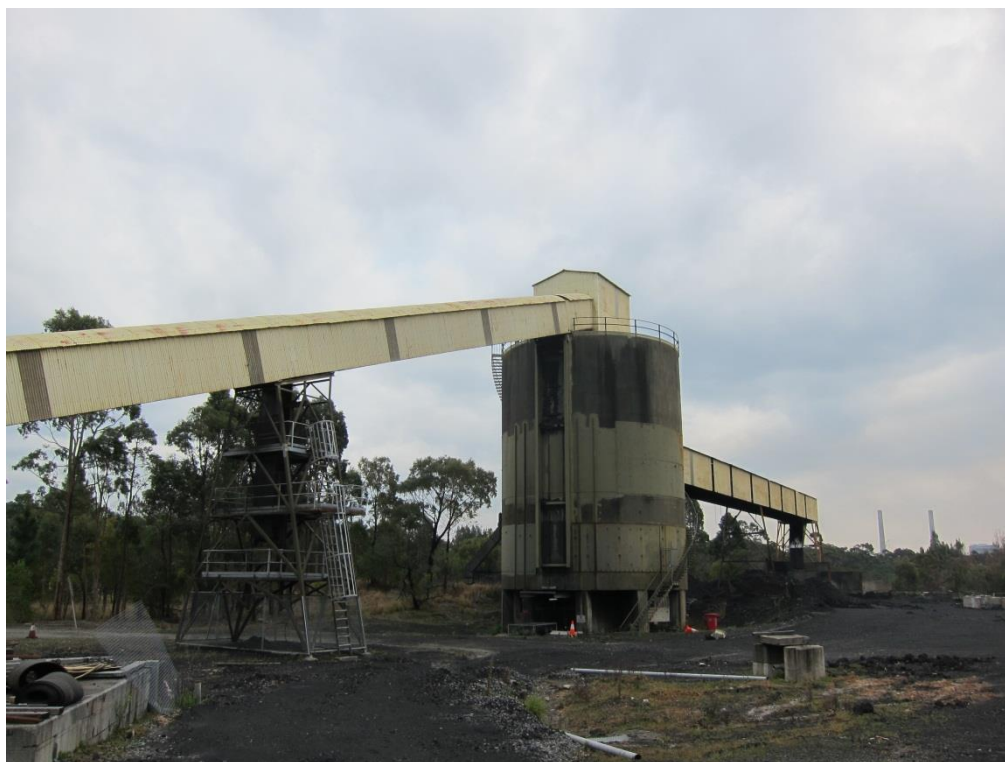
**Plate 7.18: Mannering coal stockpile area**

This area has drainage including concrete drains and sumps, which ultimately report to the Pond B water control system. A representative photo showing the Mannering coal stockpile area is presented in **Plate 7.18**. Note: The coal handling infrastructure evident in **Plate 7.19** (e.g. bin, conveyors, gantry) and reclaim tunnel are incorporated into the 1A domain.

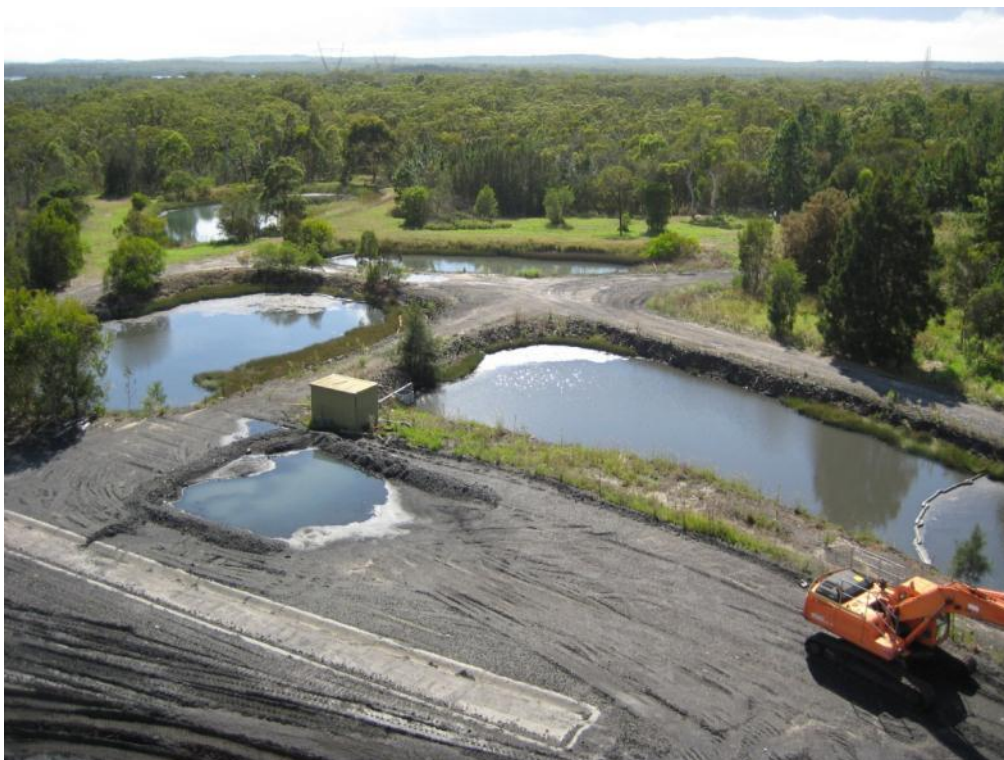
**Plate 7.19: Pond B water management control system**

Ponds B, 1, 2, 3 Dam 4 are shown on **Plan 1B**. The Pond B pollution control system, comprising four pollution control ponds (B, 1, 2, and 3) manages runoff from the pit top. The retention and settlement of storm water takes place within these ponds before water is discharged offsite via LDP1 (**Plan 1B**).

A photo of the domain (from a number of years ago) is presented in **Plate 7.19**.

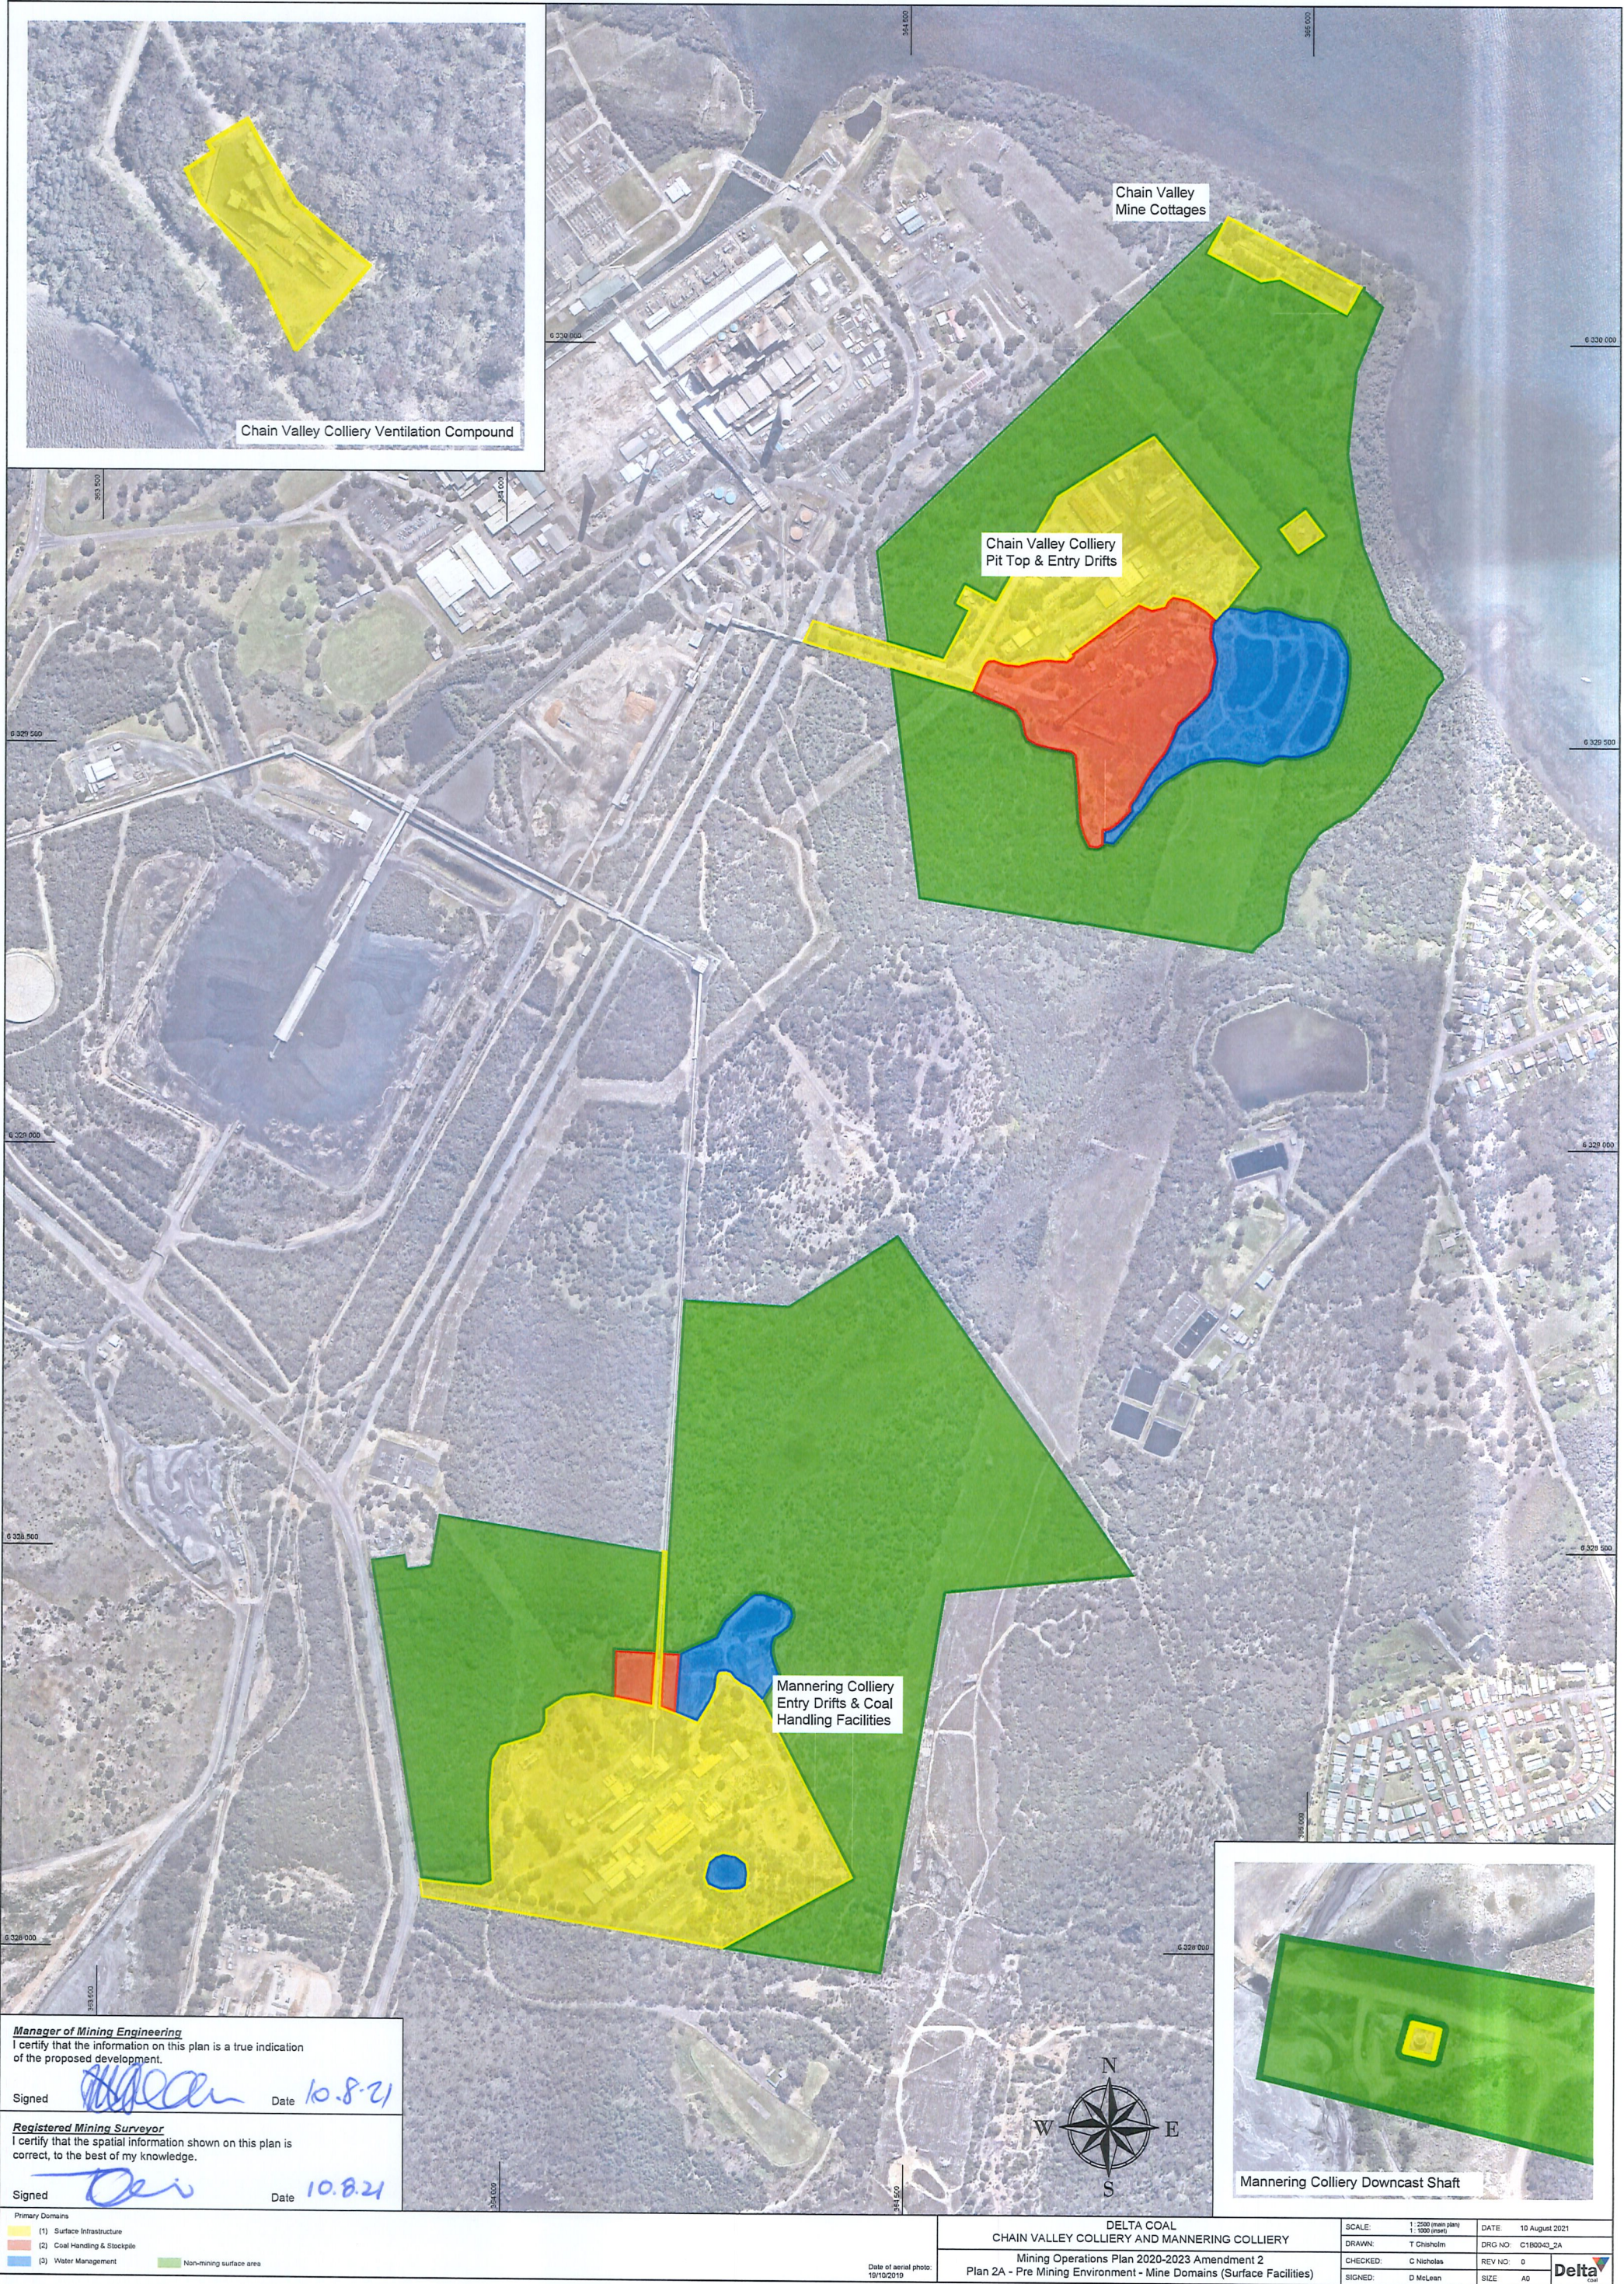
<b>Primary Domains</b>			<b>DELTA COAL</b>			<b>SCALE:</b> 1 : 8500			<b>DATE:</b> 10 August 2021		
(1) Surface Infrastructure			<b>CHAIN VALLEY COLLIERY AND MANNERING COLLIERY</b>			<b>DRAWN:</b> T Chisholm			<b>DRG NO:</b> C180043_2		
(2) Coal Handling & Stockpile			<b>Mining Operations Plan 2020-2023 Amendment 2</b>			<b>CHECKED:</b> C Nicholas			<b>REV NO:</b> 0		
(3) Water Management			<b>Plan 2 - Pre-Mining Environment - Mine Domains (Regional)</b>			<b>SIGNED:</b> D McLean			<b>SIZE:</b> A0		
Mining Disturbance Area			SSD-5465 Consent Boundary			MP06_0311 Approval Boundary					
Disturbance Area - End of MOP											
Non-mining surface disturbance
