CHAIN VALLEY COLLIERY AND MANNERING COLLIERY  
**Mining Operations Plan**  
**Amendment 2**  
**Rehabilitation Management Plan**  
**2020-2023**

Table 1 MOP Title Block

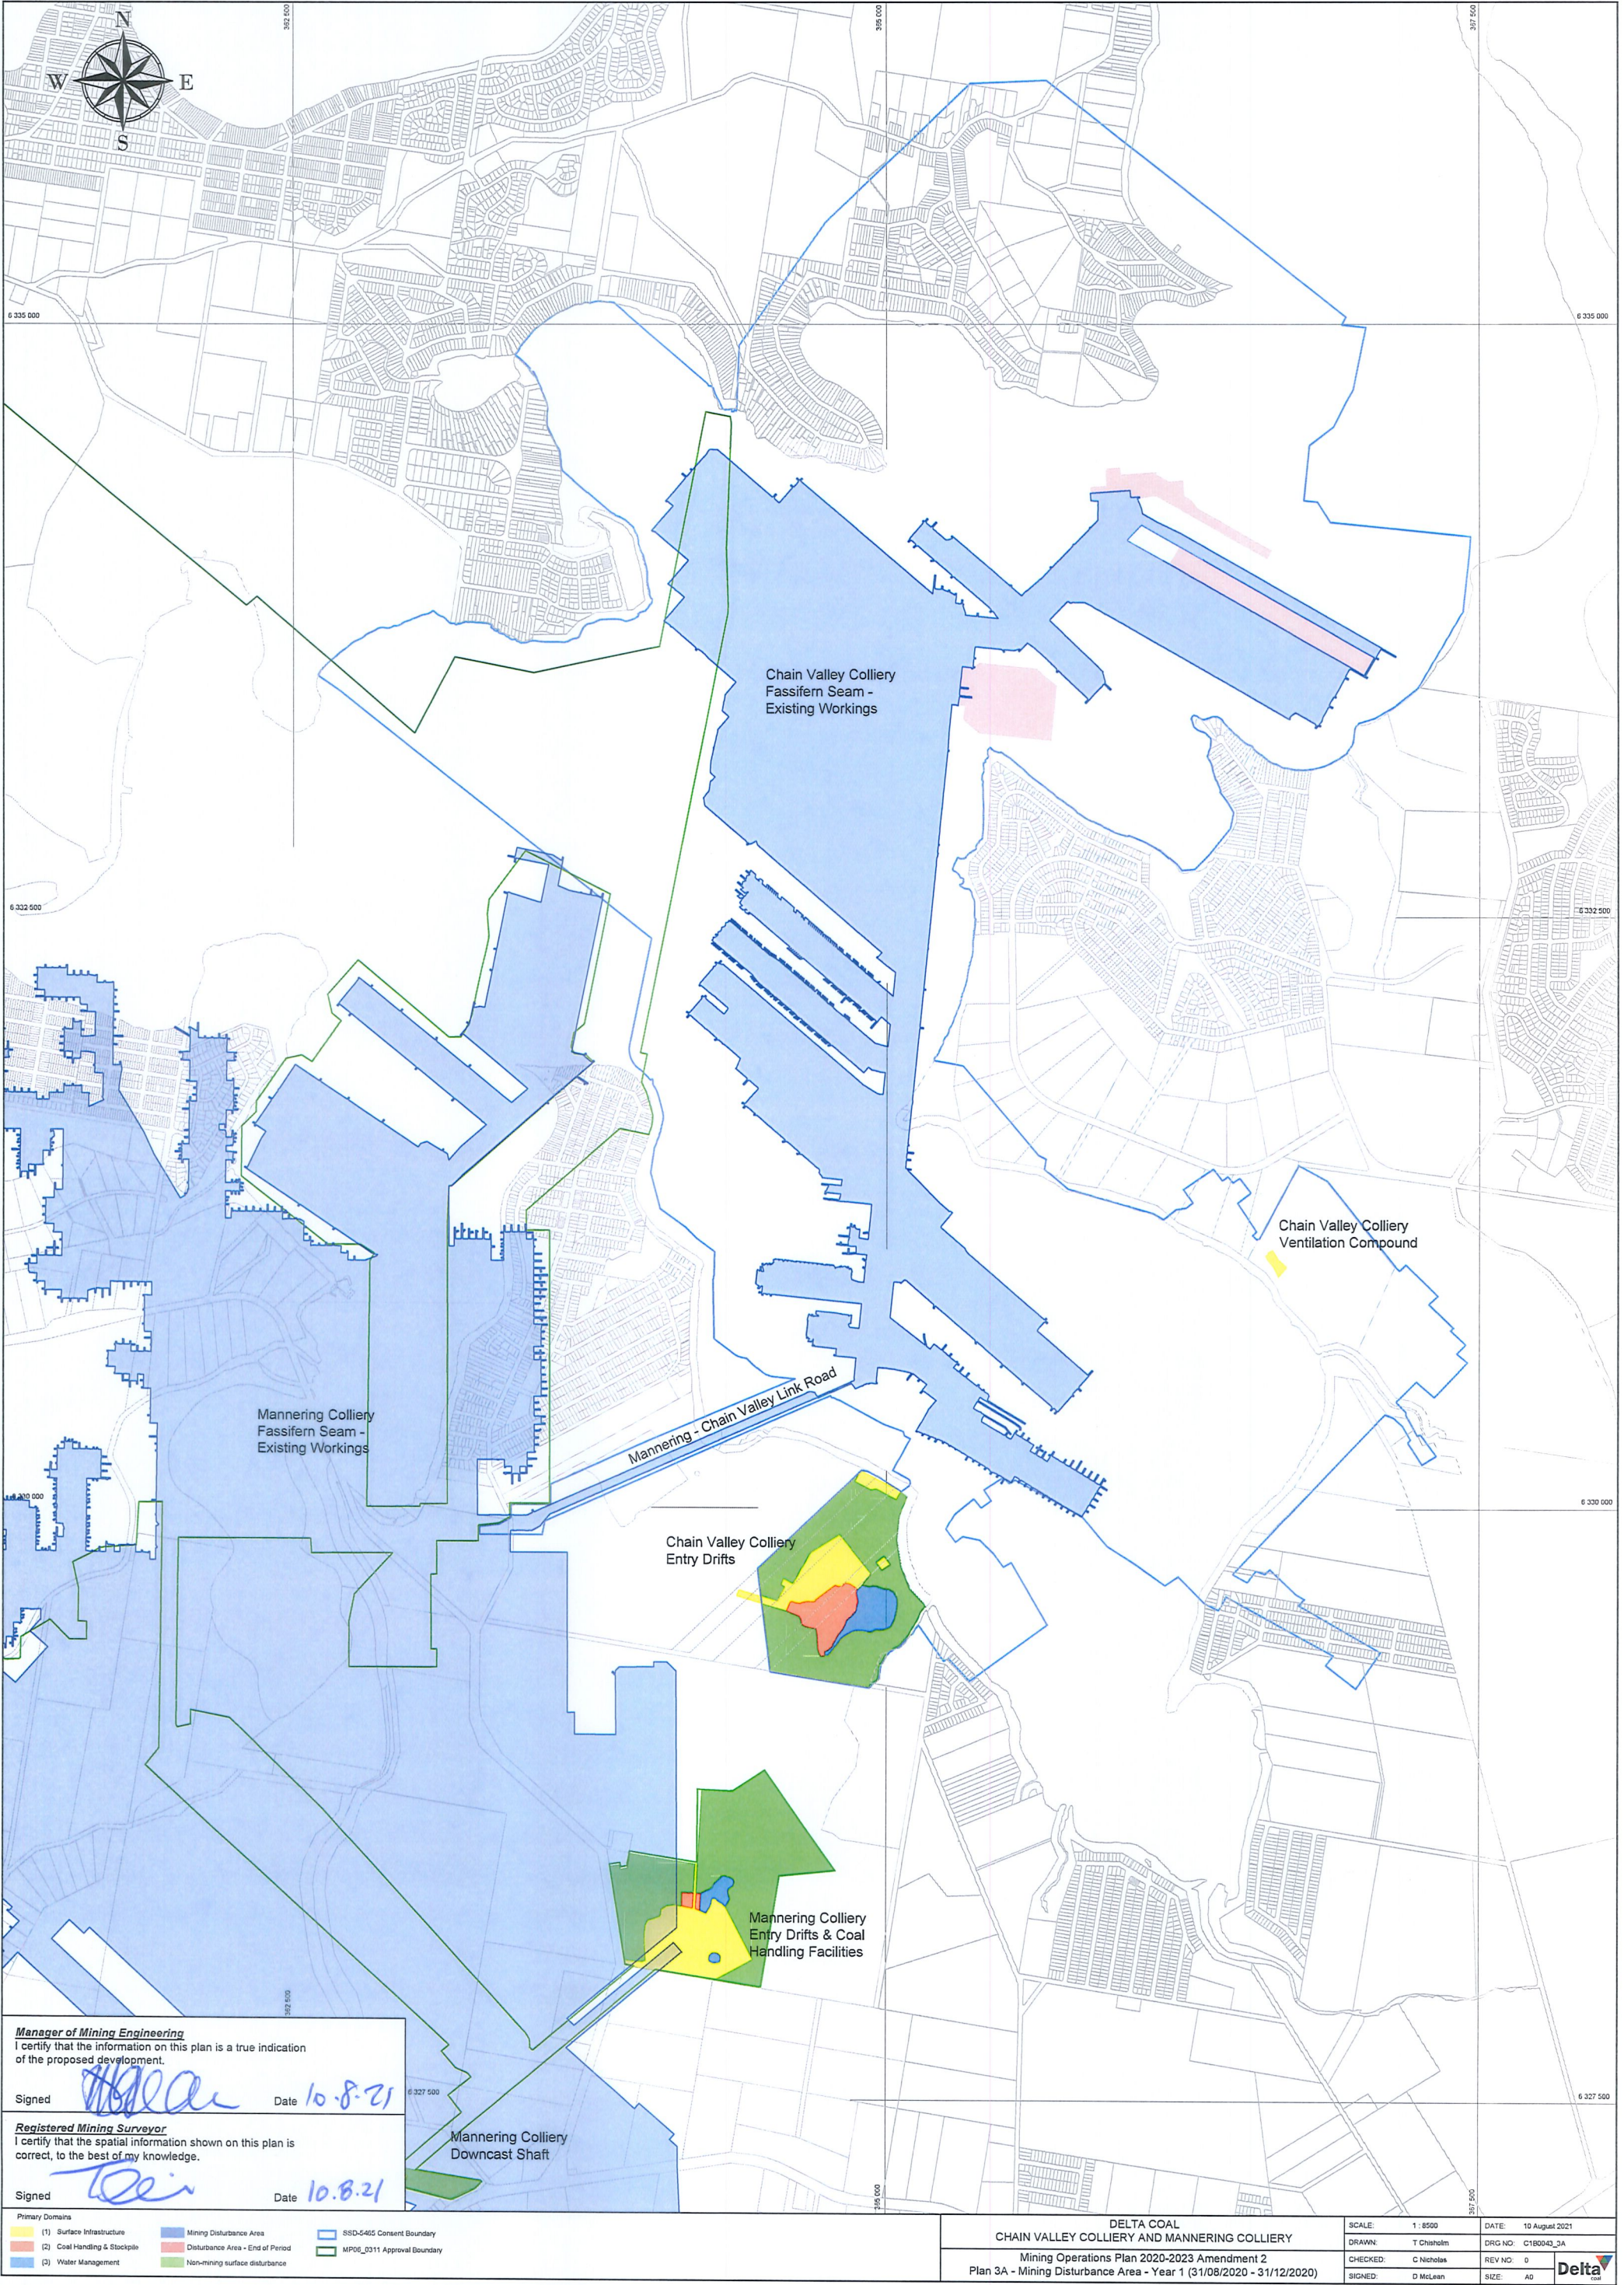
SCALE: 1:2000 (main plan) 1:1000 (insert)	DATE: 10 August 2021
DRAWN: T Chisholm	DRG NO: C180043_2A
CHECKED: C Nicholas	REV NO: 0
SIGNED: D McLeen	SIZE: A0

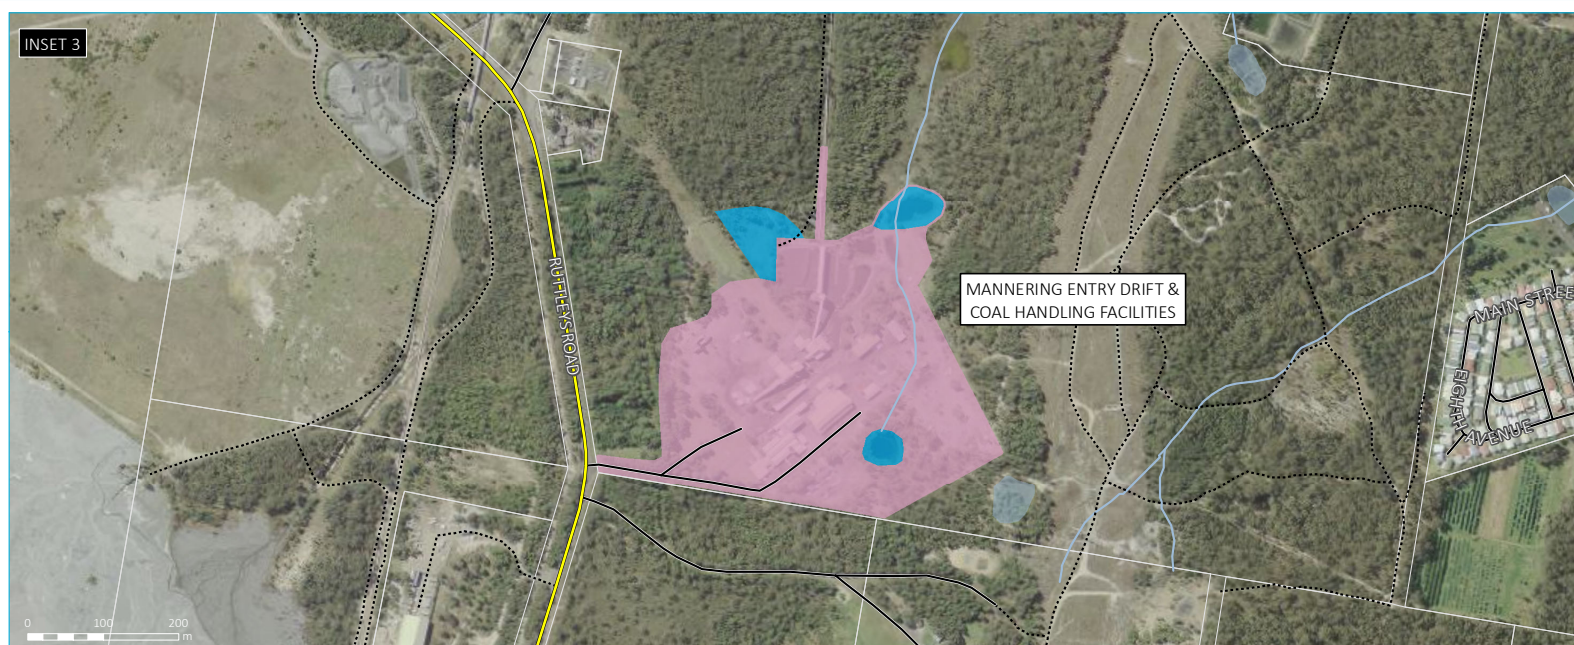
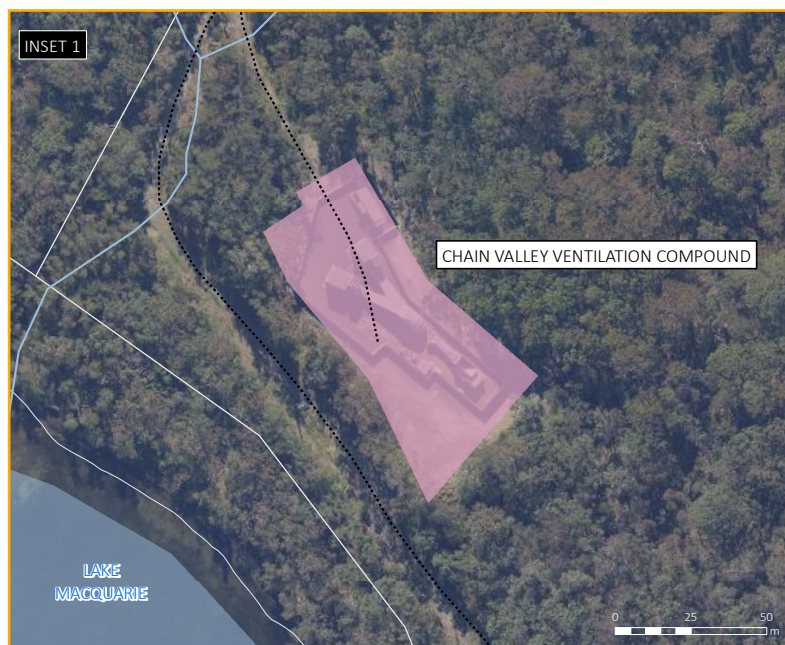
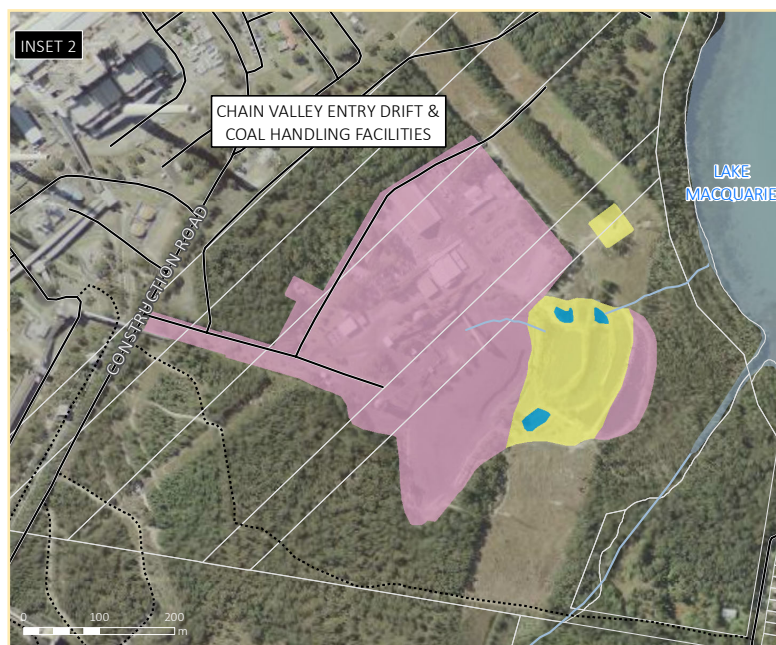
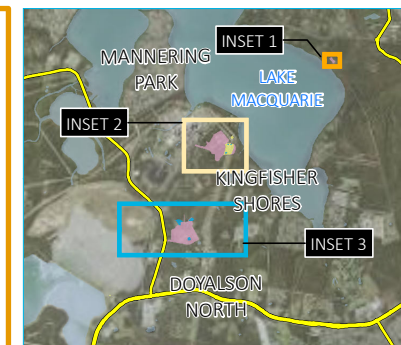
Delta Coal - Chain Valley & Manning Colliery  
Rehabilitation monitoring program  
Figure 1.1

- Water management
- PCT 1642 - Scribbly Gum - Red Bloodwood - Old Man Banksia heathy woodland of southern Central Coast (DNG)
- PCT 1642 - Scribbly Gum - Red Bloodwood - Old Man Banksia heathy woodland of southern Central Coast (woodland)

## Rehabilitation areas at Chain Valley and Manning Colliery

The broad vegetation types detailed in the MOP does not assign vegetation to Plant Community Types (PCT), which is the current method for categorising vegetation communities within NSW. Furthermore appropriate PCT attribution is necessary for obtaining benchmark data (see Section 2.10). Each PCT also assigned a zone, which indicates a broad condition class.

Location	Rehabilitation area in MOP	Rehabilitation area – this monitoring program	Rationale
MC pit top	Broad-Leaved Scribbly Gum Open Forest	PCT 1642 - Scribbly Gum - Red Bloodwood - Old Man Banksia heathy woodland of southern Central Coast_woodland	Species composition aligns with PCT 1642 and the intent of the rehabilitation is to establish woodland.
MC Downcast shaft	Grassland	N/A	Not considered further as this area will be incorporated into the Delta Power Station ash dam and will not be rehabilitated as part of the MC process.
CVC pit top	Coastal Open Woodland	PCT 1642 - Scribbly Gum - Red Bloodwood - Old Man Banksia heathy woodland of southern Central Coast_woodland	Species composition aligns with PCT 1642 and the intent of the rehabilitation is to establish woodland.
CVC upcast shaft	Swamp Sclerophyll Forest	PCT 1642 - Scribbly Gum - Red Bloodwood - Old Man Banksia heathy woodland of southern Central Coast_woodland	Judging by the surrounding communities and landforms, PCT 1642 appear to be the most appropriate rehabilitation aim. The area is somewhat ecotonal, however Swamp Sclerophyll forest is largely distributed immediately downslope of the upcast shaft rehabilitation area.

CVC pit top area under high voltage power line	Grassland	PCT 1642 - Scribbly Gum - Red Bloodwood - Old Man Banksia heathy woodland of southern Central Coast_DNG	PCT 1642_DNG (derived native grassland) has been assigned given that the grassland is likely derived from the surrounding woodland.

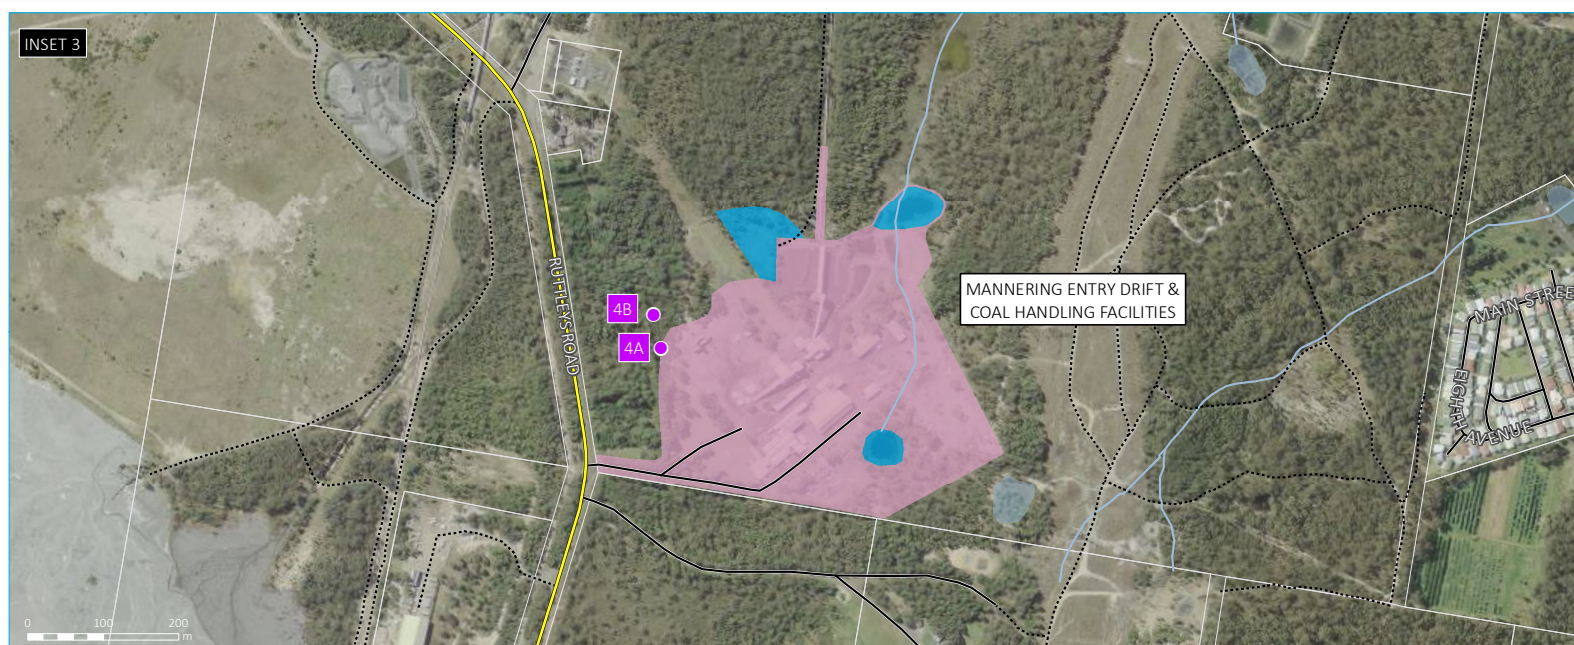
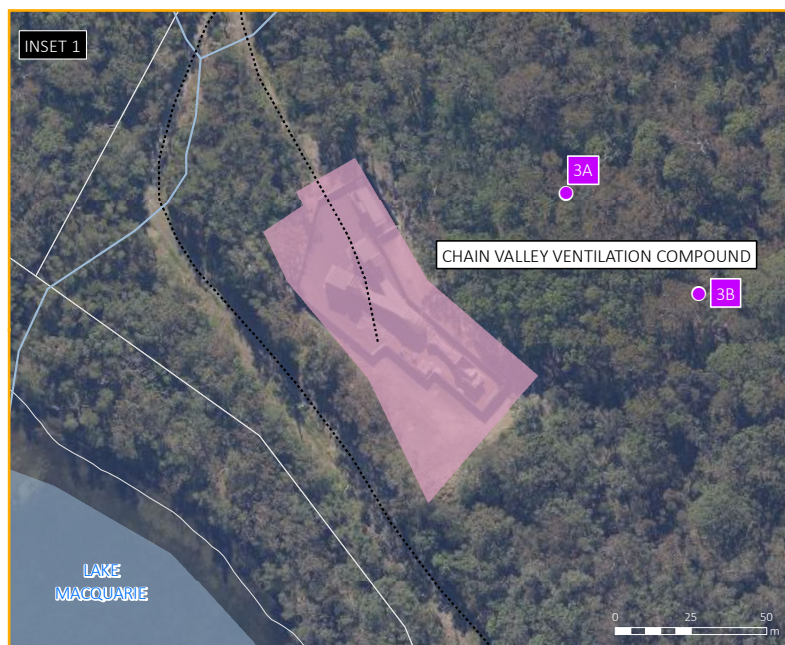
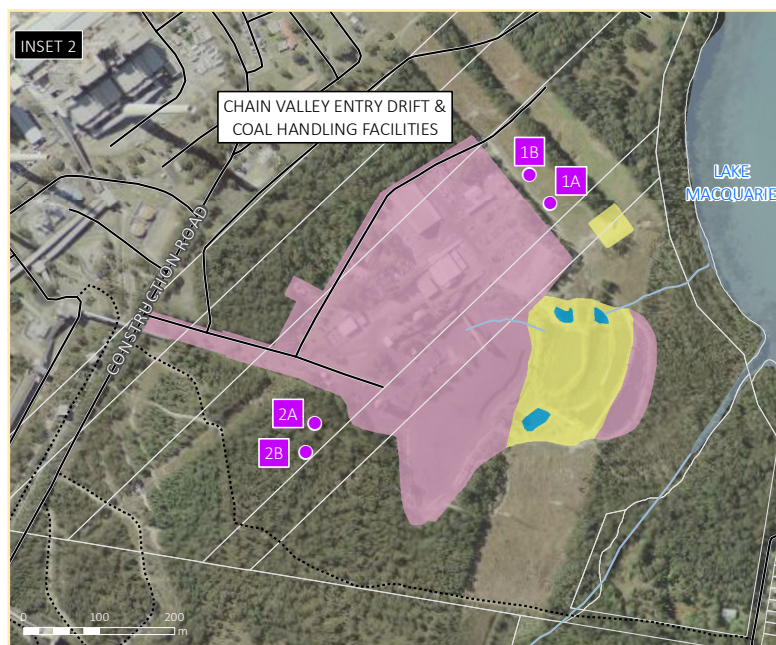
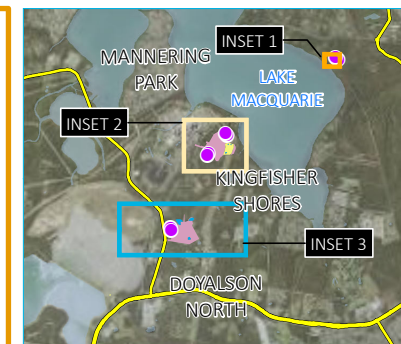
Delta Coal - Chain Valley & Mannerling Colliery  
Delta Coal analogue baseline report  
Figure 3.1

- Analogue plot location
- Main road
- Local road
- - - Vehicular track
- Watercourse/drainage line
- Waterbody
- Cadastral boundary
- Rehabilitation areas
- Water management
- PCT 1642 - Scribbly Gum - Red Bloodwood - Old Man Banksia heathy woodland of southern Central Coast (DNG)
- PCT 1642 - Scribbly Gum - Red Bloodwood - Old Man Banksia heathy woodland of southern Central Coast (woodland)

Analogue plot locations at Chain Valley and Mannerling Colliery

Plot 1 could not be permanently marked with starpickets, owing to its location in a maintained transmission easement. The location of Plot 1 was recorded using hand-held GPS, whilst the remaining three plots were marked with GPS and starpickets. Refer to Figure 3.1 for the plot locations.

A summary of the plot characteristics are provided below (Table 3.1) with location provided in Figure 3.1. The full baseline results and plot photographs are provided in Appendix A and B respectively.

Plot number	Start location (0 m)	End location (50 m)	PCT	Zone
1	0364907 m E, 6329798 m S	0364879 m E, 6329836 m S	1642	Derived native grassland (DNG)
2	0364596 m E, 6329507 m S	036484 m E, 6329489 m S	1642	Woodland
3	0366697 m E, 6331081 m S	0366741 m E, 6331050 m S	1642	Woodland
4	363986 m E, 6328229 m S	363976 m E, 6328273 m S	1642	Woodland

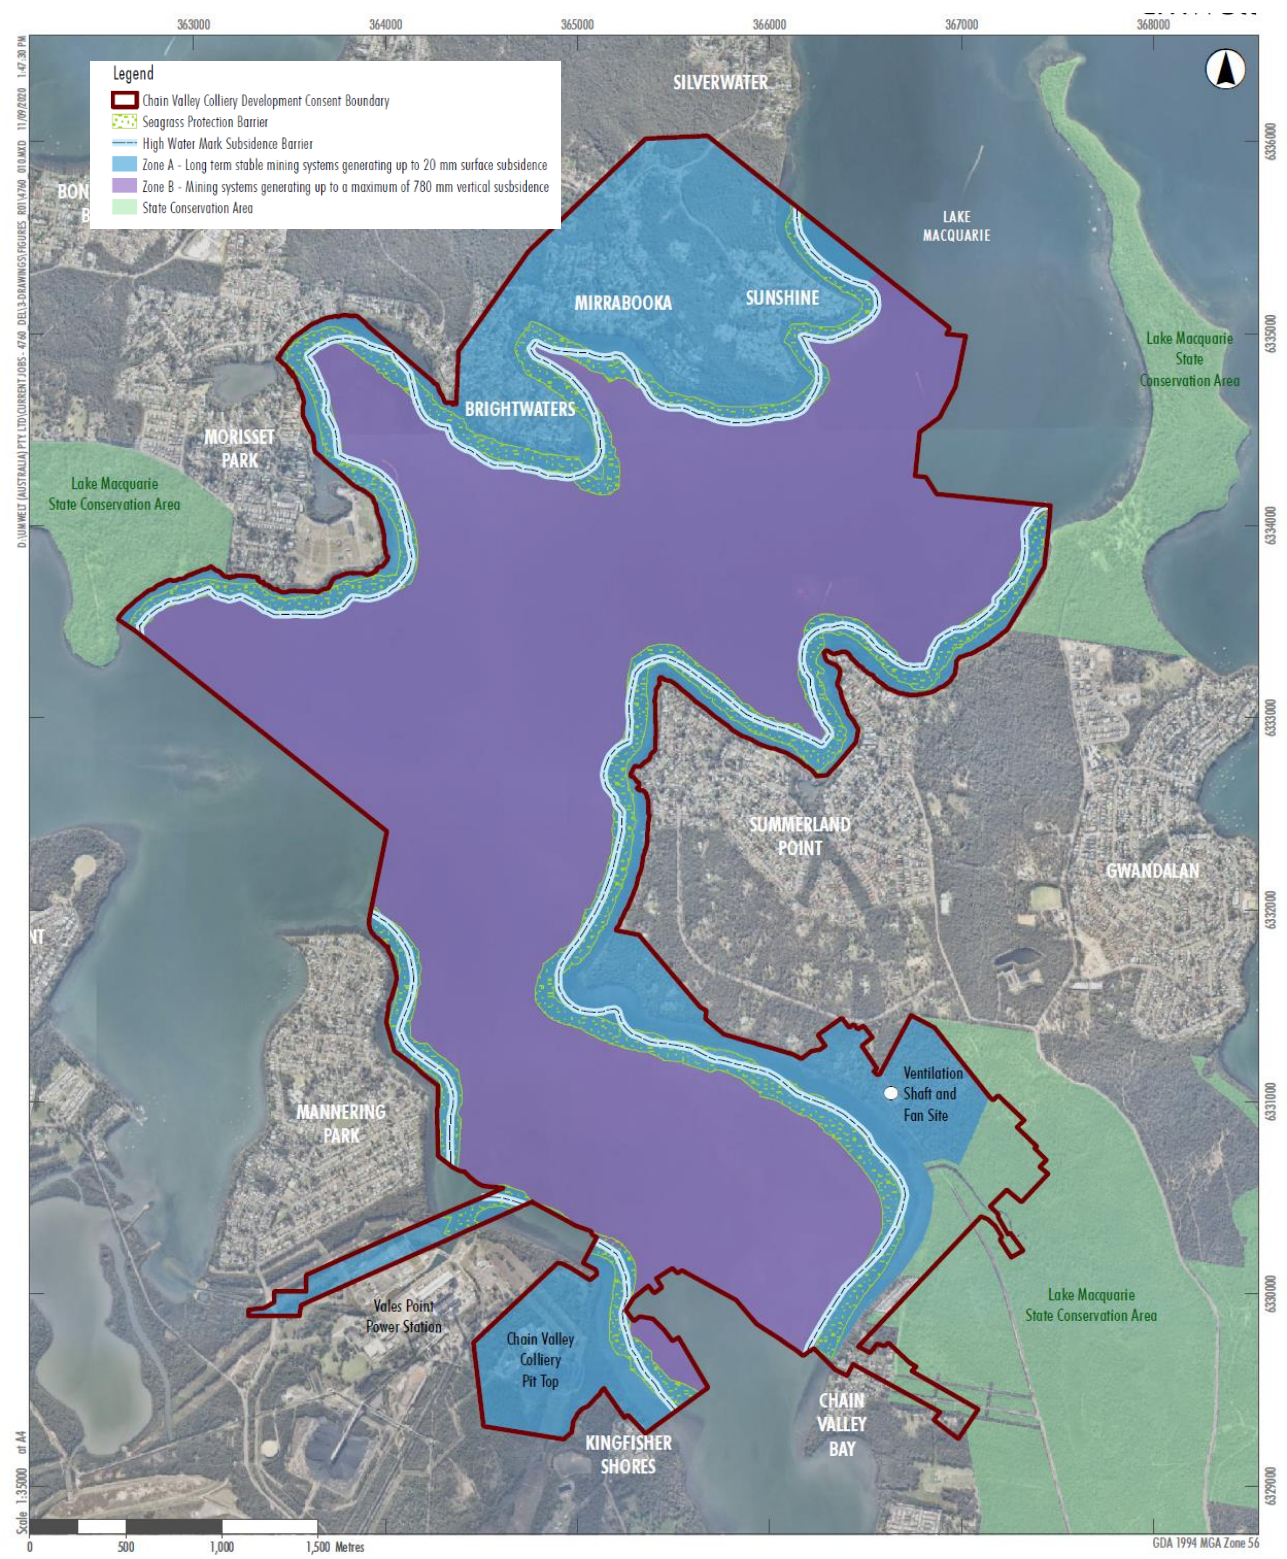
Figure 1 - Layout of the Chain Valley Project, showing Subsidence Zones A and B

All first workings developed within Subsidence Zone A (**Figure 1**) will be designed in accordance with relevant geotechnical and engineering standards to ensure negligible direct subsidence impacts to surface and built features.

The Chain Valley Colliery is situated on the southern shores of Lake Macquarie near Mannering Park, NSW. The mine has been operating since 1962. Mining is currently undertaken using extraction methods within 'Zone B' where subsidence of up to 780mm is permitted, and first workings in 'Zone A' where nil surface impacts are approved. All mining is currently occurring in the Fassifern seam, in line with Development Consent SSD-5465. The general layout of the Chain Valley Extension Project in respect to Lake Macquarie is shown on **Figure 1**.

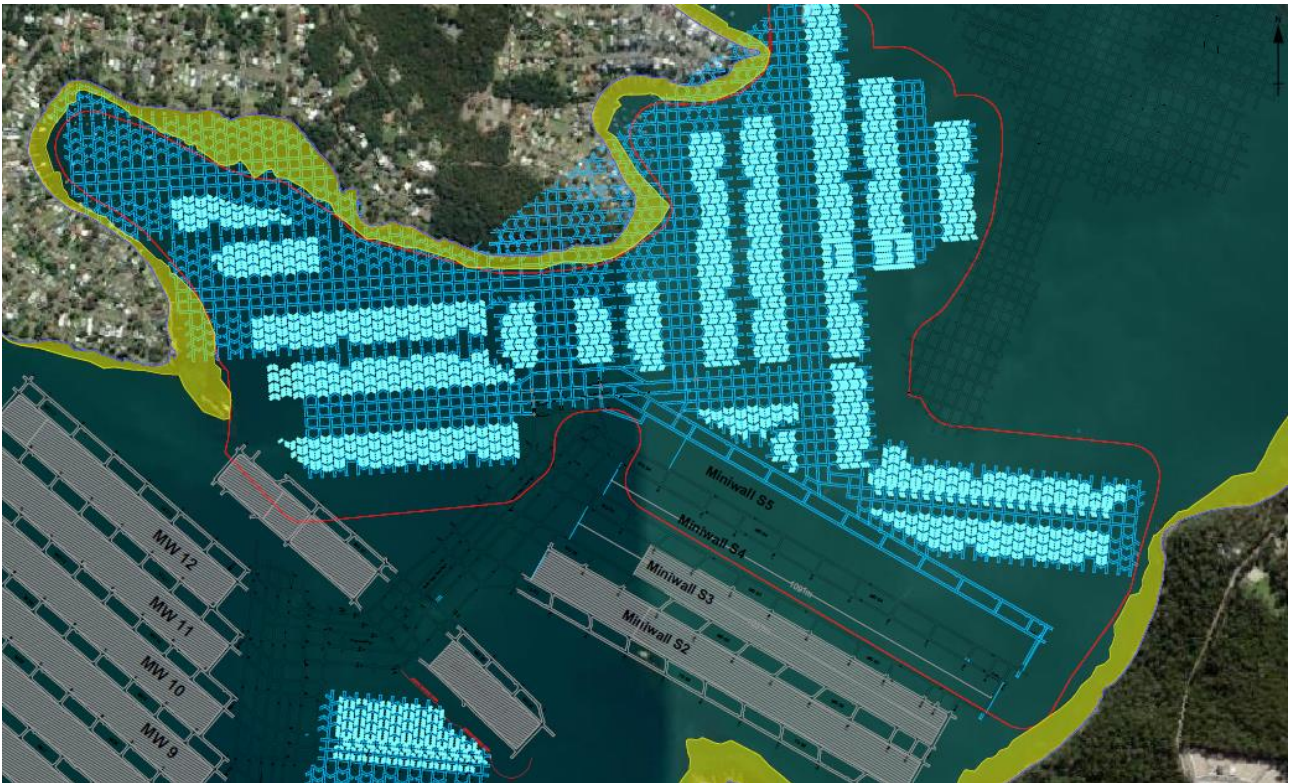
Figure 2 - Predicted Subsidence impact areas due to extraction methods under Lake Macquarie (Hill, 2020)

Subsidence modelling has predicted up to approximately 500mm of subsidence to the Lake floor associated with the planned miniwall mining in S2 to S5 and adjacent pillar extraction (Figure 2). No additional subsidence is expected to occur within the seagrass or foreshore areas as a result of Fassifern extraction. (Hill, 2018, 2019, 2020). Areas where multiple pillar extraction panel are planned has been assessed at 400-500mm, against an approved maximum of 780mm (SSD 5465).

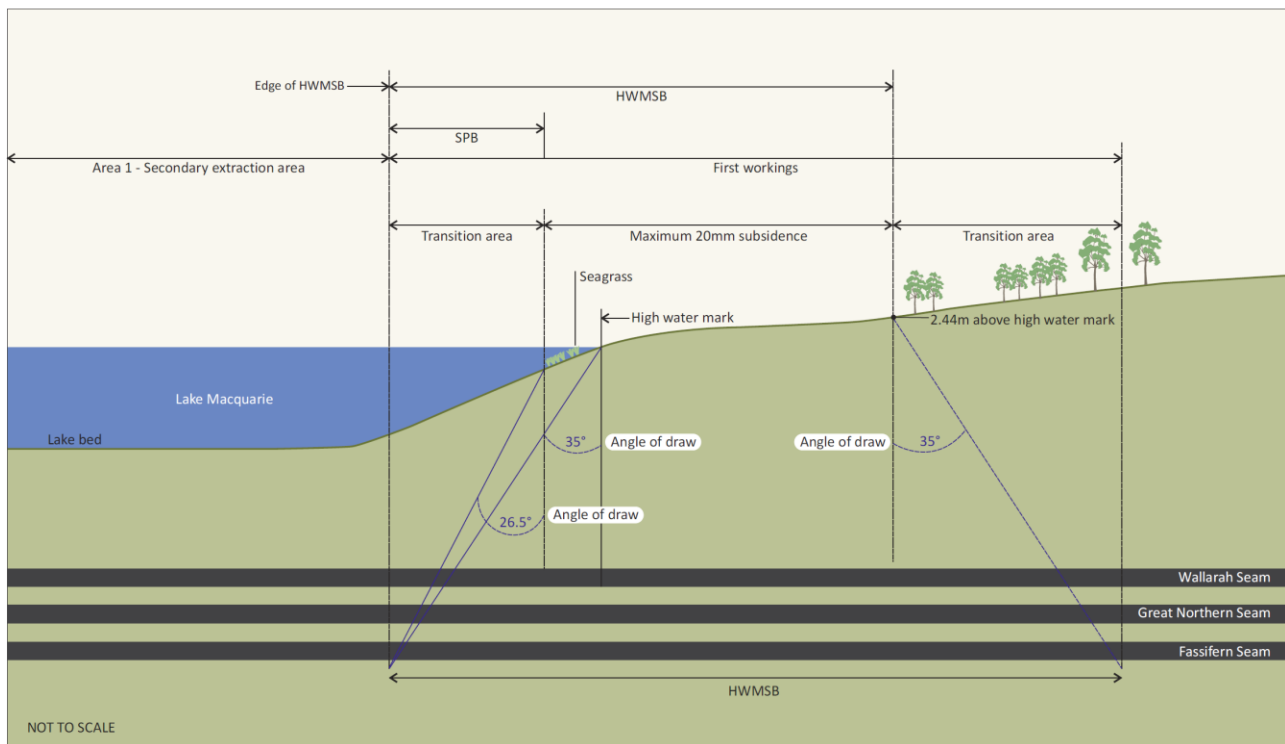
**Figure 3 - High Water Mark Subsidence Barrier Typical Diagram**

The shoreline of Lake Macquarie is protected under Mining Lease Conditions requiring Ministerial Approval to carry out mining operations within the High Water Mark Subsidence Barrier (HWMSB). The HWMSB is defined in the seam by a line defined by an angle of draw of 35° drawn lakewards from the high water level of Lake Macquarie, and on the land side, a line drawn from the 2.44m contour at 35° towards the land (Figure 5).

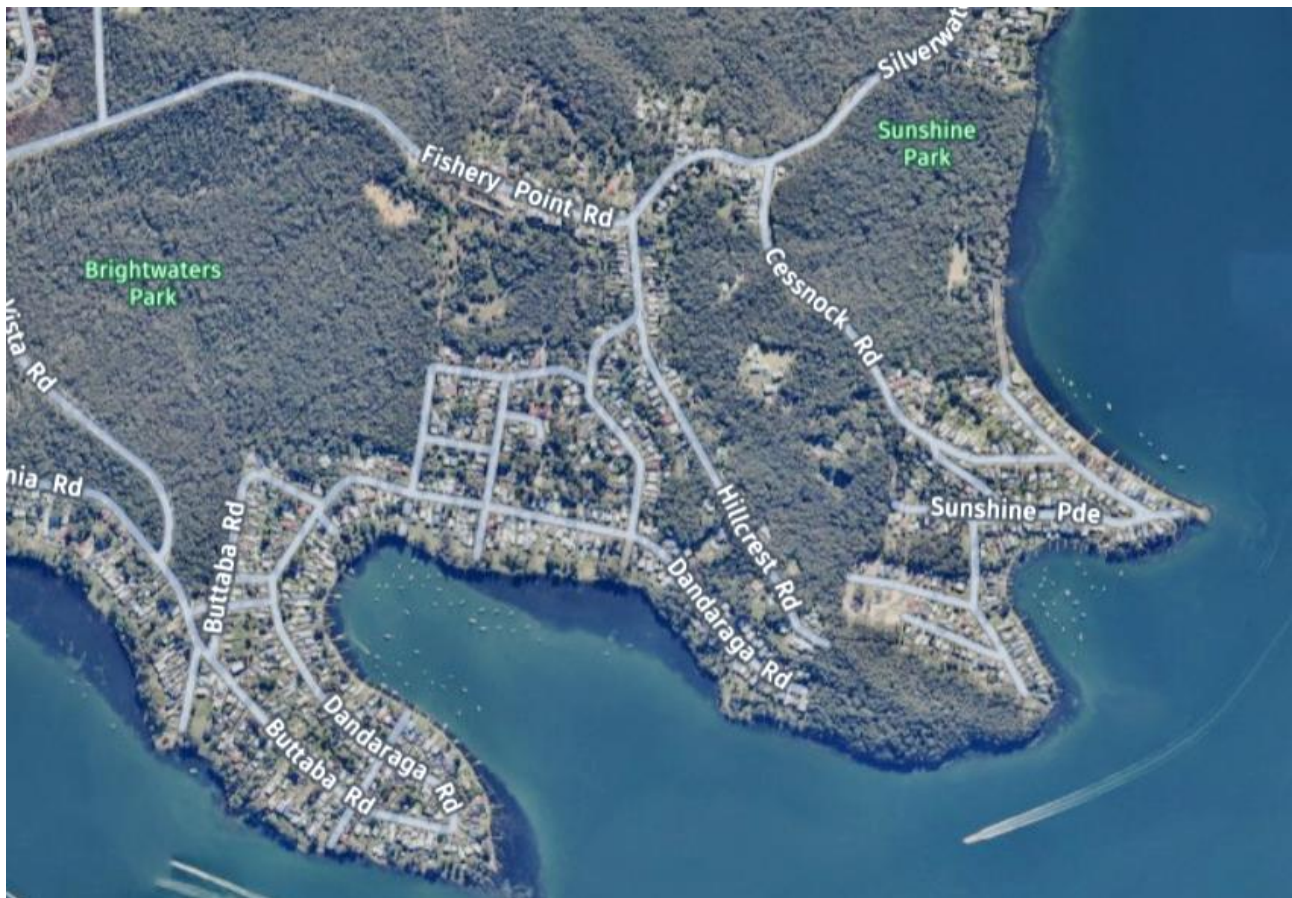
Figure 4 - Morisset East Peninsula

A key objective of the mine design is to ensure vertical subsidence within Subsidence Zone A is limited to a negligible amount (considered less than 20mm). To ensure effectiveness of the mine design, monitoring of the land area is proposed via the installation and monitoring of fixed reference along a number of the major access roads (**Figure 4**) where practical to verify subsidence performance measures.

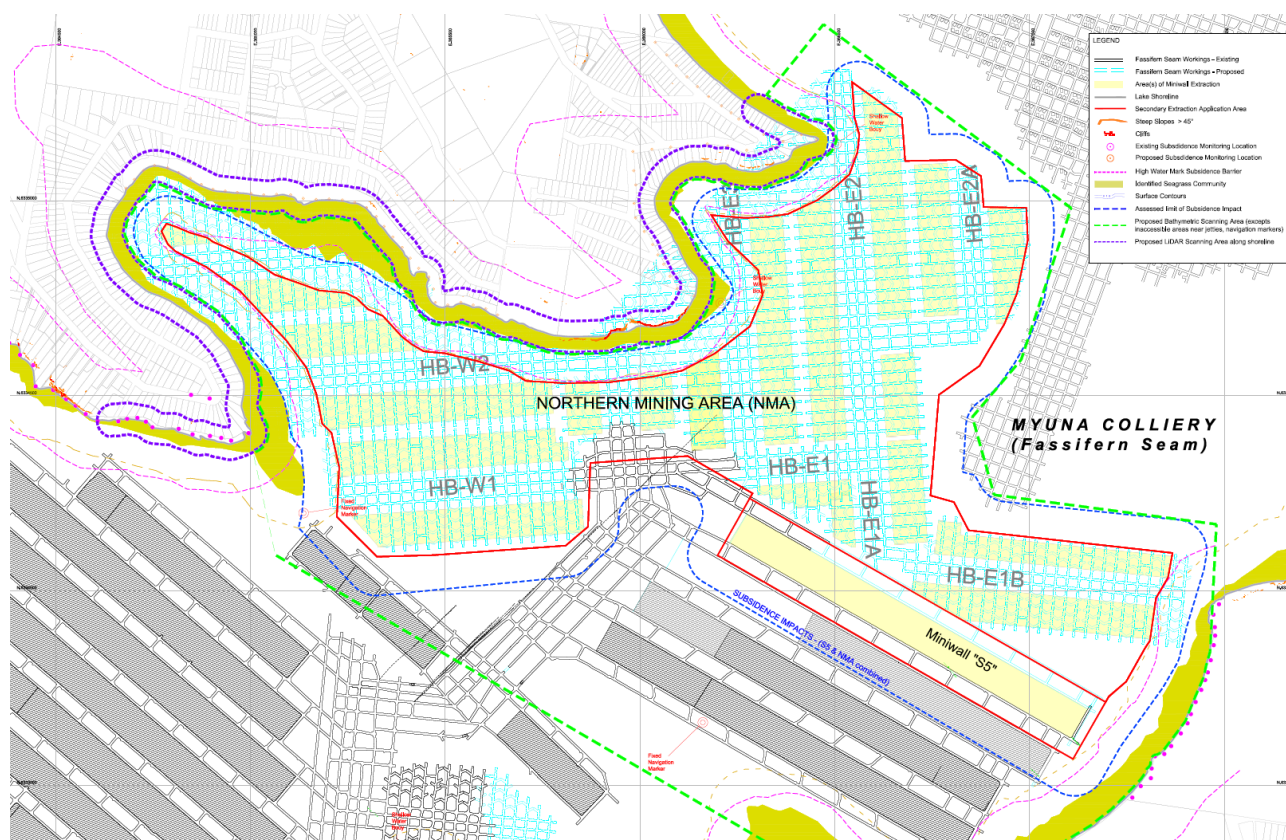
Figure 5 - Proposed Shoreline Subsidence Monitoring Locations, Summerland Point (Delta Coal Plan C4A0099\_7)

Subsidence monitoring around Pt Wolstoncroft and Brightwaters peninsula have already been established due to previous mining operations to the immediate south of the extraction area (**Figure 5**). Additional monitoring points will be established along the foreshore in relevant locations at approximately 20-30m intervals and will be reestablished where missing. New monitoring locations will be subject to landholder access arrangements and permission.
