**Environmental Management System
Delta Coal
Rehabilitation Management Plan**

Rehabilitation Management Plan Summary Table

Name of Mine /s	Chain Valley Colliery and Mannering Colliery
Name of Mine Operator	Great Southern Energy Pty Ltd (trading as Delta Coal)
Rehabilitation Management Plan Commencement Date	20 October 2022
Rehabilitation Management Version and Revision Dates	1 (20 October 2022)
Name of Mining Authorisation / Authorisation holder(s)	<p>Great Southern Energy Pty Ltd</p> <p><u>Mining Leases:</u></p> <ul style="list-style-type: none"> • ML1051 (7 July 2022 – renewal requested) • ML1052 (7 July 2022 – renewal requested) • ML1308 (4 May 2022 – renewal requested) • ML1781 (3 July 2031) • ML1782 (29 July 2026) • ML1783 (28 June 2028) • ML1784 (7 March 2023) • ML1785 (13 October 2043) • CCL706 (29 April 2022 – renewal requested) • CCL707 (30 December 2023) <p><u>Surface Leases:</u></p> <ul style="list-style-type: none"> • MPL1349 (5 October 2028) • MPL1400 (6 November 2031) • MPL337 (30 January 2037) • MPL1389 (14 May 2031) • CCL706 (29 April 2022 – renewal requested) • ML1781 – Surface Portion (3 July 2031) • ML1782 – Surface Portion (29 July 2026) <p><u>Exploration Lice

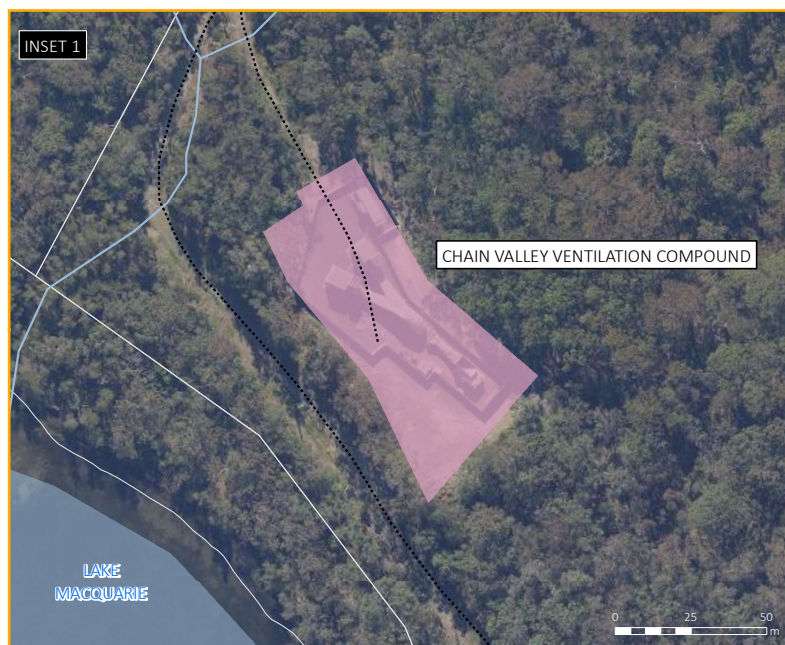
Delta Coal - Chain Valley & Manning Colliery
Rehabilitation monitoring program
Figure 1.1

- Water management
- PCT 1642 - Scribbly Gum - Red Bloodwood - Old Man Banksia heathy woodland of southern Central Coast (DNG)
- PCT 1642 - Scribbly Gum - Red Bloodwood - Old Man Banksia heathy woodland of southern Central Coast (woodland)

Rehabilitation areas at Chain Valley and Manning Colliery

Location	Rehabilitation area in MOP	Rehabilitation area – this monitoring program	Rationale
MC pit top	Broad-Leaved Scribbly Gum Open Forest	PCT 1642 - Scribbly Gum - Red Bloodwood - Old Man Banksia heathy woodland of southern Central Coast_woodland	Species composition aligns with PCT 1642 and the intent of the rehabilitation is to establish woodland.
MC Downcast shaft	Grassland	N/A	Not considered further as this area will be incorporated into the Delta Power Station ash dam and will not be rehabilitated as part of the MC process.
CVC pit top	Coastal Open Woodland	PCT 1642 - Scribbly Gum - Red Bloodwood - Old Man Banksia heathy woodland of southern Central Coast_woodland	Species composition aligns with PCT 1642 and the intent of the rehabilitation is to establish woodland.
CVC upcast shaft	Swamp Sclerophyll Forest	PCT 1642 - Scribbly Gum - Red Bloodwood - Old Man Banksia heathy woodland of southern Central Coast_woodland	Judging by the surrounding communities and landforms, PCT 1642 appear to be the most appropriate rehabilitation aim. The area is somewhat ecotonal, however Swamp Sclerophyll forest is largely distributed immediately downslope of the upcast shaft rehabilitation area.

CVC pit top area under high voltage power line	Grassland	PCT 1642 - Scribbly Gum - Red Bloodwood - Old Man Banksia heathy woodland of southern Central Coast_DNG	PCT 1642_DNG (derived native grassland) has been assigned given that the grassland is likely derived from the surrounding woodland.

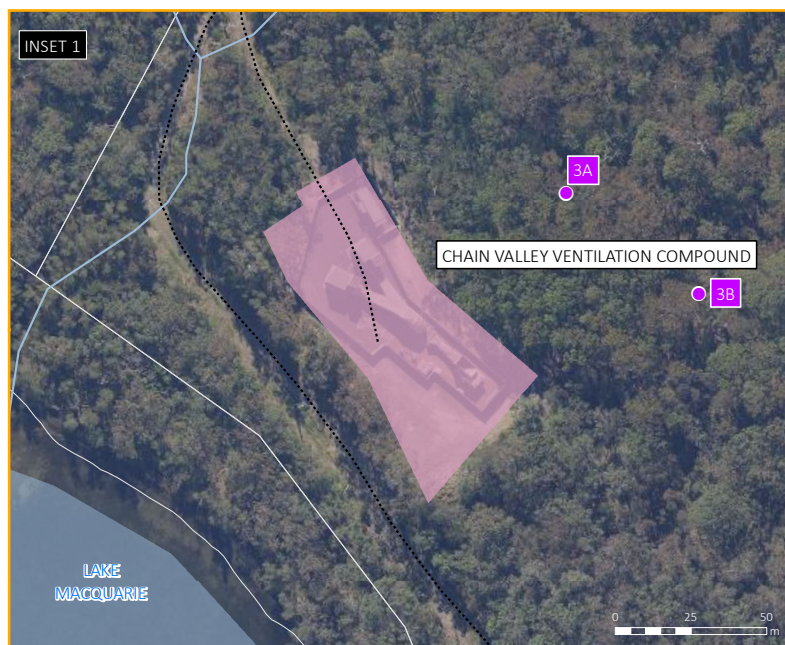
Delta Coal - Chain Valley & Manning Colliery
Delta Coal analogue baseline report
Figure 3.1

- Analogue plot location
- Main road
- Local road
- - - Vehicular track
- Watercourse/drainage line
- Waterbody
- Cadastral boundary
- Rehabilitation areas
- Water management
- PCT 1642 - Scribbly Gum - Red Bloodwood - Old Man Banksia heathy woodland of southern Central Coast (DNG)
- PCT 1642 - Scribbly Gum - Red Bloodwood - Old Man Banksia heathy woodland of southern Central Coast (woodland)

Analogue plot locations at Chain Valley and Manning Colliery

Plot 1 could not be permanently marked with starpickets, owing to its location in a maintained transmission easement. The location of Plot 1 was recorded using hand-held GPS, whilst the remaining three plots were marked with GPS and starpickets. Refer to Figure 3.1 for the plot locations.

A summary of the plot characteristics are provided below (Table 3.1) with location provided in Figure 3.1. The full baseline results and plot photographs are provided in Appendix A and B respectively.

Plot number	Start location (0 m)	End location (50 m)	PCT	Zone
1	0364907 m E, 6329798 m S	0364879 m E, 6329836 m S	1642	Derived native grassland (DNG)
2	0364596 m E, 6329507 m S	036484 m E, 6329489 m S	1642	Woodland
3	0366697 m E, 6331081 m S	0366741 m E, 6331050 m S	1642	Woodland
4	363986 m E, 6328229 m S	363976 m E, 6328273 m S	1642	Woodland

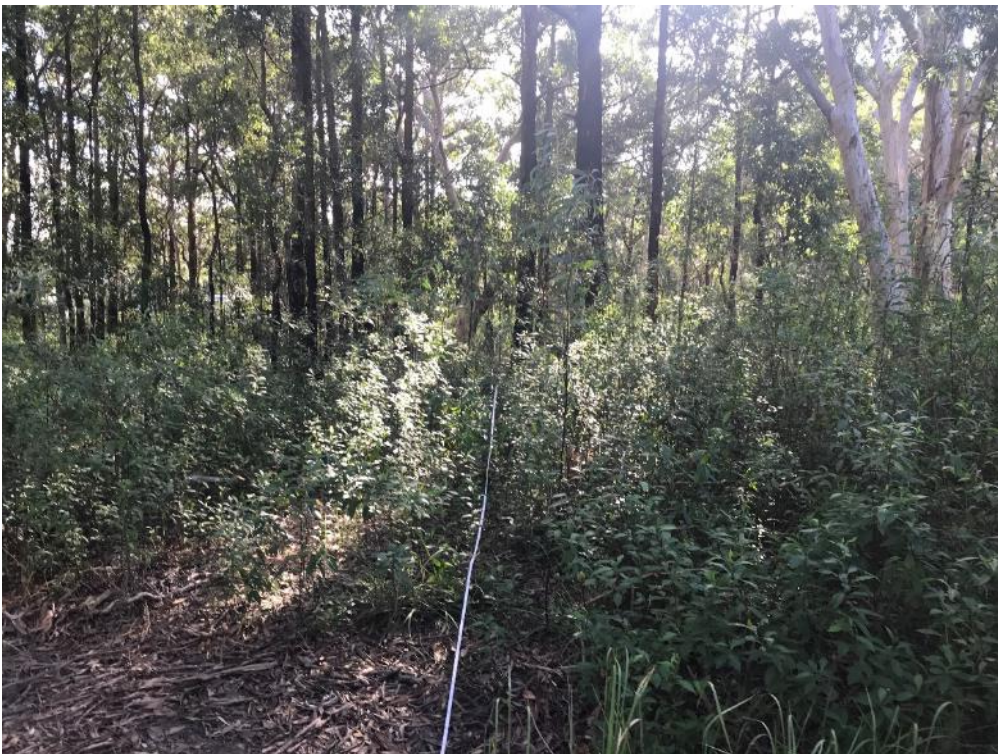
Photograph B.16 Plot 3 end

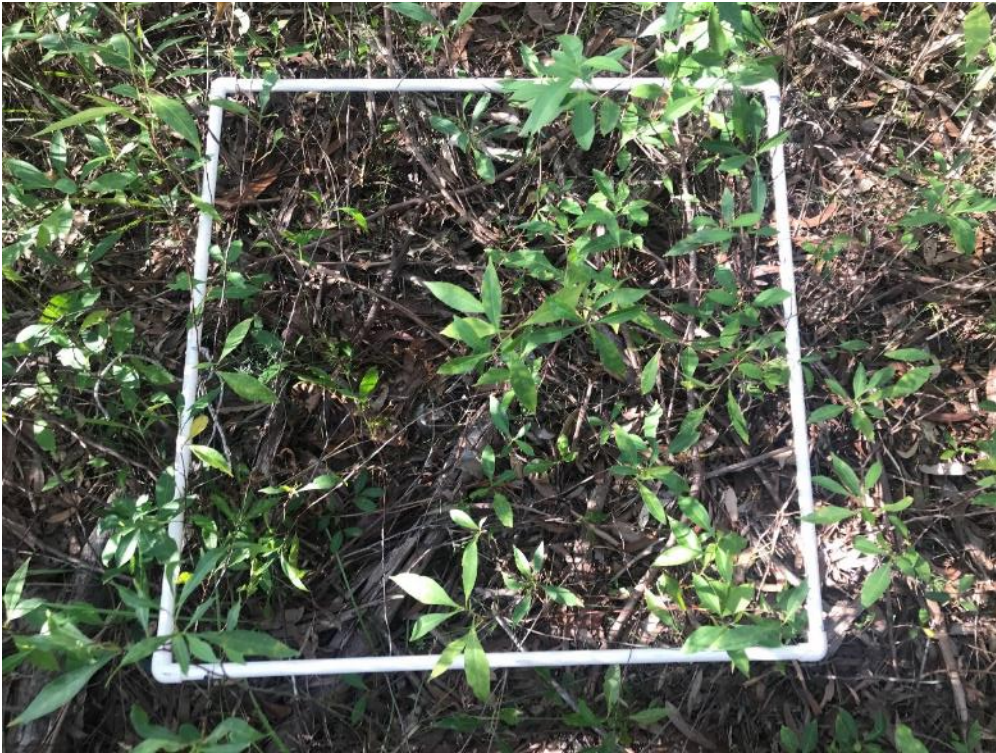
Photograph B.17 **Subplot 1**

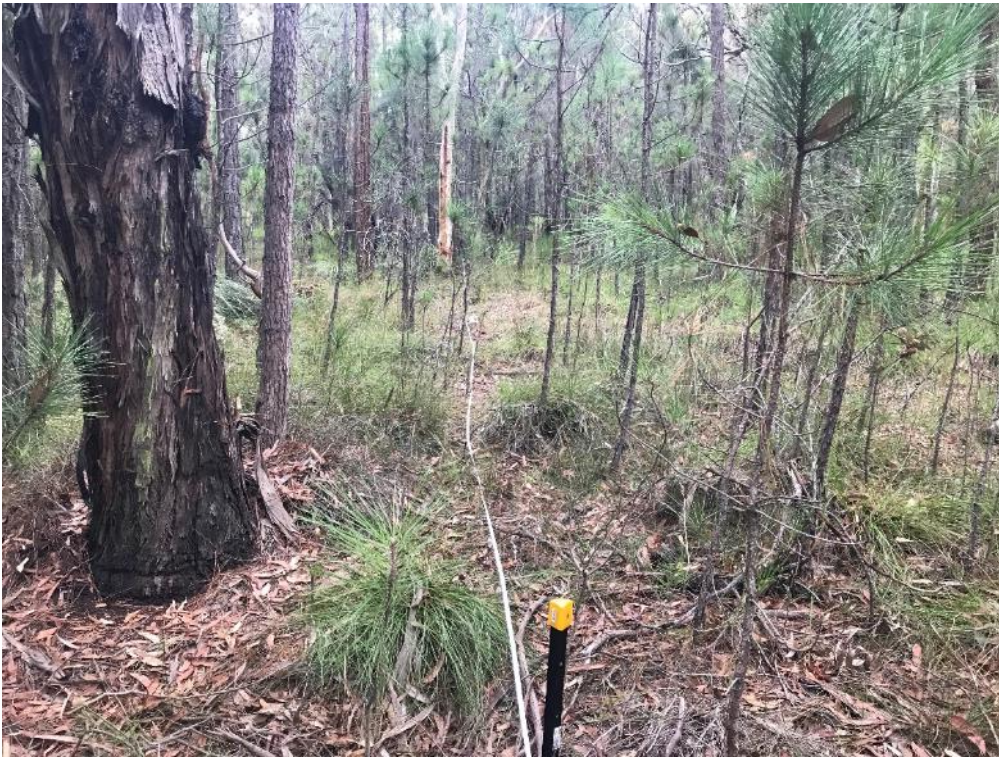
Photograph B.23 **Plot 4 end**

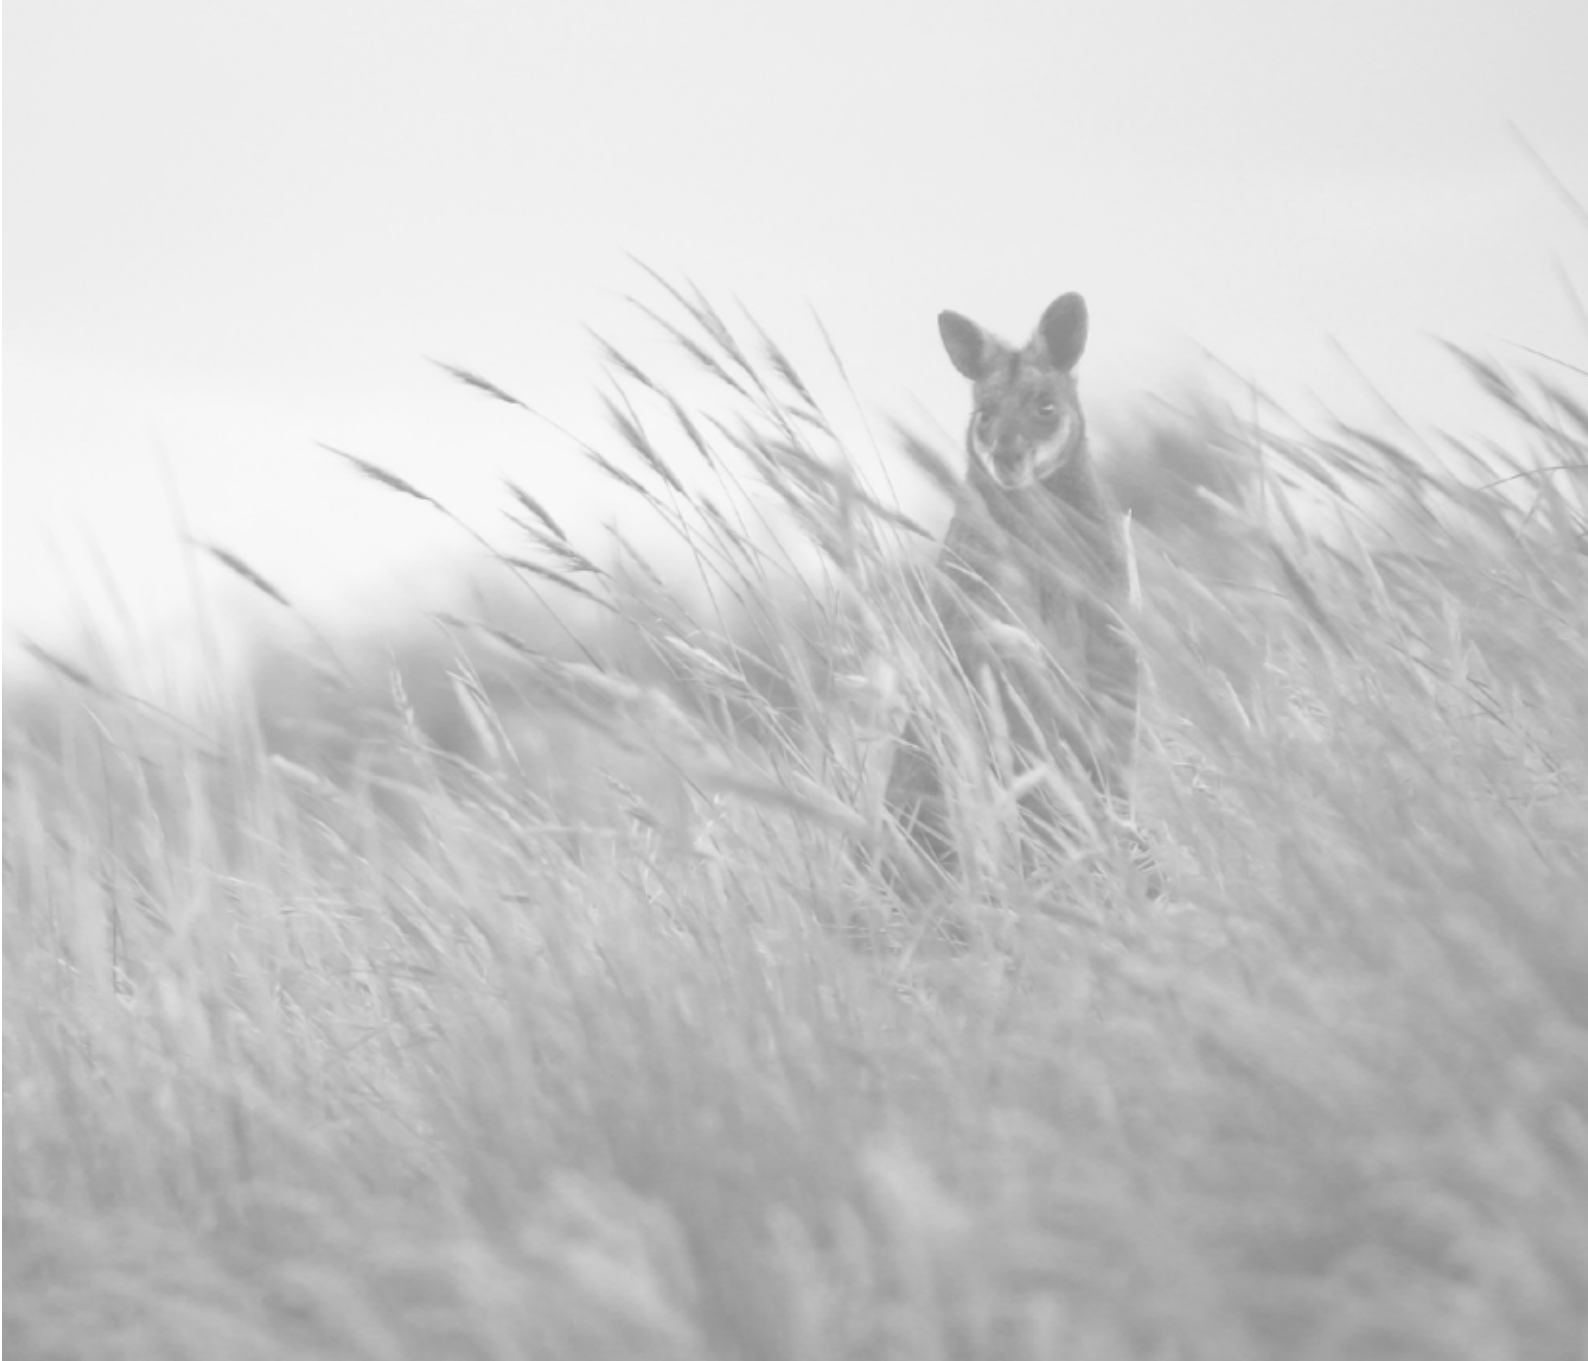
Field sheet template

CVC Biodiversity rehabilitation monitoring - Transect
