**Environmental Management System
Delta Coal
Rehabilitation Management Plan**

Rehabilitation Management Plan Summary Table

Name of Mine /s	Chain Valley Colliery and Mannering Colliery
Name of Mine Operator	Great Southern Energy Pty Ltd (trading as Delta Coal)
Rehabilitation Management Plan Commencement Date	20 October 2022
Rehabilitation Management Version and Revision Dates	1 (20 October 2022)
Name of Mining Authorisation / Authorisation holder(s)	<p>Great Southern Energy Pty Ltd</p> <p><u>Mining Leases:</u></p> <ul style="list-style-type: none"> • ML1051 (7 July 2022 – renewal requested) • ML1052 (7 July 2022 – renewal requested) • ML1308 (4 May 2022 – renewal requested) • ML1781 (3 July 2031) • ML1782 (29 July 2026) • ML1783 (28 June 2028) • ML1784 (7 March 2023) • ML1785 (13 October 2043) • CCL706 (29 April 2022 – renewal requested) • CCL707 (30 December 2023) <p><u>Surface Leases:</u></p> <ul style="list-style-type: none"> • MPL1349 (5 October 2028) • MPL1400 (6 November 2031) • MPL337 (30 January 2037) • MPL1389 (14 May 2031) • CCL706 (29 April 2022 – renewal requested) • ML1781 – Surface Portion (3 July 2031) • ML1782 – Surface Portion (29 July 2026) <p><u>Exploration Lice

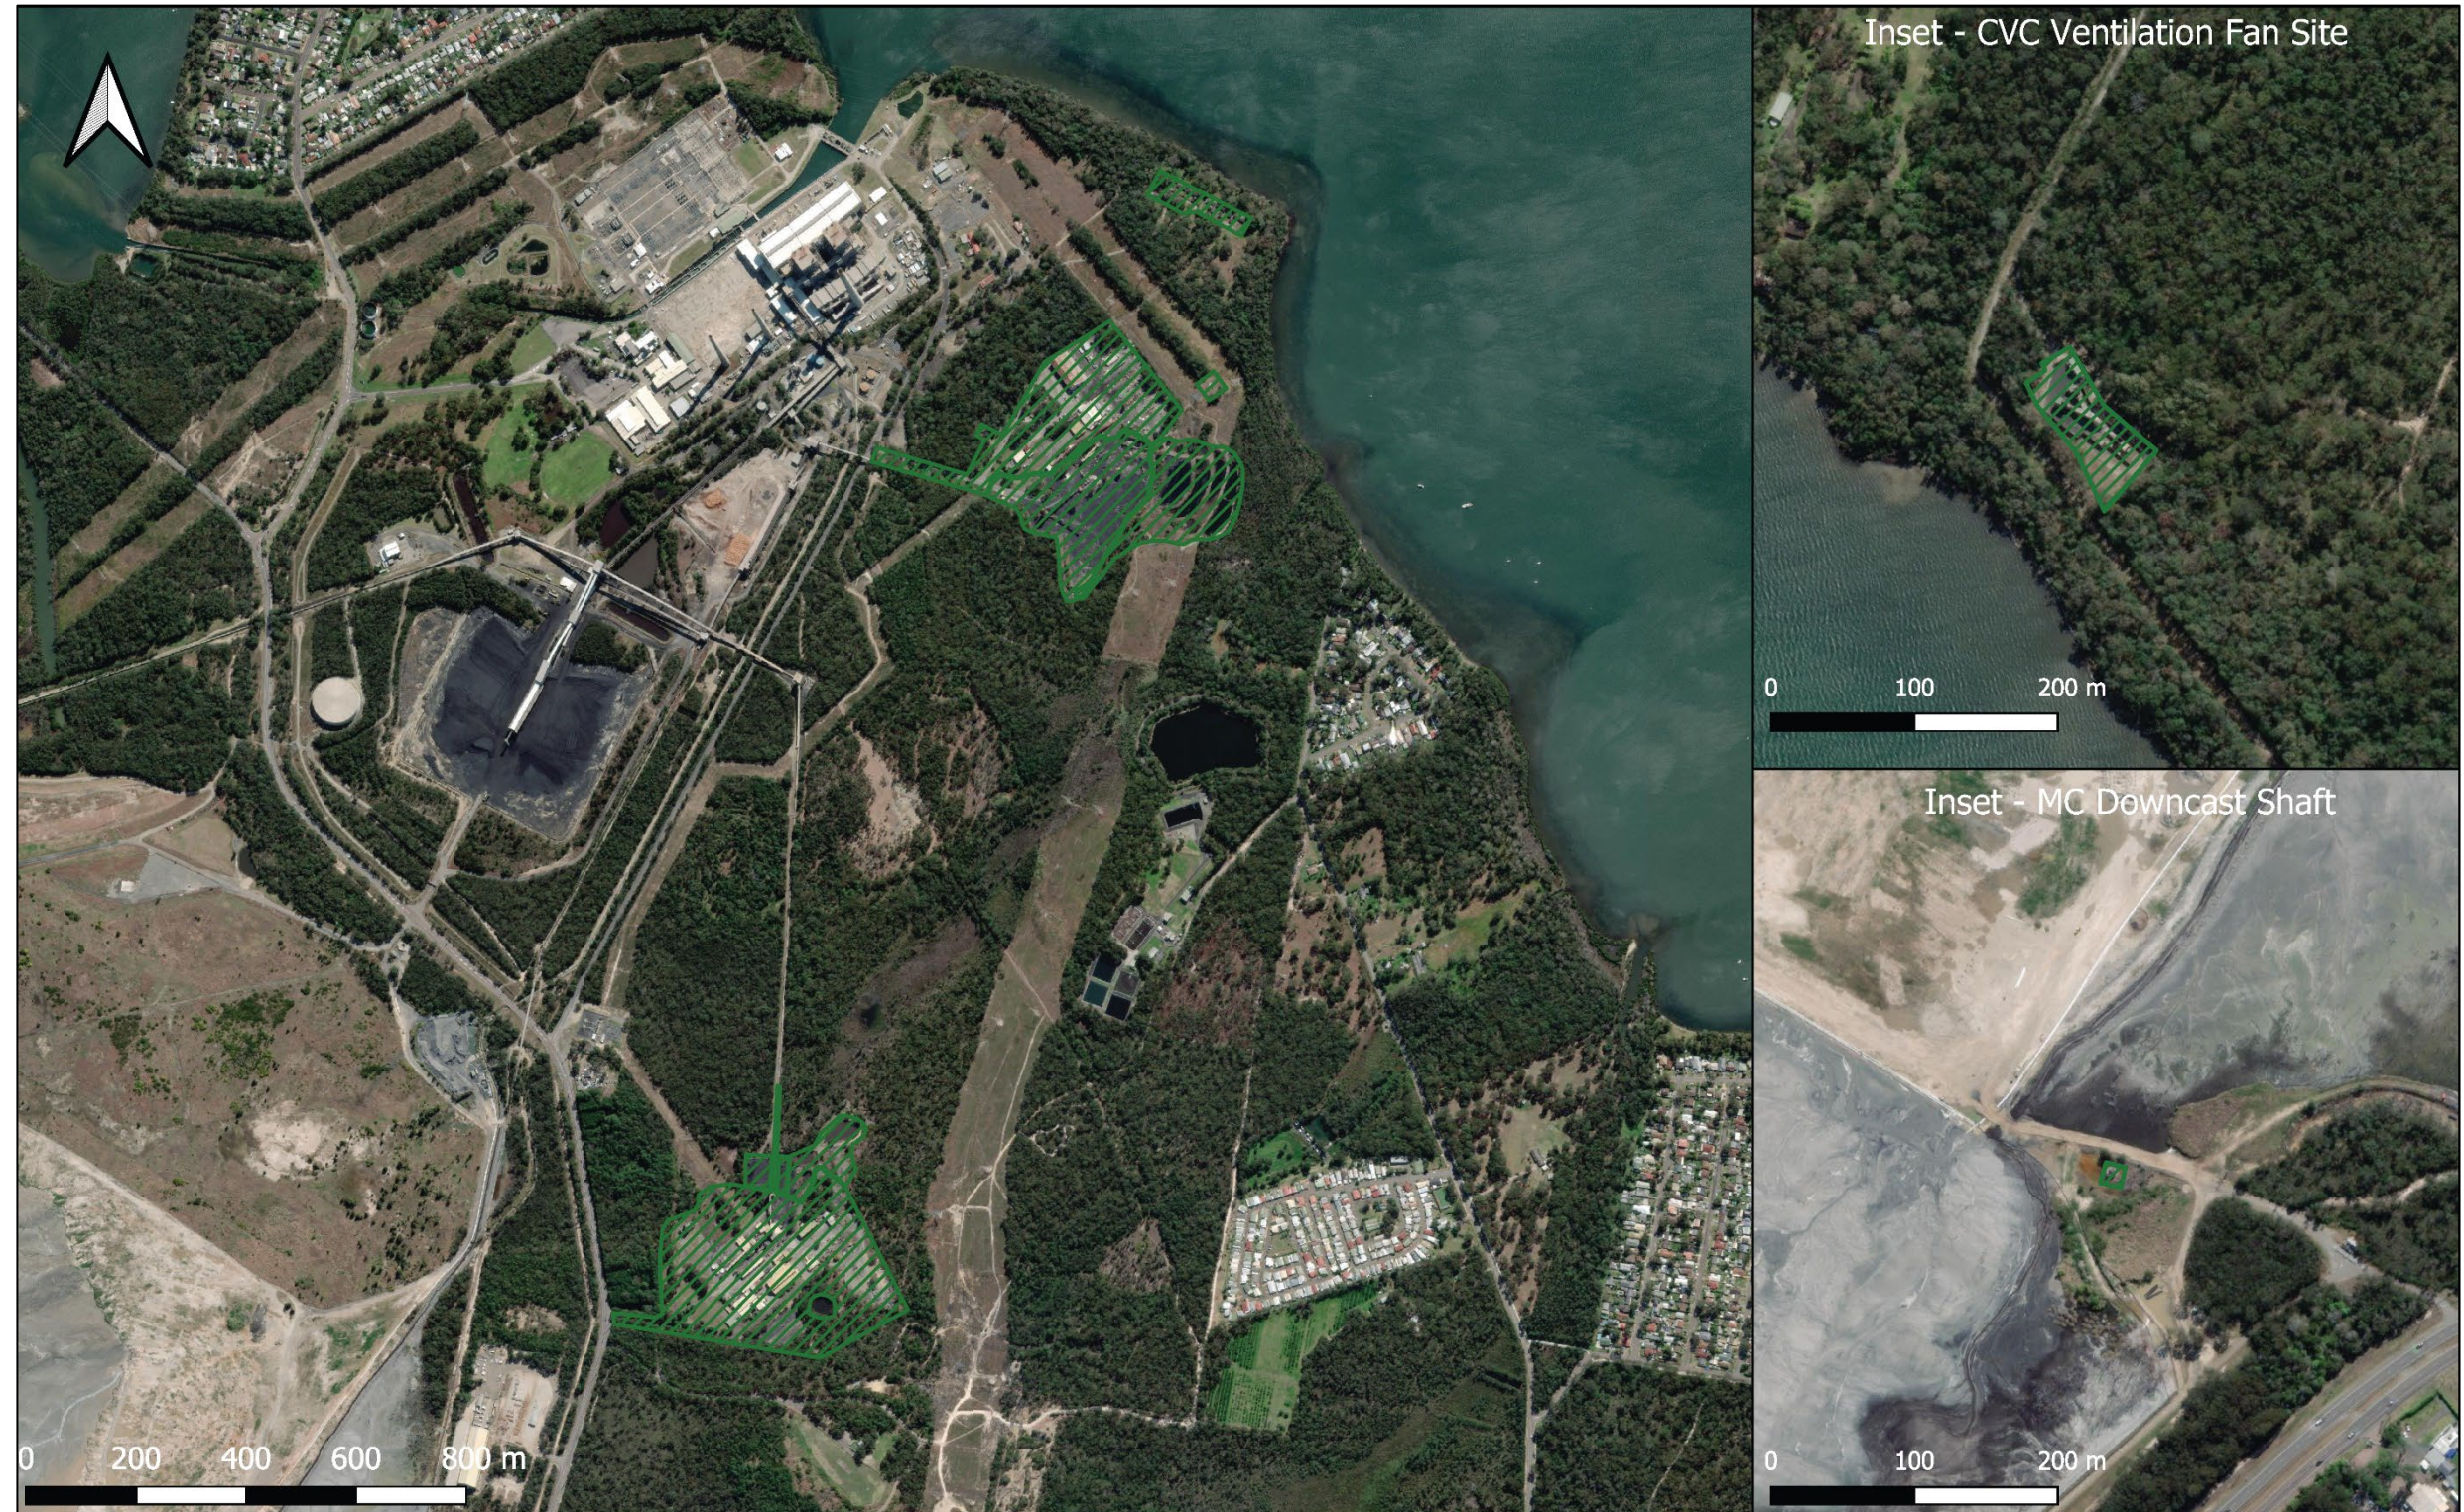
<div>Forecast Area</div> <div><div></div> Forecast Disturbance</div> <div><div></div> Forecast Land Prepared for Rehabilitation</div> <div><div></div> Ecosystem and Land Use Establishment</div>		<div>Delta Coal - Chain Valley Colliery and Mannering Colliery Rehabilitation Management Plan</div>	<div>Mine Name: Chain Valley Colliery Drawn by: LM Date: 30/08/2022</div>	<div><div>Delta</div><div>coal</div></div>
		<div>Plan 6: Life of Mine Rehabilitation 2031-2033</div>
