TITLE Biodiversity Management Plan
 DOC ID
 SITE Chain Valley Colliery

Environmental Management System
Chain Valley Colliery
Biodiversity Management Plan

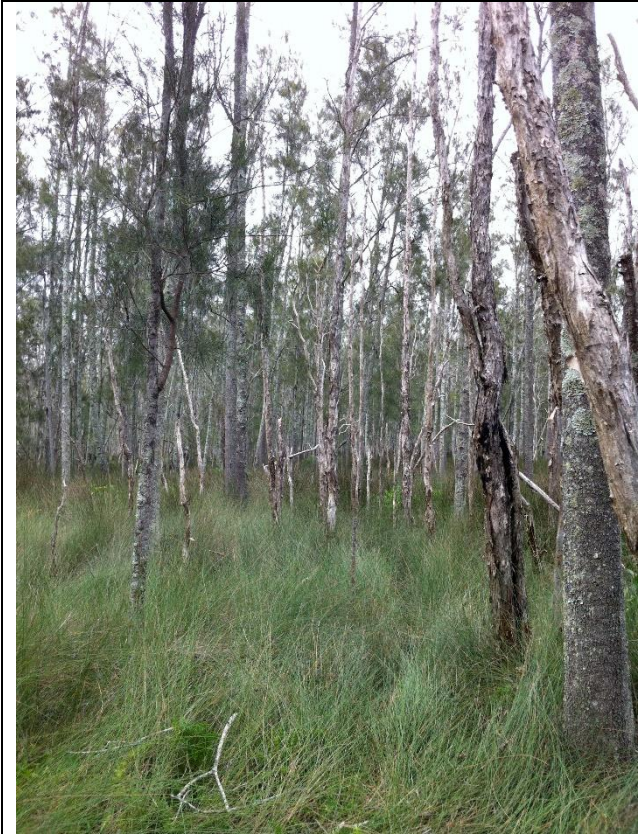
Plate 1 - Plot 1: CVC Swamp Oak Floodplain Forest

Native vegetation in this area is in good to moderate condition, with an overall weighted score of 82.2%. The trigger value for remedial works is when the weighted score is less than 60%, in 2023 the combined weighted score for the two plots was 67.8%, annual biodiversity monitoring data is presented in the annual biodiversity monitoring reports, made available on the Delta Coal website (www.deltapae.com.au). Subsequent monitoring events will be compared against these baseline results for Swamp oak forest in the biodiversity enhancement area to monitor the overall weighted score against this trigger value. Photographs of Plot 1 and Plot 2 areas are provided as Plate 1 and Plate 2. **Figure 2** shows the location of Plot 1 and Plot 2.

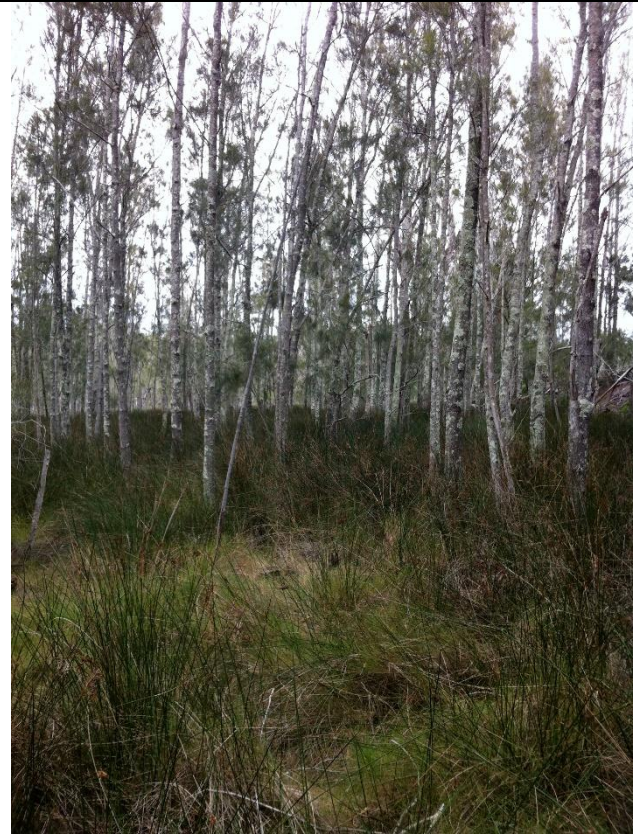
Plate 2 - Plot 2: CVC Swamp Oak Floodplain Forest

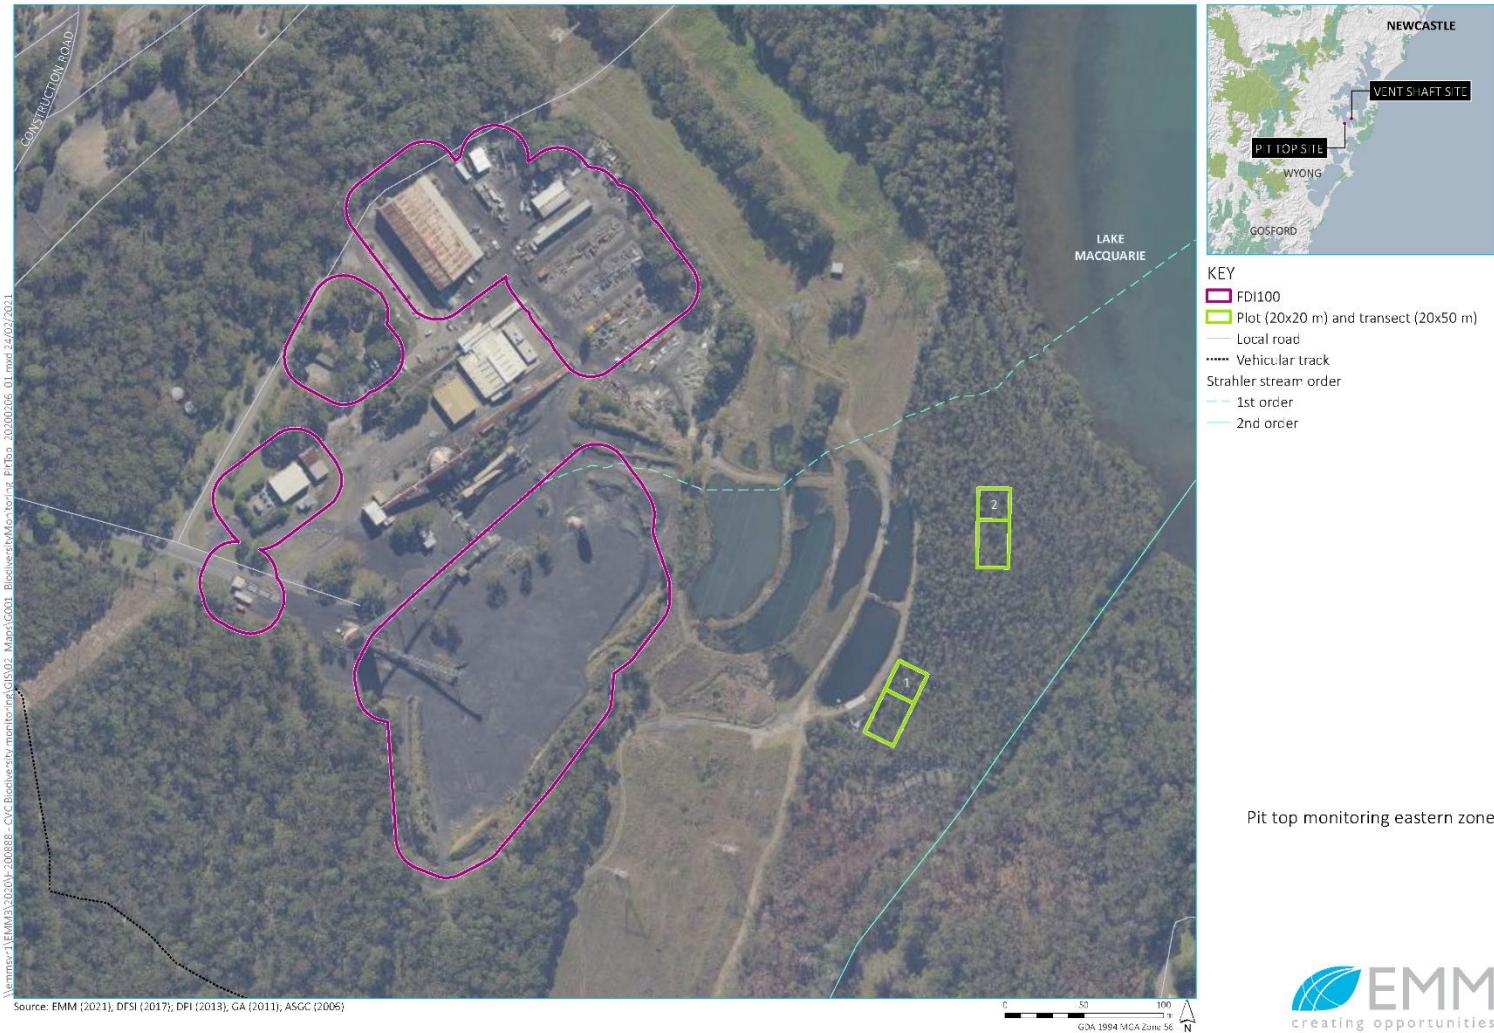
Figure 2 - Biodiversity Monitoring Plot Locations

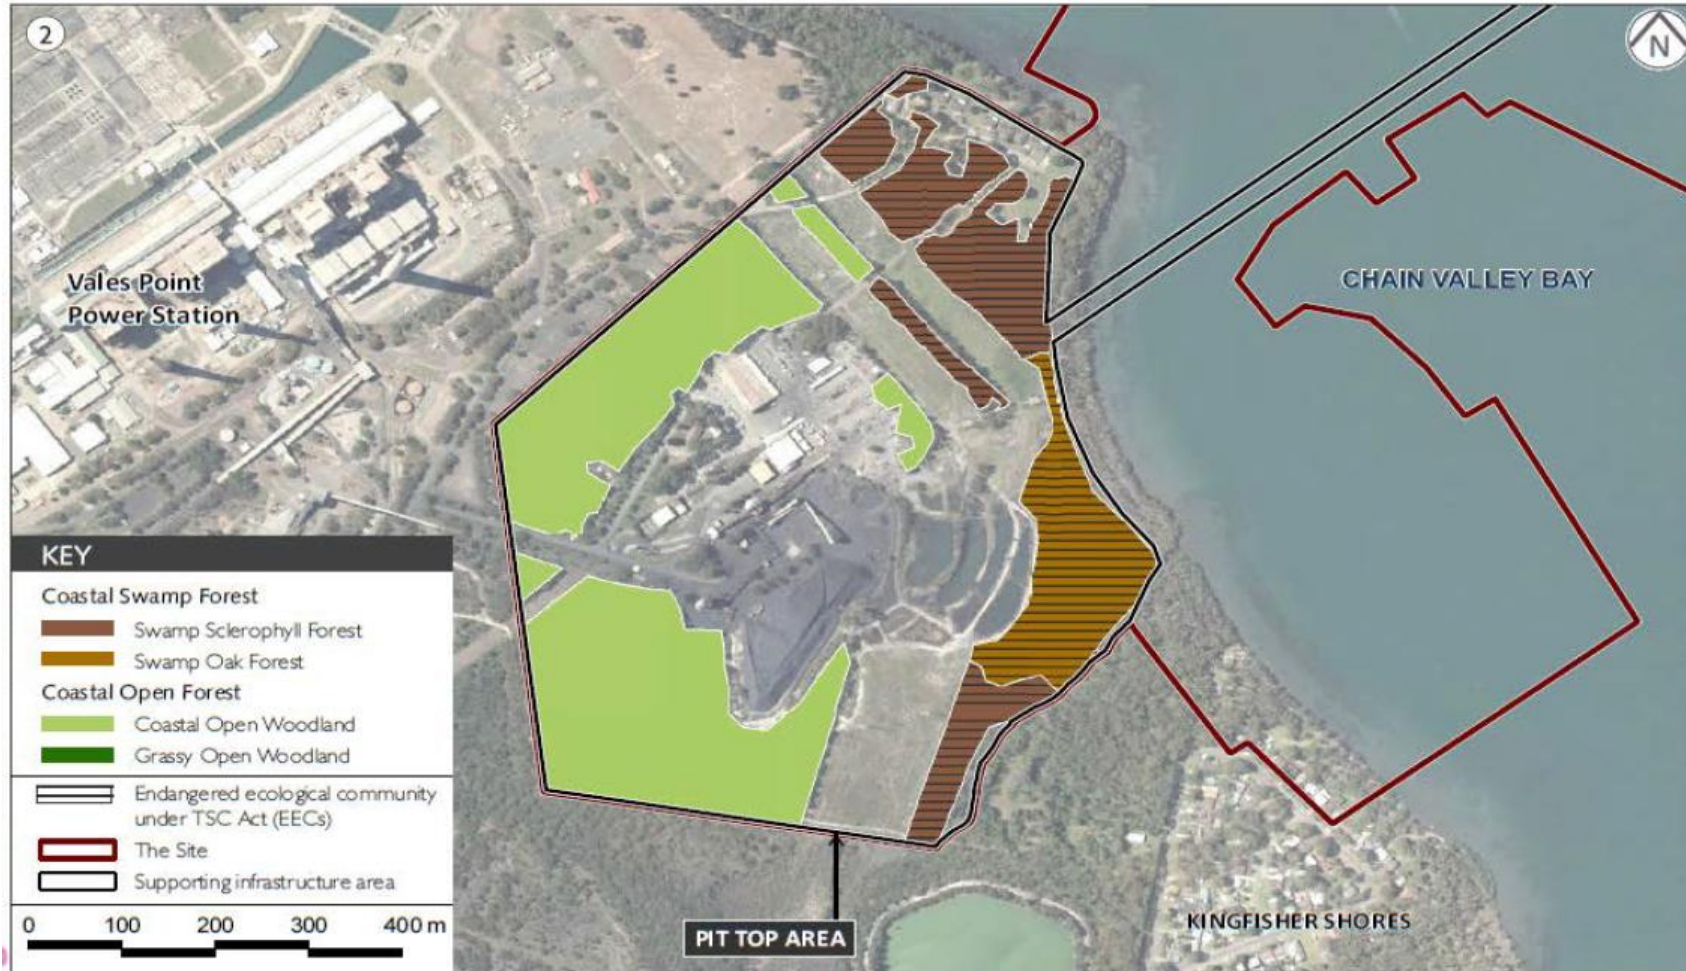
Figure 5: Biodiversity Enhancement Area

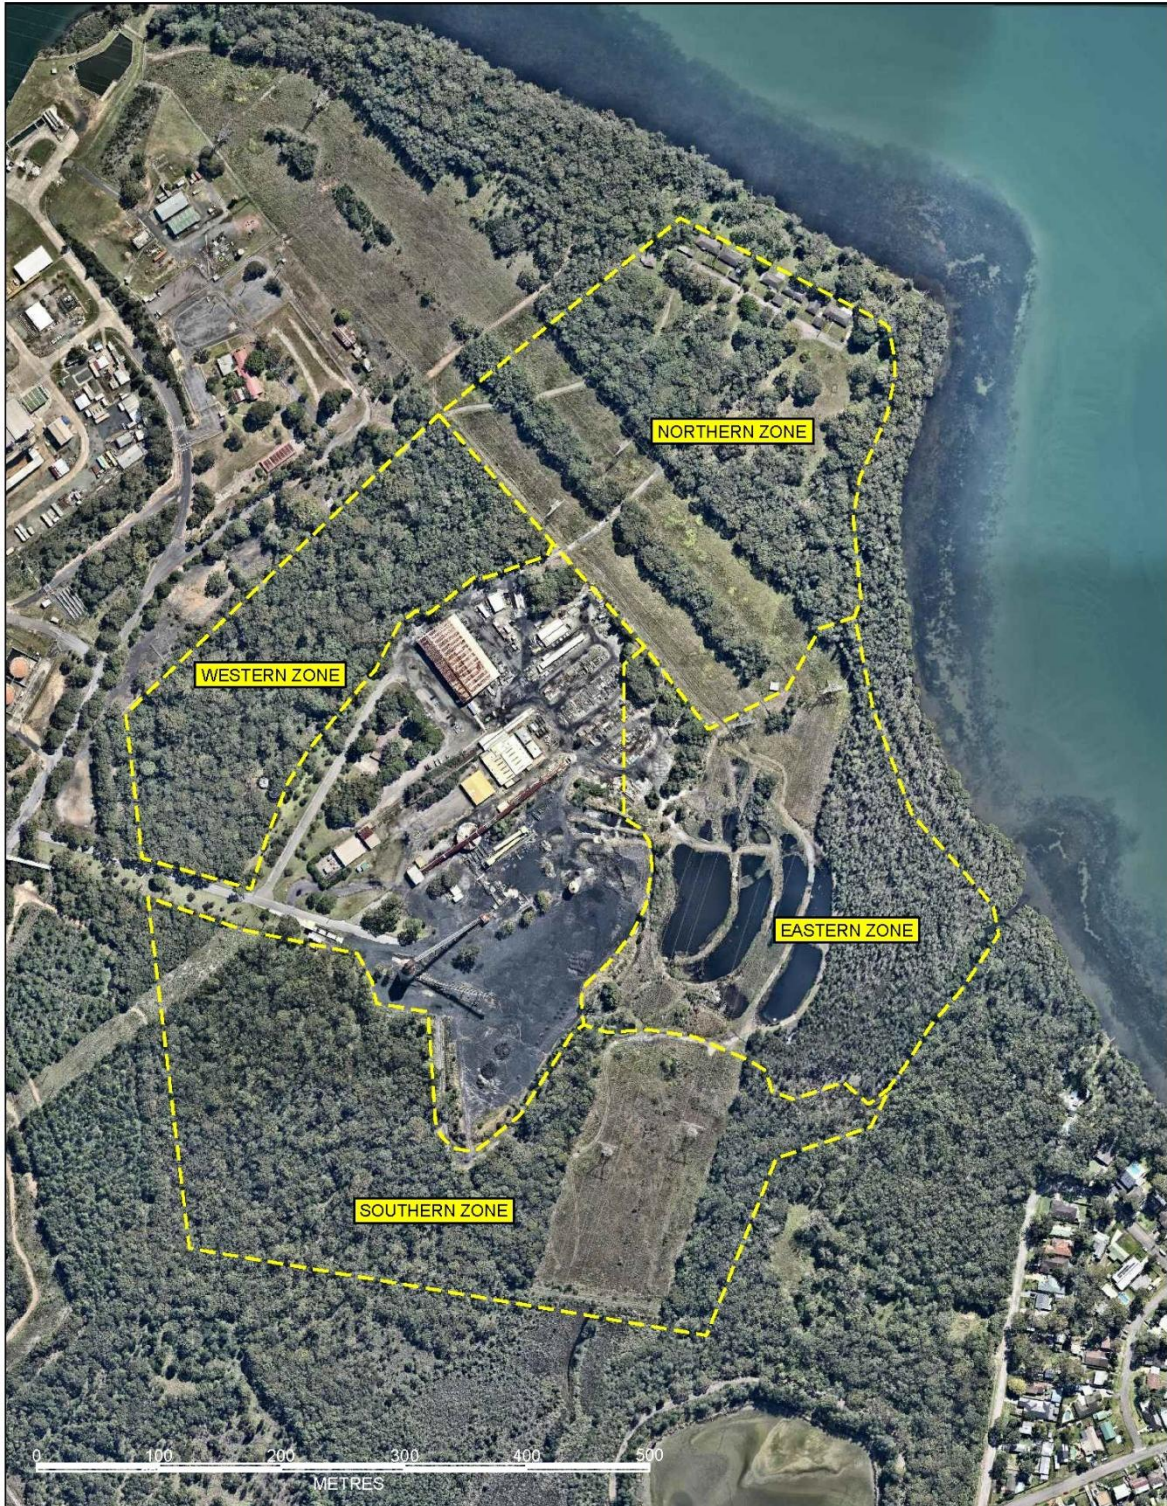
Figure 6: Pit Top Area Weed Management Zones

DELTA COAL CHAIN VALLEY COLLIERY		SCALE: 1:5000	DATE: 21 Nov 2019
	SURFACE FACILITIES VEGETATION MAPPING ZONES		DRAWN: T Chisholm	DRG NO: C150272
			CHECKED: K Weekes	REV NO: 0
			SIGNED: -	SIZE: A4

Monitoring Regime	Site	Monitoring Frequency	Methodology
Weeds	Pit Top area Ventilation Shaft	Annually	Target existing locations and significant new occurrences of weed species (Figure 6 and Figure 7) in each management zone. Record: <ul style="list-style-type: none"> - the number of individual weeds, the estimated size of infestation (i.e. m² for large infestations); - the estimated distance to native vegetation; and - recommended control measures.
Feral animals	Pit Top area and Ventilation Shaft	Annually	Monitor activity of feral species by searching for tracks, diggings, scats, burrows and sightings of individuals. Monitoring to be undertaken in conjunction with weed monitoring.
Bushfire risk /uncontrolled public access	Pit Top area Ventilation shaft	Annually prior to the fire season	APZ and fire trails (access to ventilation shaft area, access to houses to the north of the pit top area and tracks south of the pit top area to the transmission lines) to be visually inspected annually prior to the fire season (1 st October – 31 st March). Security firm to continue site security patrols and remote monitoring of security systems/alarms. Public access issues to be reported via standard incident form or in conjunction with weed/feral animal monitoring programs.

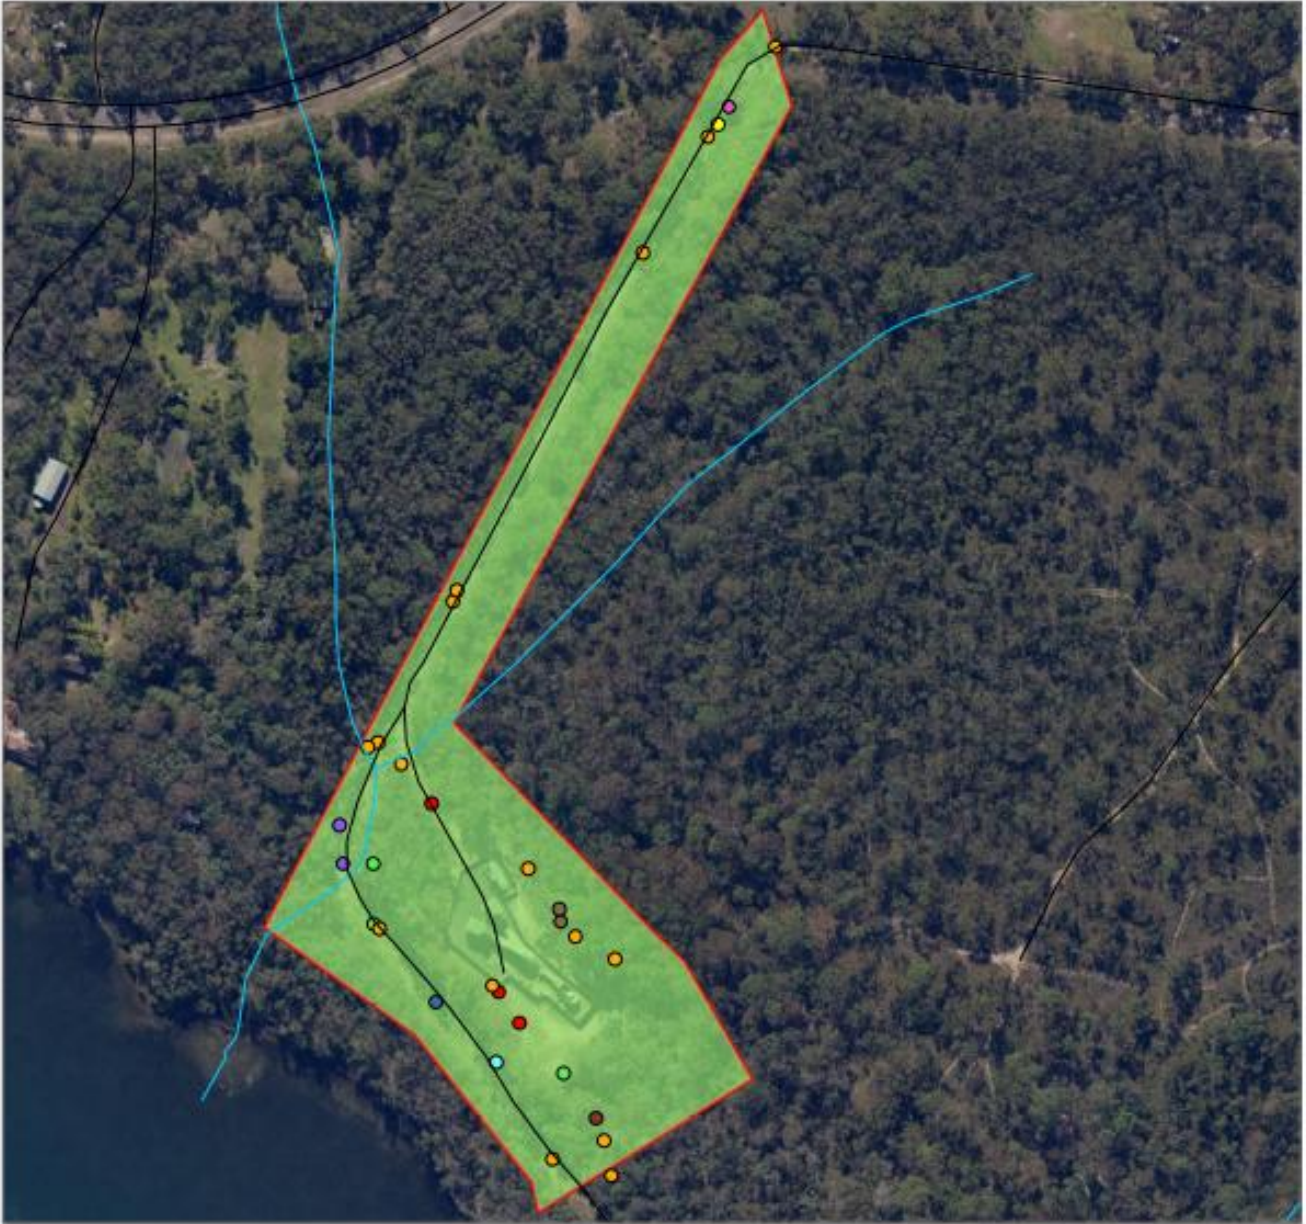
Figure 7: Ventilation Shaft Weed Management Zone and Distribution

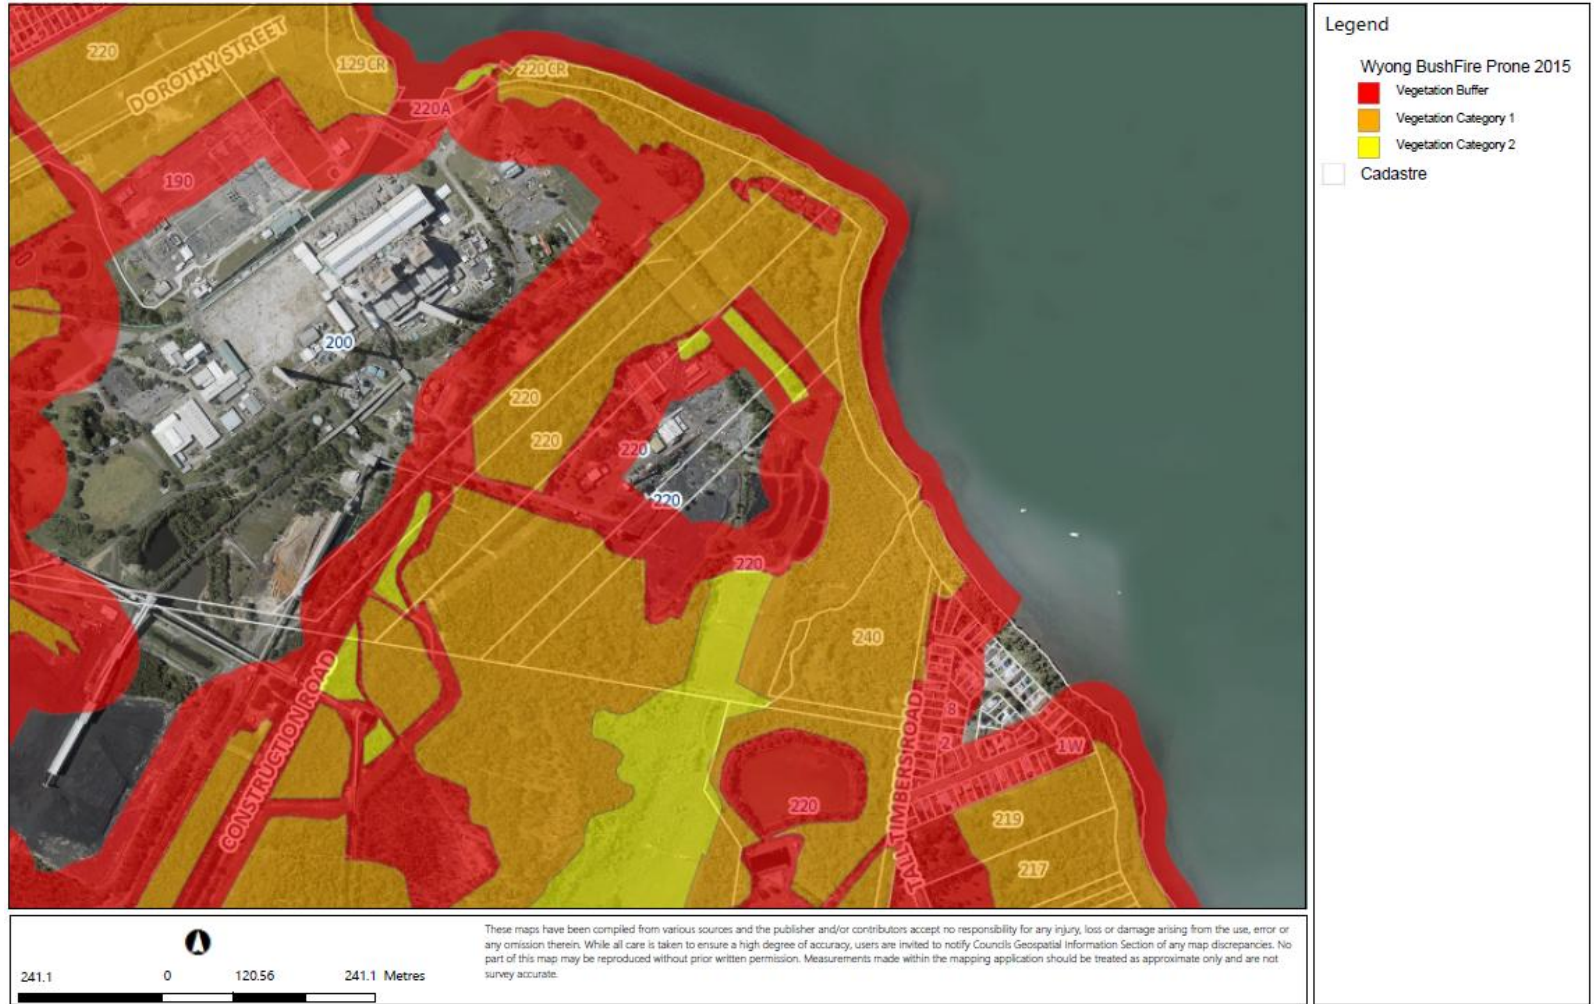
Figure 8: Bushfire Prone Land Map for the Pit Top Area (Source: Central Coast Council, 2015)

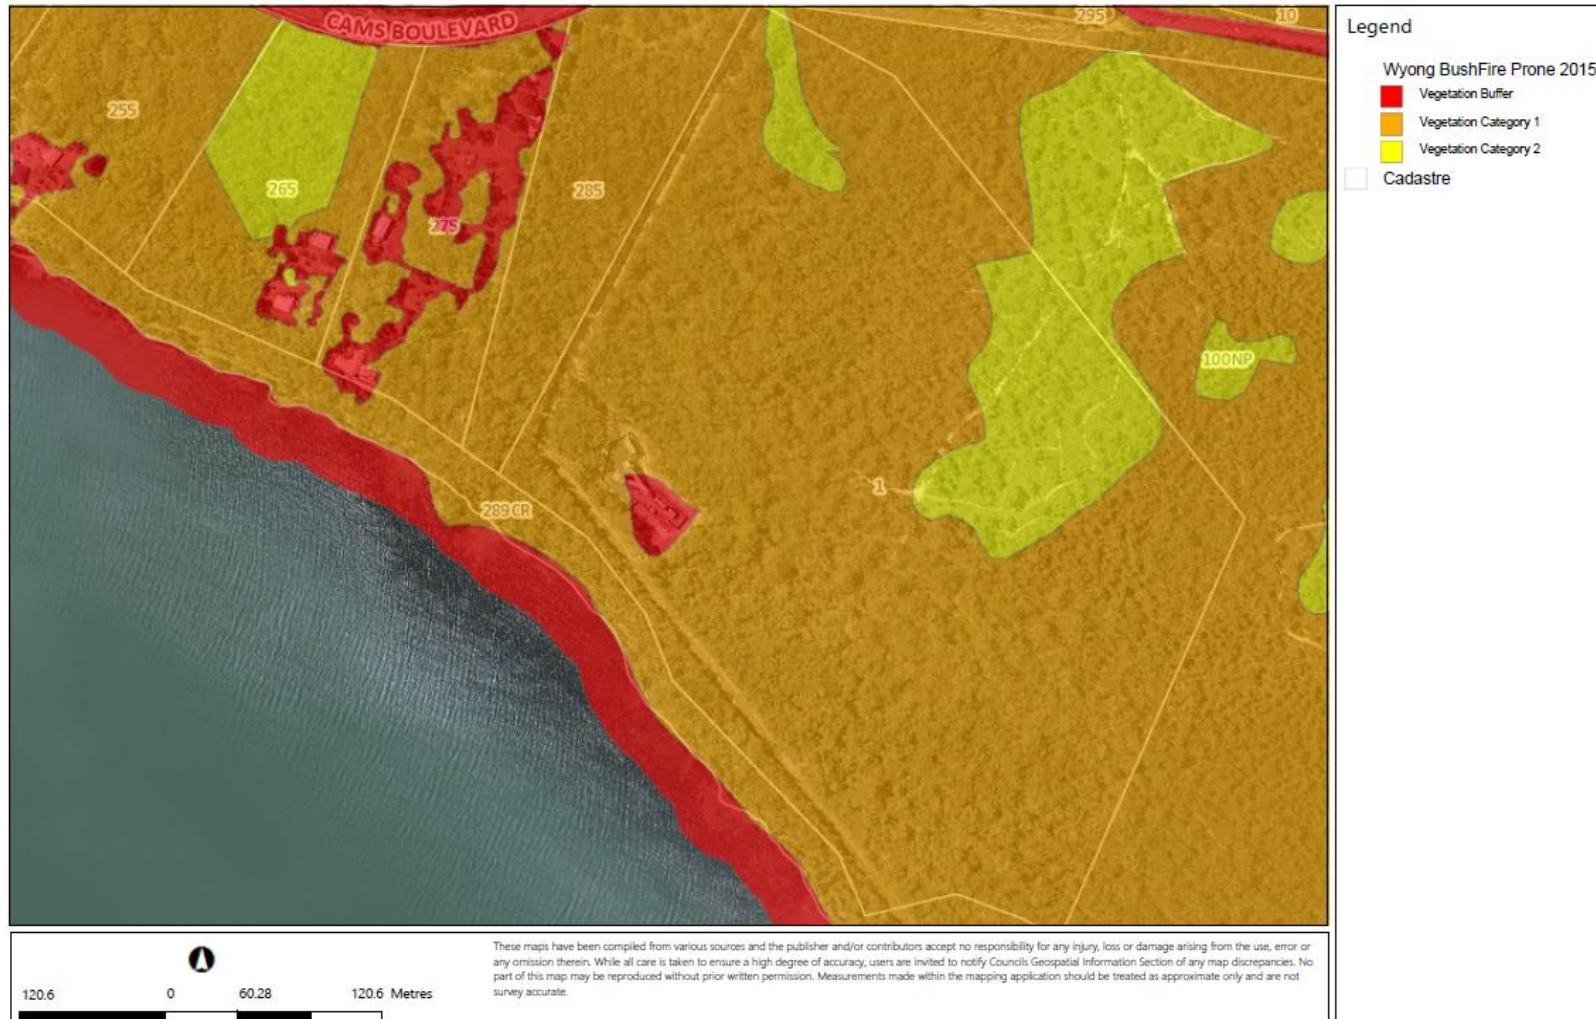
Figure 9: Bushfire Prone Land Map for the Ventilation Shaft Area (Source: Central Coast Council, 2015).

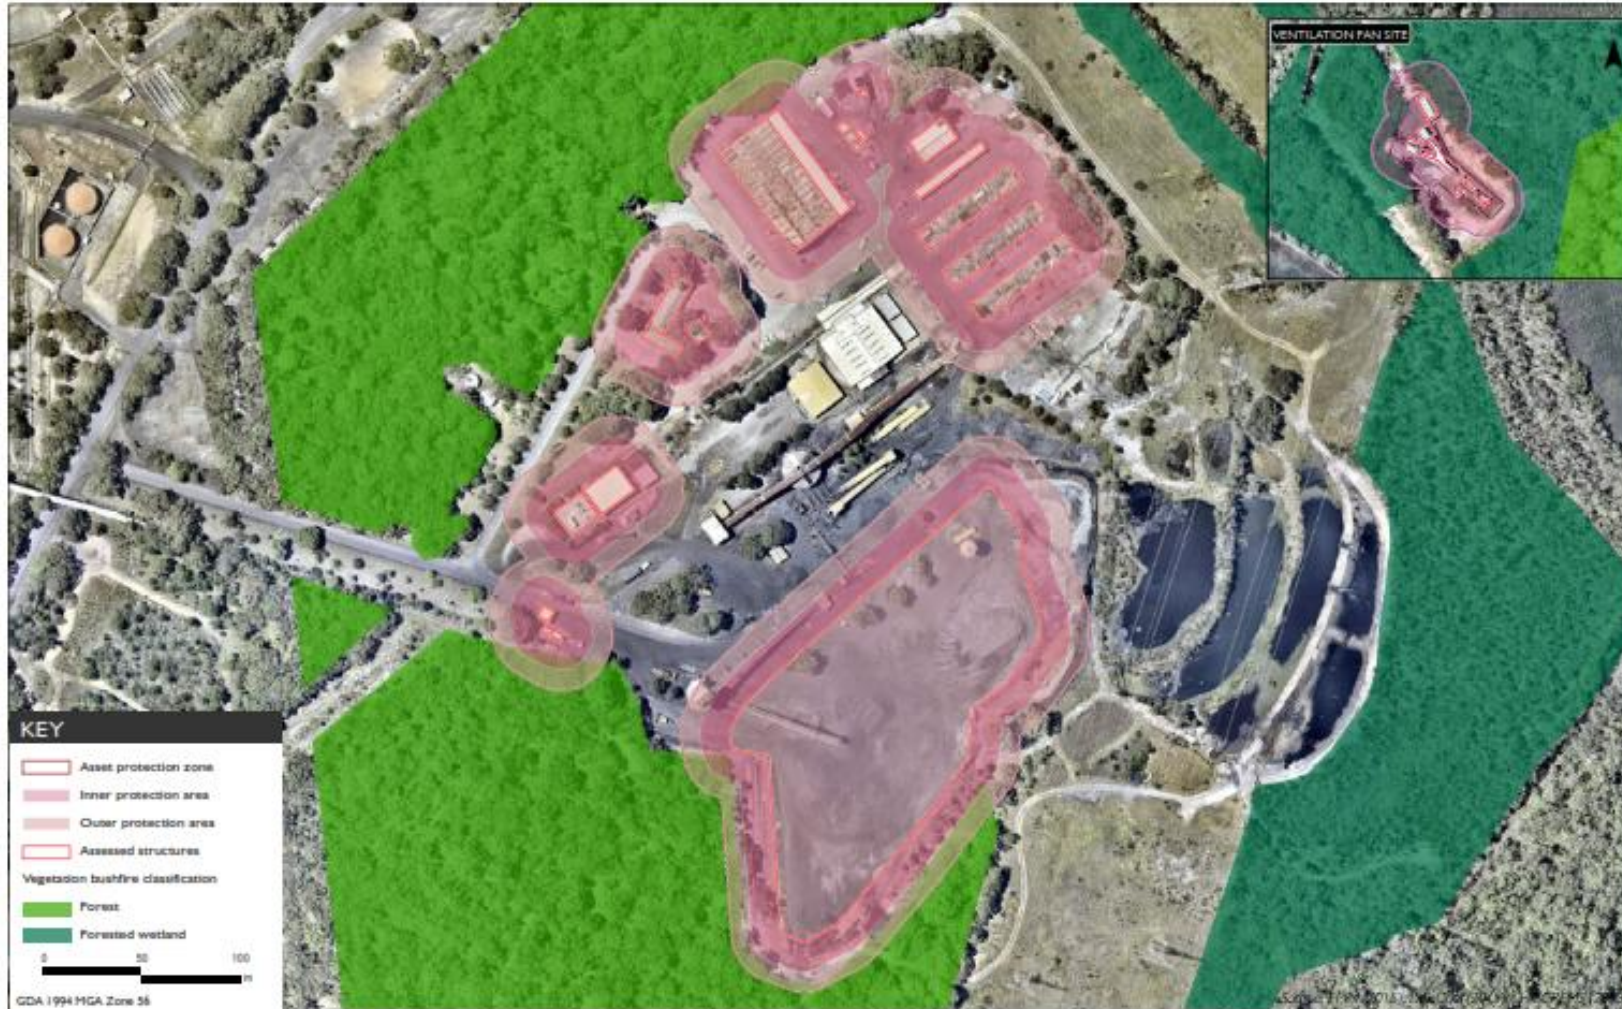
Figure 10: Asset Protection Zones

APZs were determined using the PBP guideline which compares the bushfire hazard vegetation classification, bushfire weather and slope classes on bushfire prone land to derive their minimum extent. The vegetation communities and slope classes were characterised in accordance with Appendix 4 of the PBP. CVC is located in the Greater Hunter Fire Weather Area (Fire Danger Index 100).

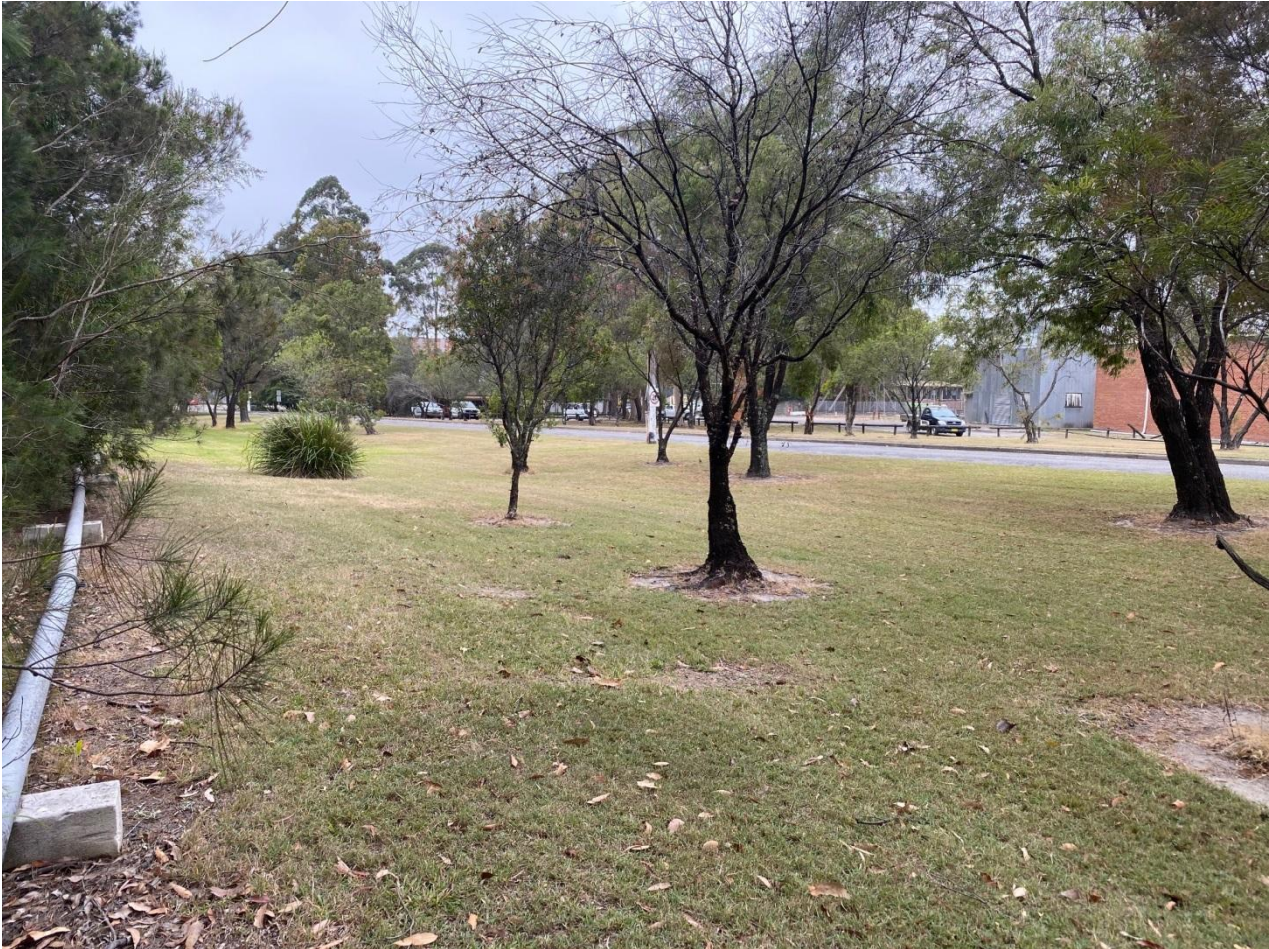
An example of the pit top APZ can be seen in **Figure 11**.

Figure 11: Firebreak between CVC Pit Top Area and Surrounding Bush

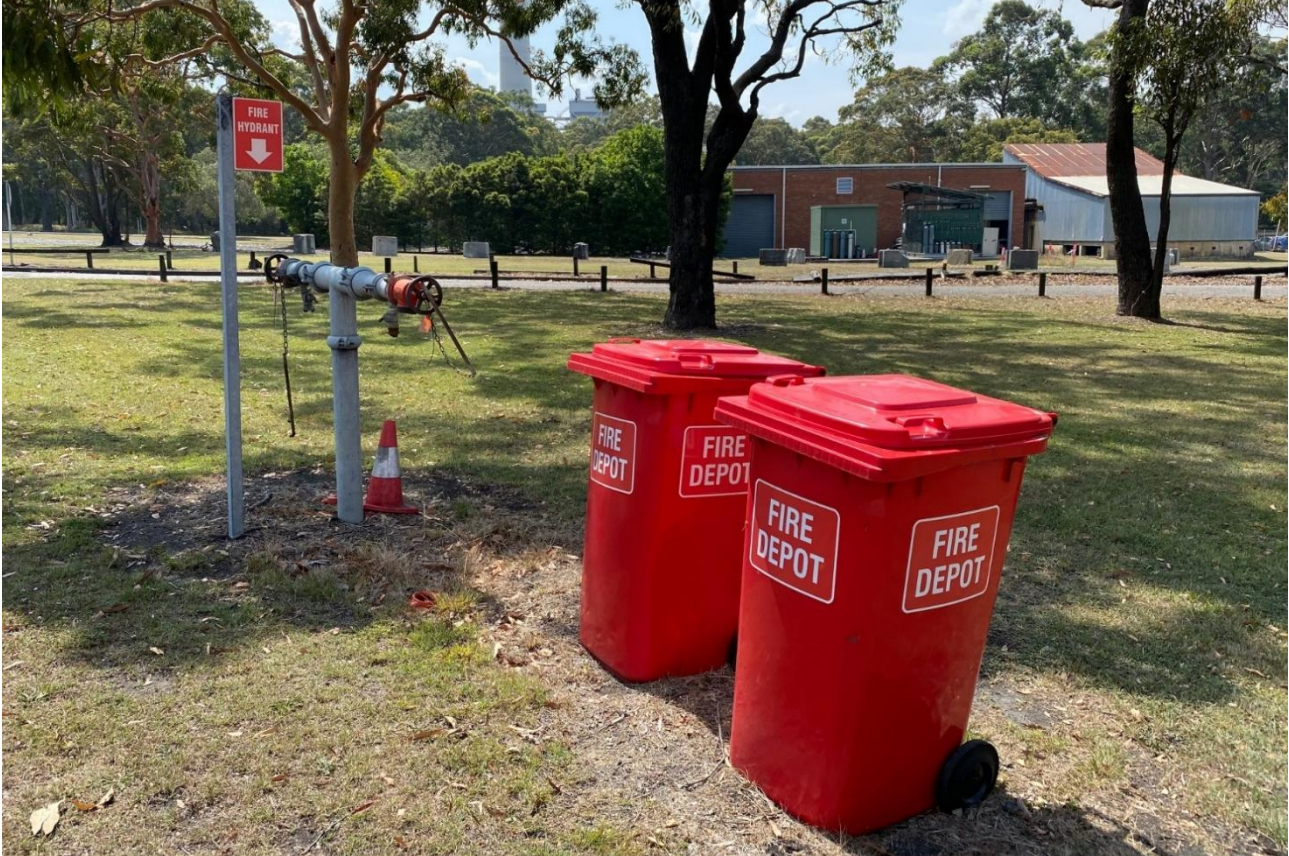
Figure 12: CVC Water Access Points
